Safety Factor Assessment 5-Year Update

San Miguel Electric Cooperative Power Plant CCR Ponds Atascosa County, Texas

October 2021

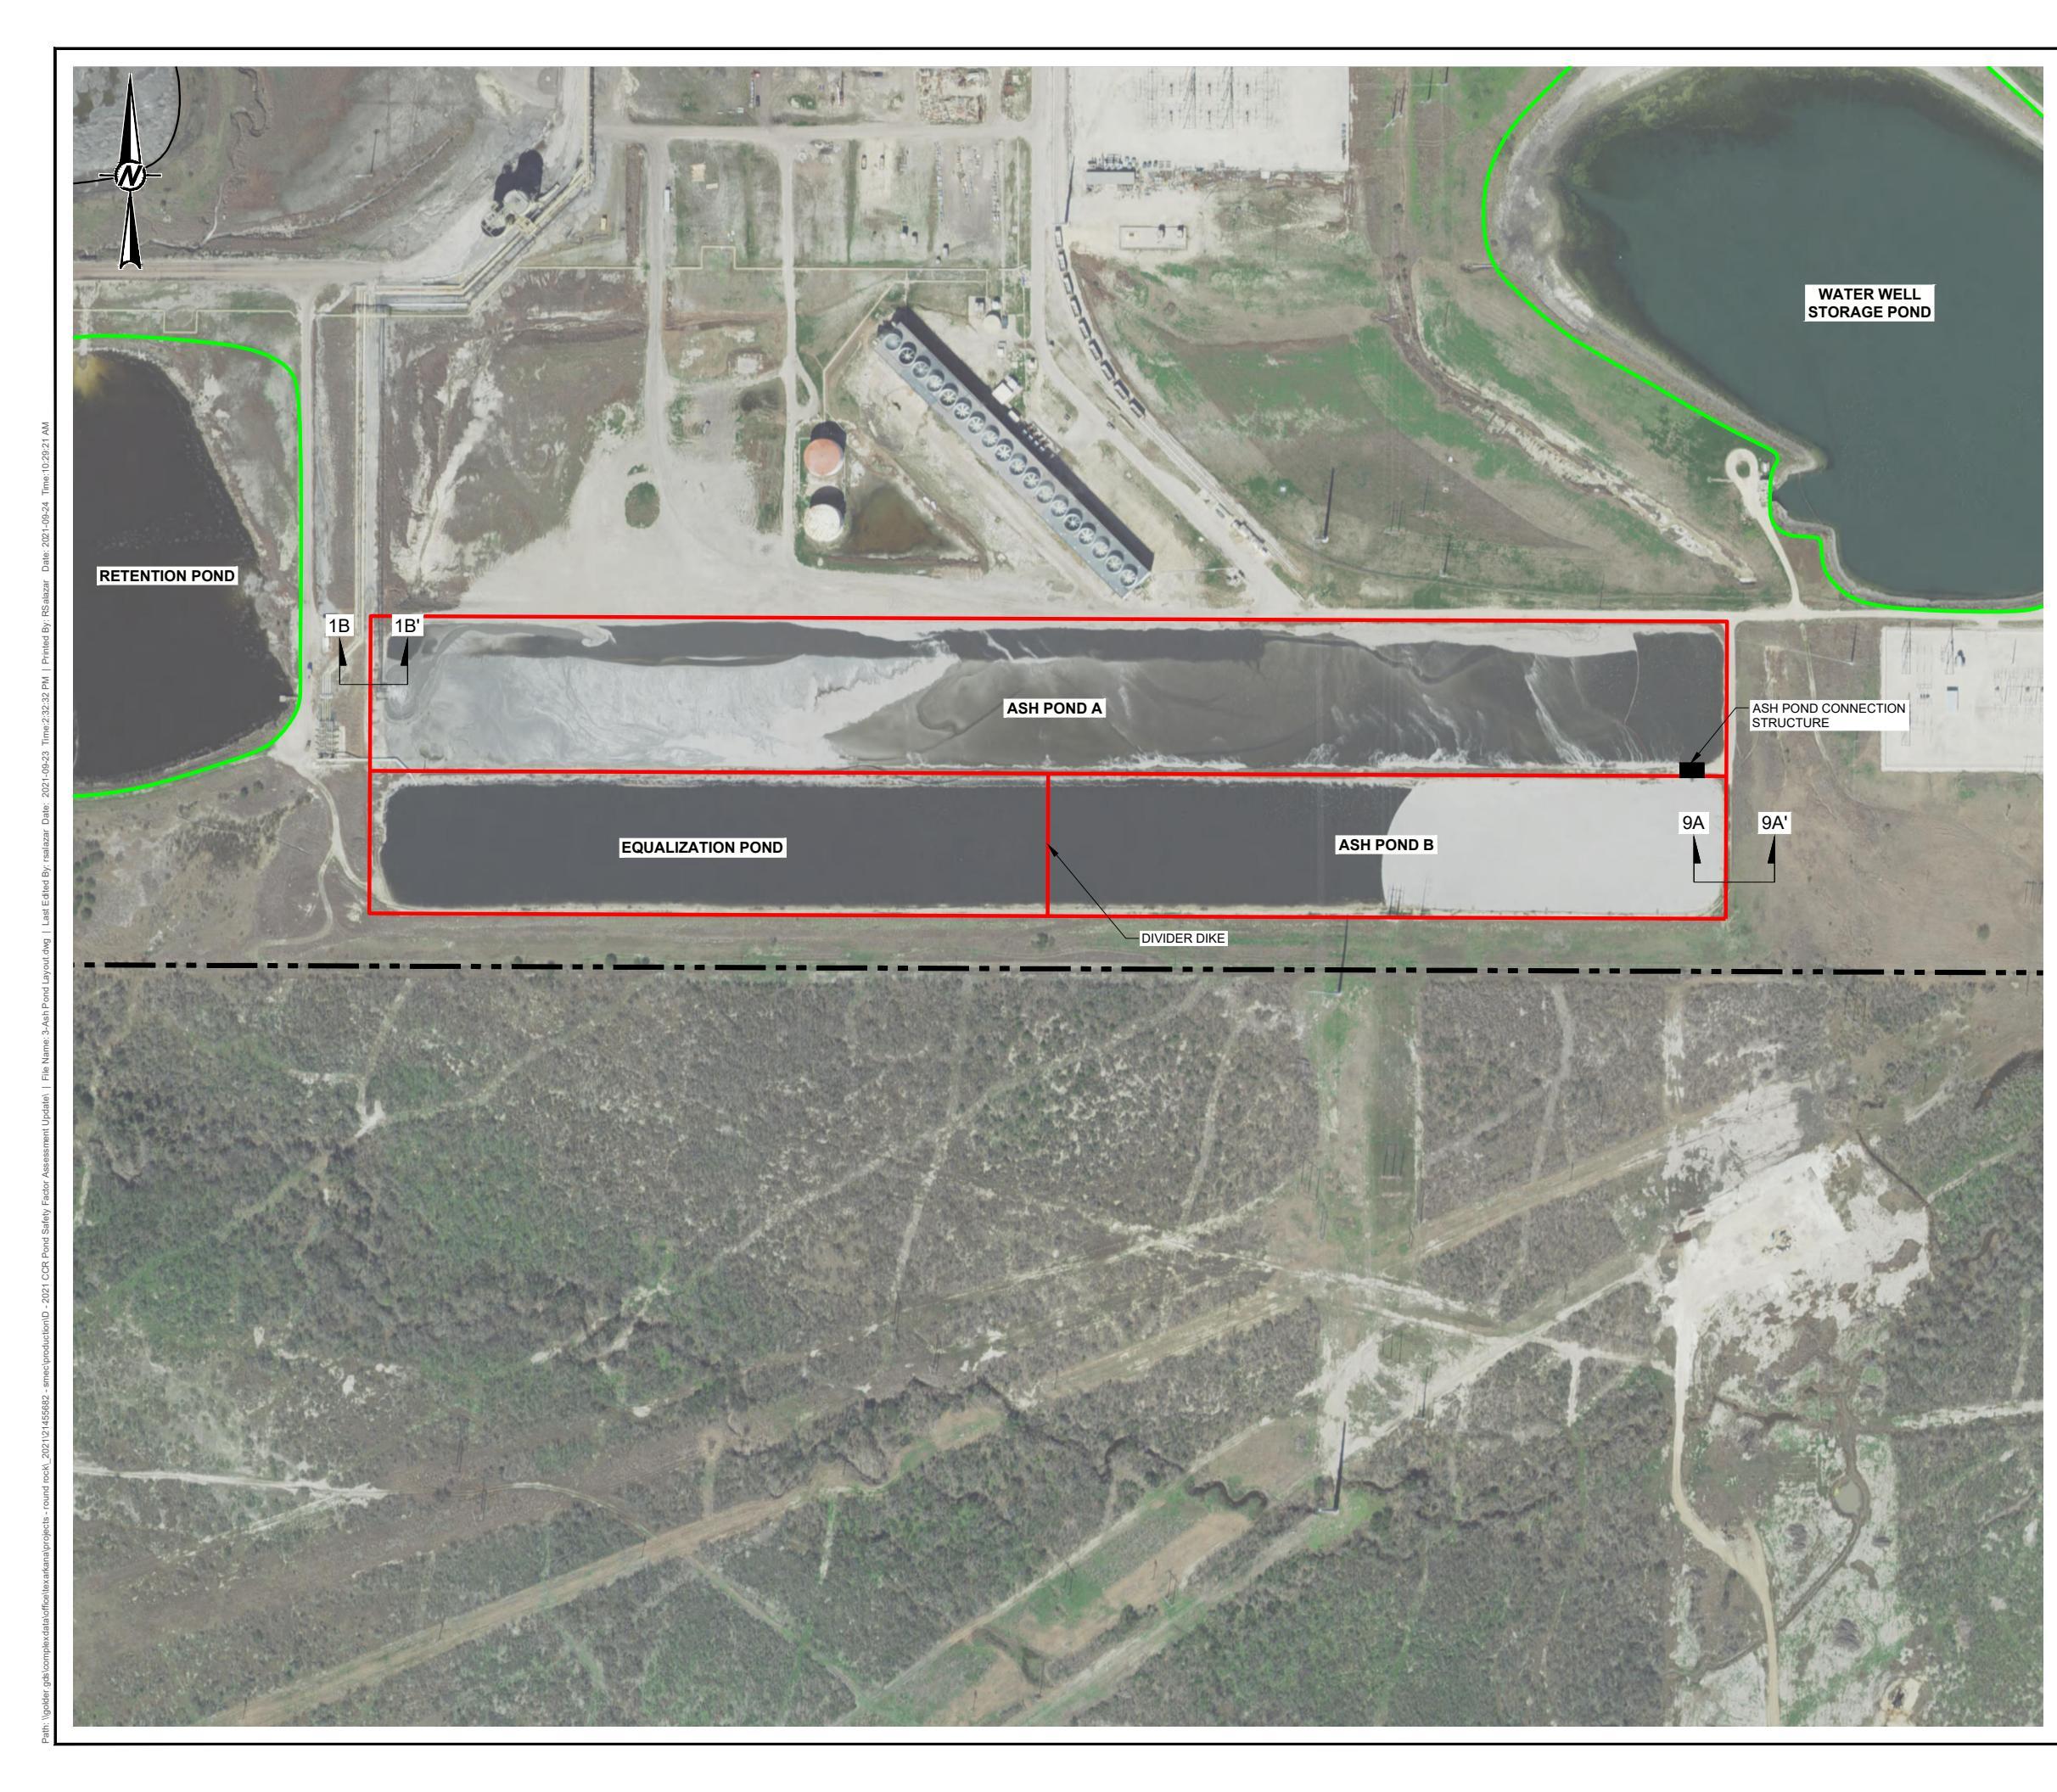
TITLE ASH POND LAYOUT

Section 1B, located along the western embankment of Ash Pond A and Section 9A, located along the eastern embankment of Ash Pond B were analyzed. The critical cross-section locations are shown on Figure 3.
