SHIFT KIT™ T.M.

TURBO HYDRA-MATIC 200

SK200™ SHIFT KIT™ T.M.

1976-78 INSTRUCTION SHEET

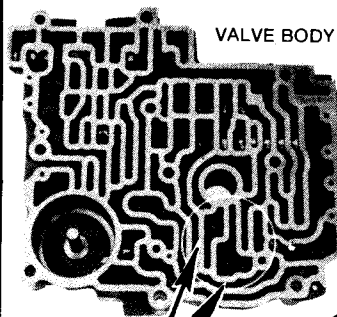
FIGURE 1

TWO HATCHET SHAPED PASSAGES HERE

HOW TO IDENTIFY 1976-78 TYPE

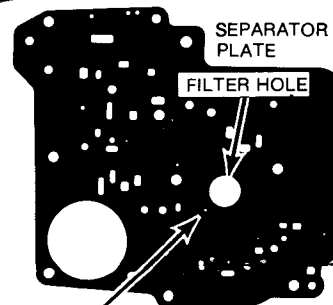
FIGURE 2

THIS KIT FITS
THIS TYPE ONLY

REVERSE BOOST HOLE LOCATED
AT THE 7:30 O'CLOCK POSITION
IN RELATION TO THE FILTER HOLE

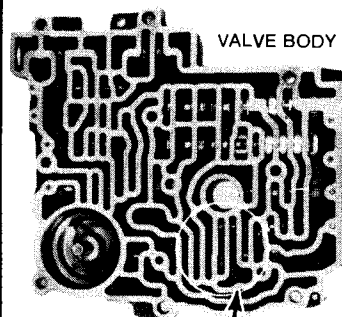
FIGURE 3

ONE FIRE AXE SHAPED PASSAGE

HOW TO IDENTIFY 1979 TYPE

THIS KIT WILL
NOT FIT THIS
TYPE V.B.

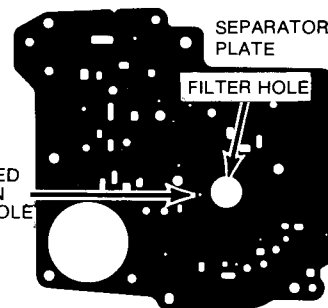
FIGURE 4

REVERSE BOOST HOLE LOCATED
AT THE 9:00 O'CLOCK POSITION
IN RELATION TO THE FILTER HOLE

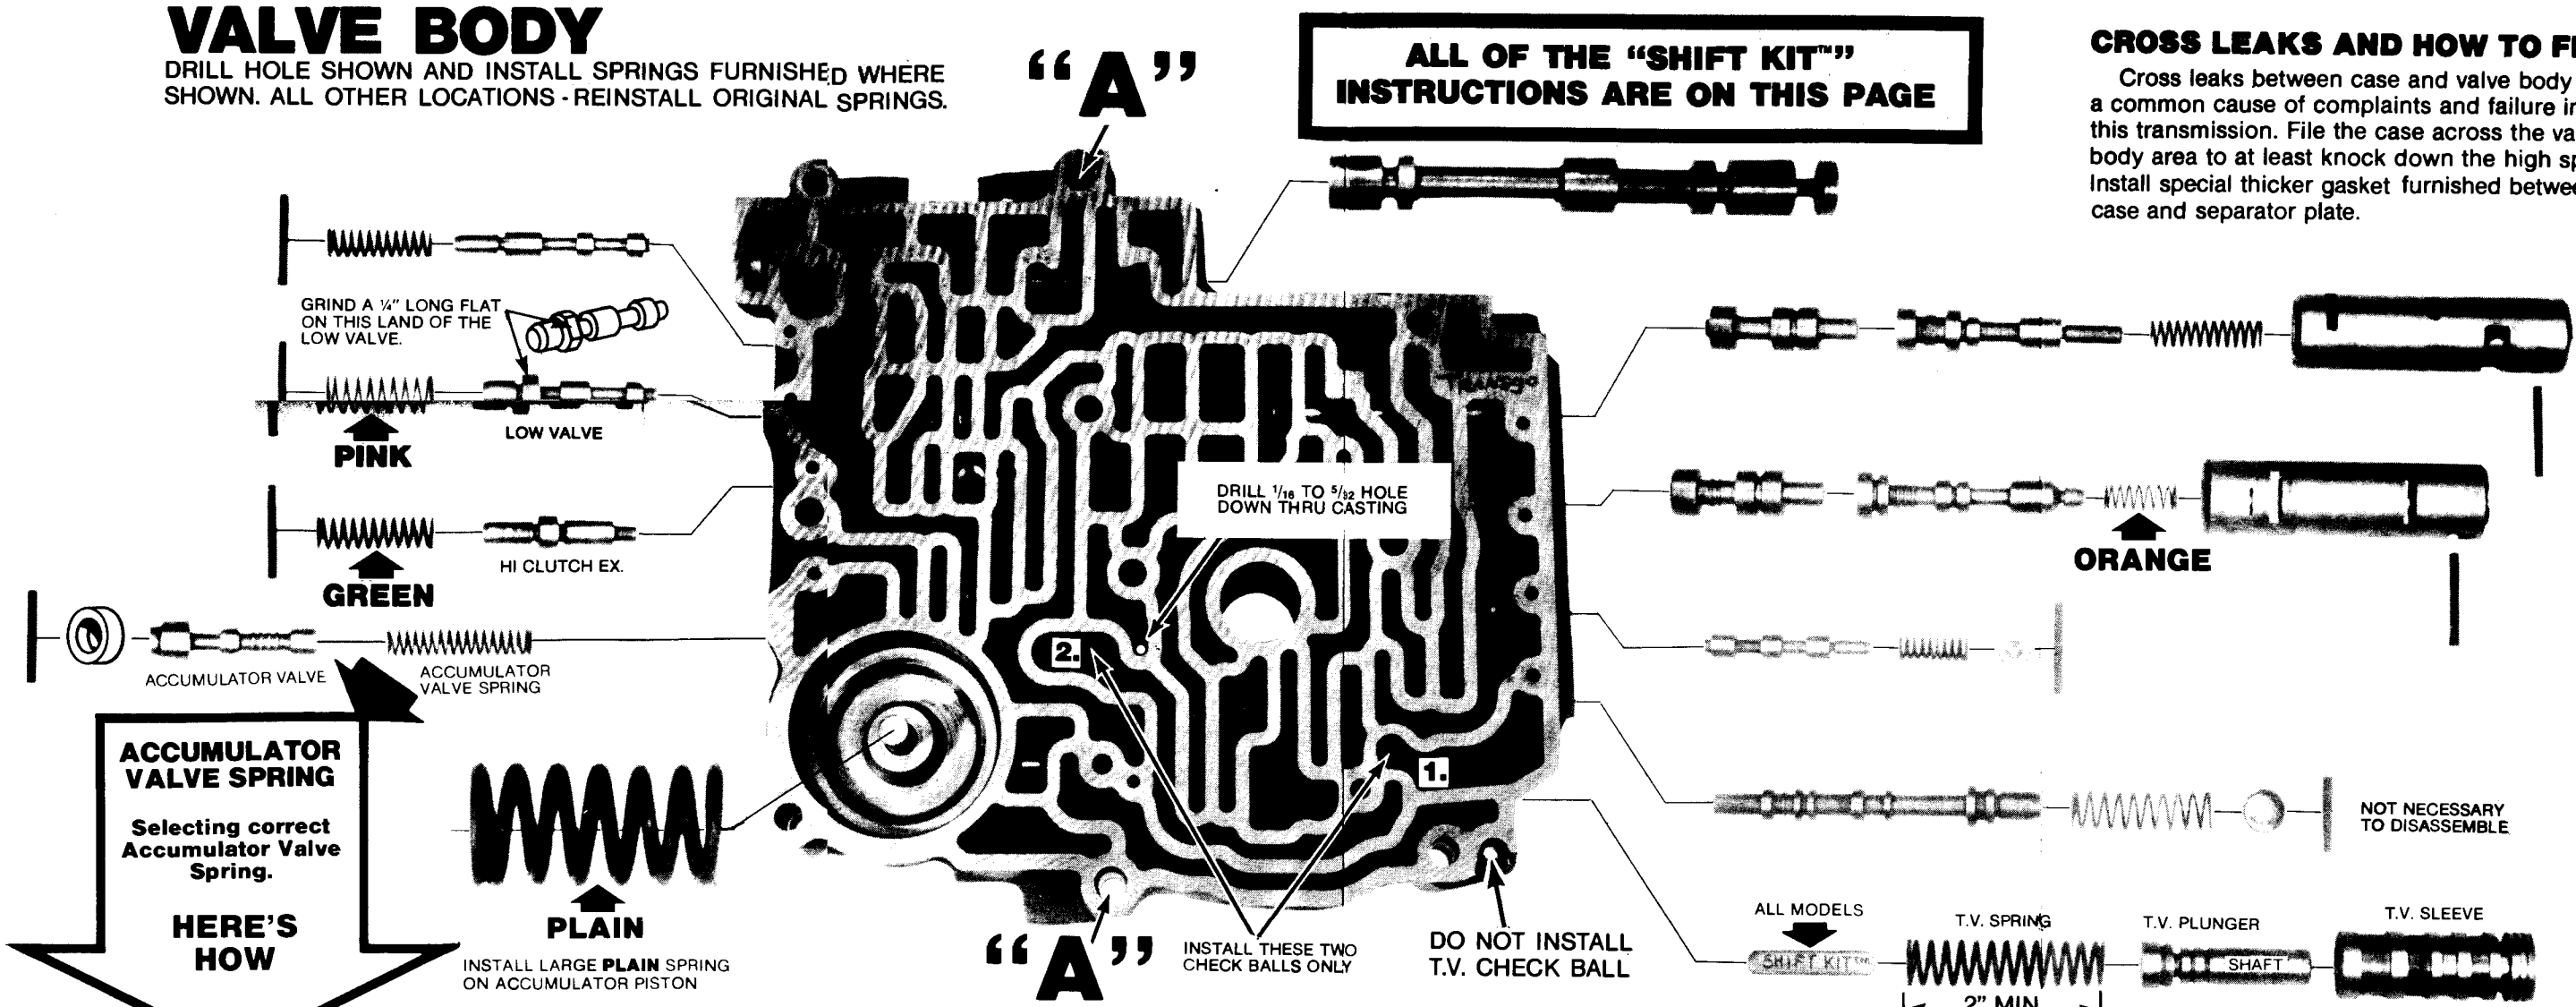
VALVE BODY

CROSS LEAKS AND HOW TO FIX:
Cross leaks between case and valve body are a common cause of complaints and failure in this transmission. File the case across the valve body area to at least knock down the high spots. Install special thicker gasket furnished between case and separator plate.

DRILL HOLE SHOWN AND INSTALL SPRINGS FURNISHED WHERE SHOWN. ALL OTHER LOCATIONS - REINSTALL ORIGINAL SPRINGS.

NOTE: There are two bolt holes in the valve body marked "A." These two holes are close fitting "Line Up Holes." Always install and tighten these two bolts first and your gaskets and separator plate will be aligned perfectly.

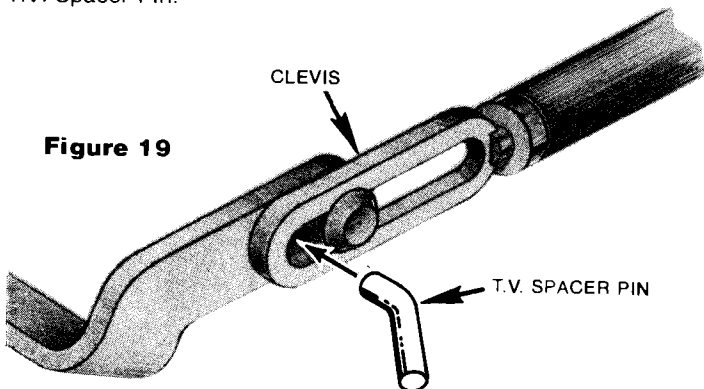
Figure 19

Adjustment with T.V. pin gives earliest possible shifts while still retaining kick downs.

THIRD STEP: With tab up as shown in Figure 17, pull clevis forward and insert the T.V. Spacer Pin (furnished) as shown in Figure 19. Hold spacer pin in position and push throttle to wide open. Now push down T.V. adjustment locking tab. Remove T.V. Spacer Pin.

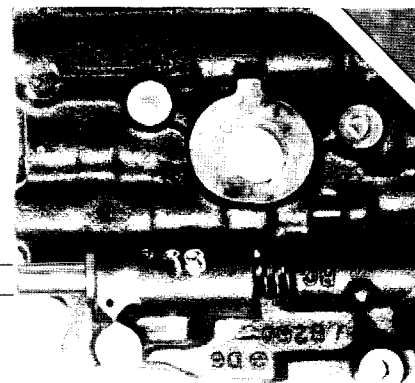
Figure 21

3. T.V. PLUNGER SHAFT AND SLEEVE MISMATCHED WITH T.V. VALVE:

If T.V. Plunger Shaft and Sleeve is too **SMALL**, you will have erratic very late upshifts or no upshift.

If T.V. Plunger Shaft and Sleeve is too **LARGE**, the throttle will be hard to push.

The Shaft on the T.V. Plunger comes in 3 different sizes (diameters) to match 3 different T.V. Valve sizes.

The code on the T.V. Valve, in the valve body, will tell you what size T.V. Plunger and Sleeve must be used. Follow the arrow from "T.V. VALVE" in FIGURE 8 (page 2-3) and look at the spool part of the valve as you move the valve back and forth slowly.

- 1 Machined Rib = Use .430 Dia. Plunger and Sleeve
- 2 Machined Ribs = Use .390 Dia. Plunger and Sleeve
- No Machined Rib = Use .357 Dia. Plunger and Sleeve
