4T65E SHIFT KIT®

Long shifts, hard shifts, chatter with heavy acceleration from stop, no lockup or 4th. Codes P1811--PO741

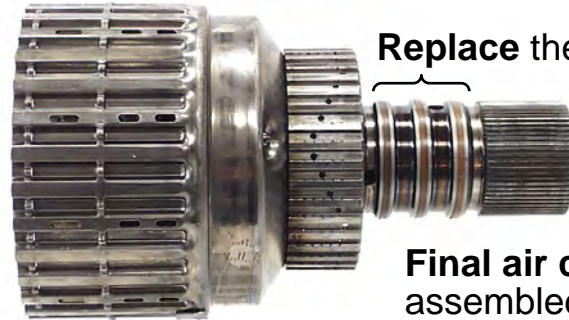
Input piston worn. **Replace it.**
The three input drum solid teflon rings shrink, **always** replace them.

Replace these rings.

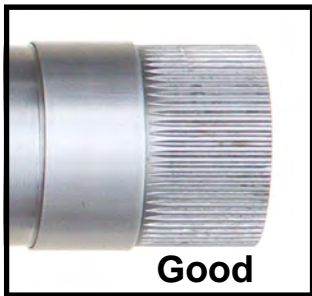
Good

Look at splines.

4th clutch hub

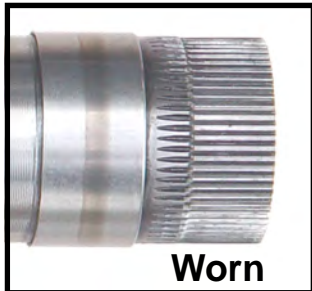
Worn

Funny looking splines are no laughing matter. They will **strip** so don't ignore them. It's no 4th.
