SK° 604 Non-VLP 604/41TE & 606/42LE 1989-2006 Also fits 42RLE 2003-2006

Corrects / Prevents / Reduces

Delay or No Forward or Reverse, Rough Coast Down 4-3, Stabilizes Clutch Pressure & CVI's.

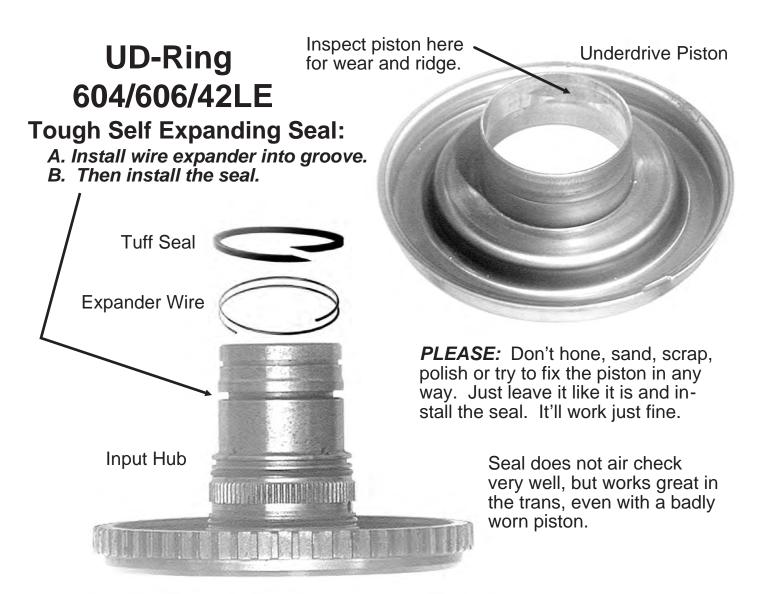
COMPLAINT: Limp or Delayed Forward movement when cold, OR Limp after long freeway run: Code 36 & 39 or 53

Close inspection of underdrive piston bore will show wear and a ridge where the piston has rubbed against the seal groove in the input hub. This ridge nibbles the seal and the wear causes cold leak.

With a worn piston or a cut seal there will be a delay or no forward cold and sometimes limp on cold startup: until the seal warms and becomes more pliable.

During a long run in 4th the seal relaxes and fails to re-seal quickly causing limp, during a 4-3 coast downshift between 26 and 19mph. The computer sees the delayed apply by watching the sensors and places trans in limp and sets code 36 along with 39 or 53.

A temporary solution is a new piston for \$27. A better fix is a quality self expanding seal that is pliable enough to seal into worn area and tough enough that the ridge won't cut it.

It's included in 606/604 Shift Kit®.
