# SK<sup>®</sup> AX4N Shift Kit<sup>®</sup> Fits 1995 to 2005 AX4N & 4F50N

2004-2005 Units: Skip pages 5-6 See extra page.

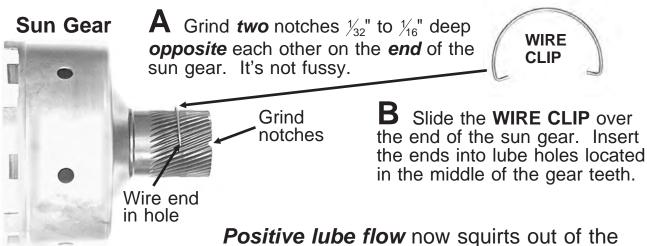
**Positive lube flow** now squirts out of the notches on end of sun gear directly onto the planetary gear teeth and the needle bearing.

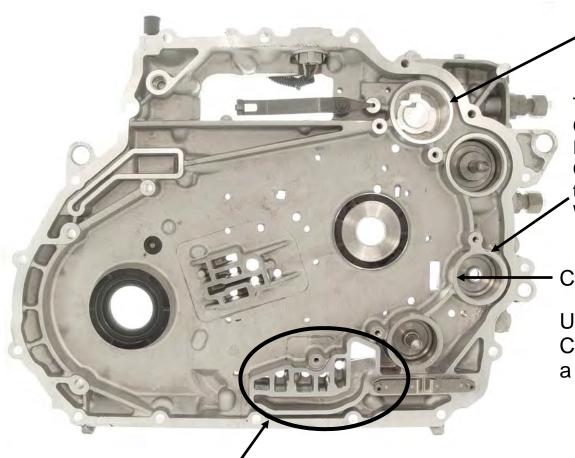
There are 2 LATE STYLE Channel Casting gaskets! The size of the REVERSE Accumulator was changed! Check gasket at this location and at the bottom area inside the oval shown! Wrong Gasket causes LOW LINE!

Case Cover Gasket blows out here.

Look carefully for changes in this area. Make sure Gasket match's with Case & Case Cover passages.

Do not install white Spring with this type1-2 Accumulator Piston.

Use contact type sealer on Gasket & CASE surface. *Gasgacinch* Sealer is a good one.
