SK® CD4E-Jr Shift Kit® Series 7D Corrects/Prevents/Reduces

Converter Slip and Code 628

Ford CD4E Mazda LA4A-EL

READ THIS: CD4E Repair Data

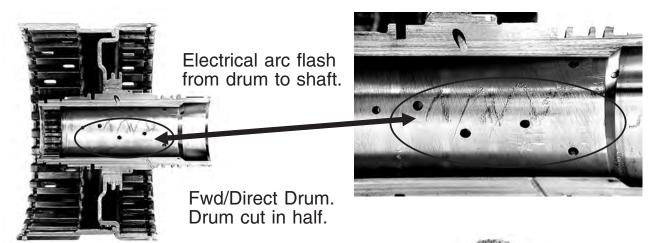
1994 to 97 4cyl Probes and Mazda 626's have a serious ground strap problem that will eat this trans up in a few days—Unless you prevent it. It may look like a lack of lube, but the cause is the engine is starting through the bushing and the gears instead of through the ground strap. The parts shown are out of trans that came back three times.

Melted bushing

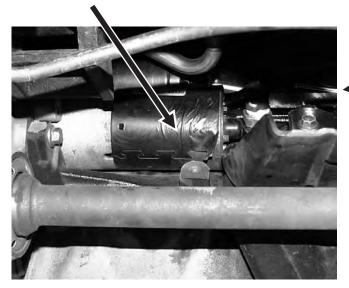
Engine Ground Strap Pad File the pad and both sides of the ground strap.

The car factory put locktite here which can insulate the strap.

Remove the ground strap that goes from battery to the fender. Clean the paint and the strap and reconnect it.

How to check for solid ground: Attach a volt meter from the negative terminal of battery over to the trans. It must read .09V or less, even while starting the engine.
