GF4A-EL Shift Kit®

Probe: All 1993. 1994-97 with 2.5L [Ford designation: 4EAT-GF] Mazda: 1994-97 MX-6/626 with 2.5L-1995-97 Millenia with 2.5L

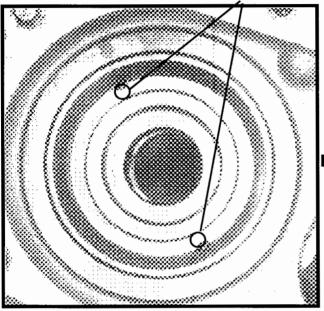
Prevent front seal blowout.

The bearing race covers 2/3 of the front seal drainback holes.

1. Use 1/4" drill. Drill about 1/4" deep just inboard of the moon shaped holes.

Then re--aim drill outboard and drill into the drainback holes.
Do not use goop on front seal. Install front seal clean and dry. **Bell housing**

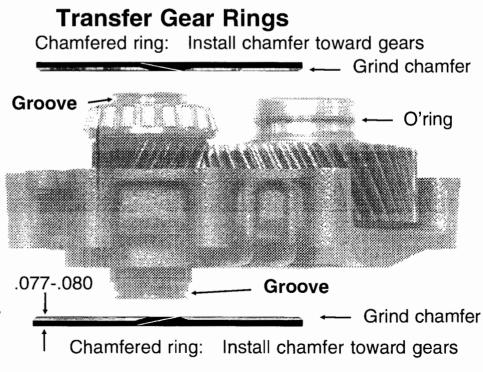
Complaints: 3-4 clutch burn-up; Runaway instead of 2-3 shift; Long and soft 2-3 upshift. Two things effect these rings. Fix the rings: Grind a 45° chamfer about 1/3 of the way across the OD. Skip the portion close to the scarf cut. Run your finger nail around the edges to scrape off any fringe or grinding burrs. Then pull the ring out flat once to open it up. Install it in groove with Vaseline. Some replacement rings are too narrow or wide. All Teflon rings in this trans should be .077 to .080 wide.

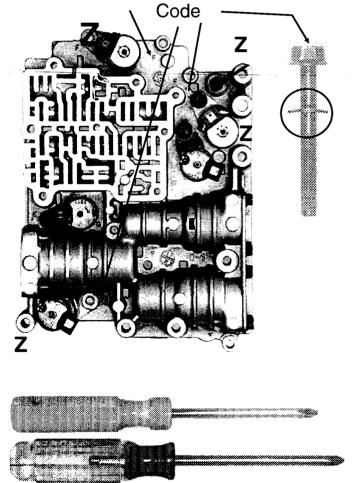
Valve Body

Bolts have special angled washers. The high side goes towards bolt head. Bolts have an alphabet *code* on head and matching *code* next to each hole in the VB. That's where they install.

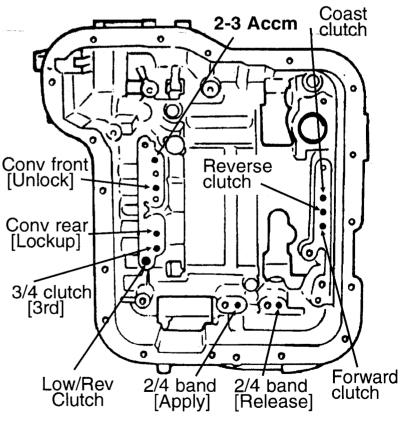
Air checking

With pump oil can, pump 20 squirts into circuit. Apply with air. The 3/4 clutch may take 40 squirts to apply. Don't expect it to be air tight, but 30 lbs of air should apply the clutch.
