## Inspection Report (Generator)

Year	2005
Make	Airman
Model	185
Serial Number	Unit #102
Hour Meter Reading	6,249 + 1,798 (two hour meter readings)
Previous Application (e.g., earth moving, mining, demolition, etc)	General Contractors

Engine Type (Make, Model, Cylinders, Hp)	NISSAN - 4 Cyl. - TD27 - 2.6L - 49HP
Emissions Tier	Tier 1
Engine Fuel Type	Diesel
Engine Photos

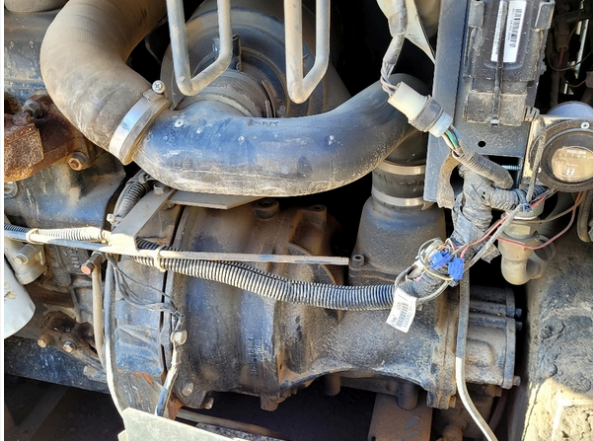
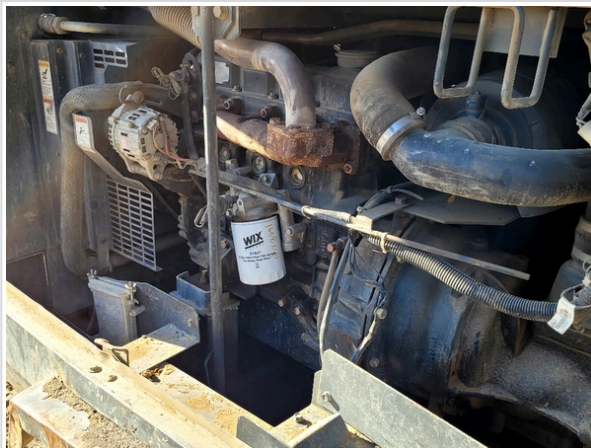
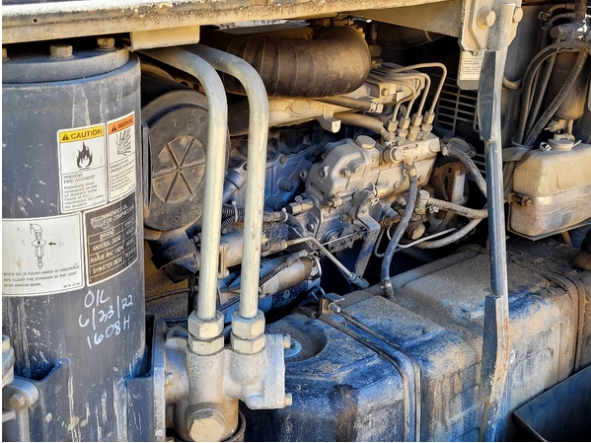
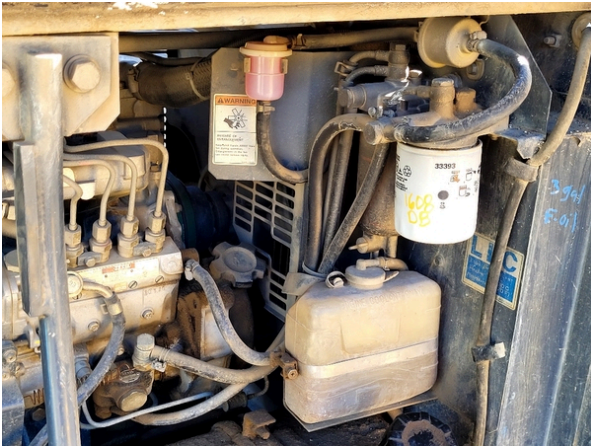
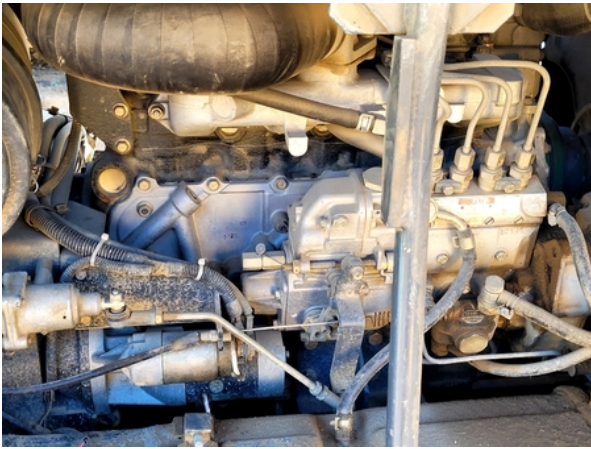
<b>Blow-by (Visual Observation Check)</b>	No
<b>Unusual Noises (Upon Start-up, Idle, Shutdown)</b>	No
<b>Unusual Noise Notes</b>	No unusual noises heard
<b>Engine Exhaust Color</b>	Clear
<b>Battery</b>	3 - Normal Wear & Tear
<b>Battery Condition</b>	Clean & dry appearance, tight connections

Radiator	3 - Normal Wear & Tear
Radiator Condition	Radiator fins & components appear to be in good working order, no signs of damage or leaks
Belts	3 - Normal Wear & Tear
Belt Condition	Belts appear in good condition & alignment with proper tension
Hoses	3 - Normal Wear & Tear
Hose Condition	Firm, pliant hoses with no signs of wear or leaks
Water Pump	3 - Normal Wear & Tear
Water Pump Condition	No unusual pump noises heard
Cooling System Leaks	No
Coolant Color / Appearance	3 - Normal Wear & Tear
Coolant Color/Appearance Notes	Normal Translucent appearance, no visual signs of contamination
Oil Leaks	No
Oil Color / Appearance	3 - Normal Wear & Tear
Oil Color / Appearance Notes	Clean oil appearance, no signs of cross contamination, Appropriate oil level
Fuel Leaks	No
Requires DEF (Diesel Exhaust Fluid)	No
Overall Engine Appearance	Clean & dry
