## Enterprise Equipment Inspection

Category	Excavator
Travel System	Track Undercarriage
Comments	
Year	2017
Make	Takeuchi
Model	TB210R
Fleet ID	10651427
Serial Number	211001733
Serial Number Plate

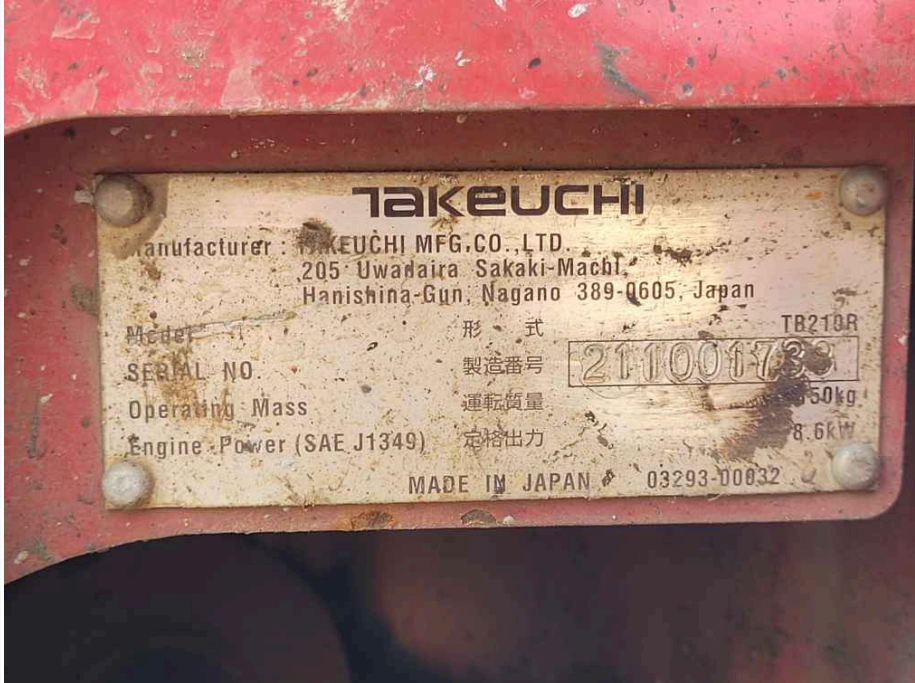
<p>The image shows a metal serial number plate for a Takeuchi excavator. The plate is mounted on a red-painted metal surface. It contains the following information:</p> <ul style="list-style-type: none"> <li><b>TAKEUCHI</b> (Manufacturer Name)</li> <li>Manufacturer: TAKEUCHI MFG. CO., LTD.</li> <li>Address: 205 Uwadaira Sakaki-Machi, Hanishina-Gun, Nagano 389-0605, Japan</li> <li>Model: TB210R</li> <li>SERIAL NO.: 211001733</li> <li>Operating Mass: 50kg</li> <li>Engine Power (SAE J1349): 8.6kW</li> <li>MADE IN JAPAN</li> <li>03293-00032</li> </ul>
Hour Meter Reading	119

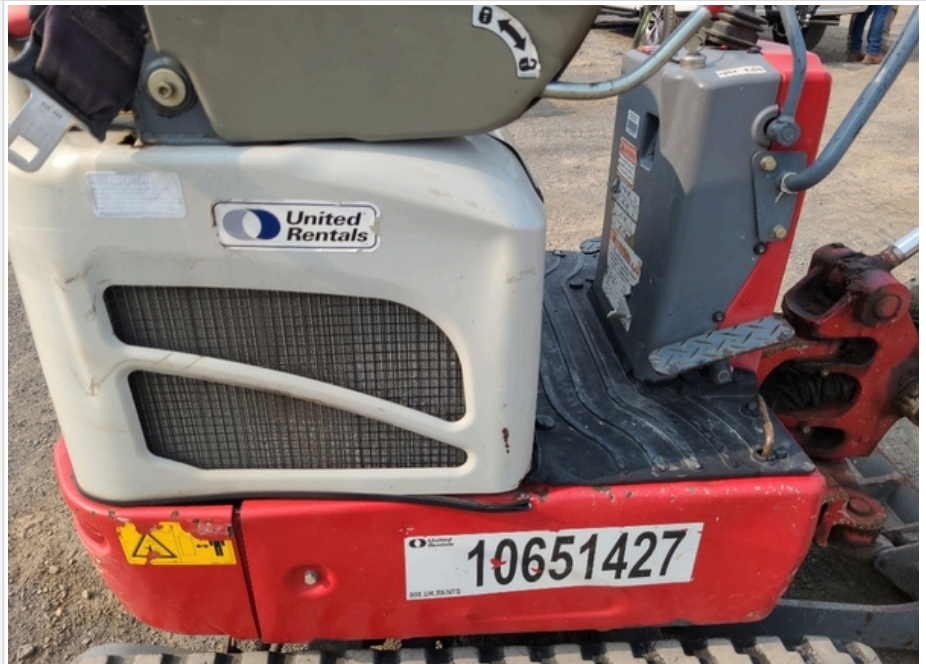
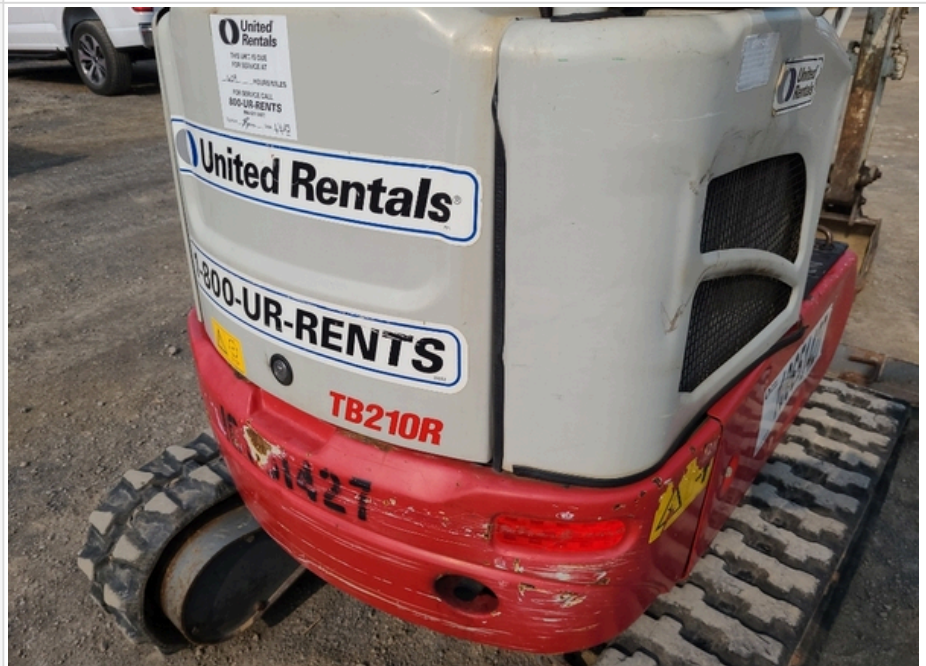
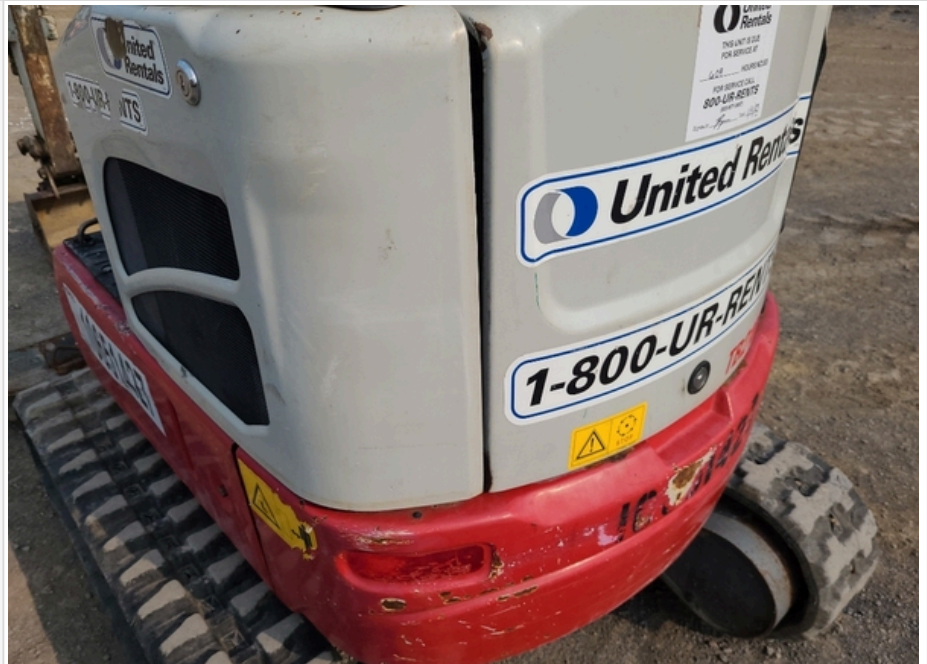
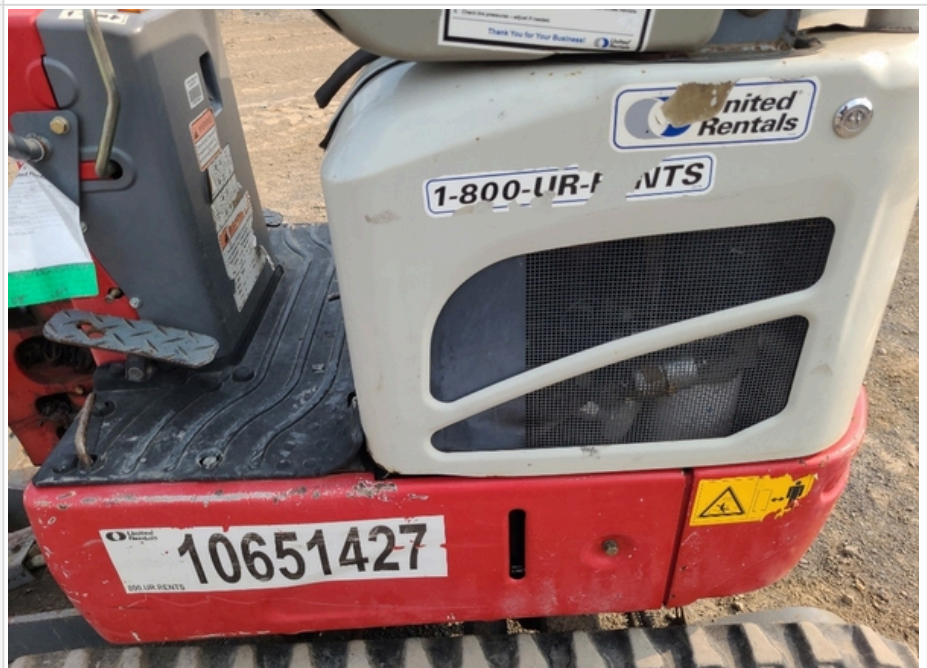
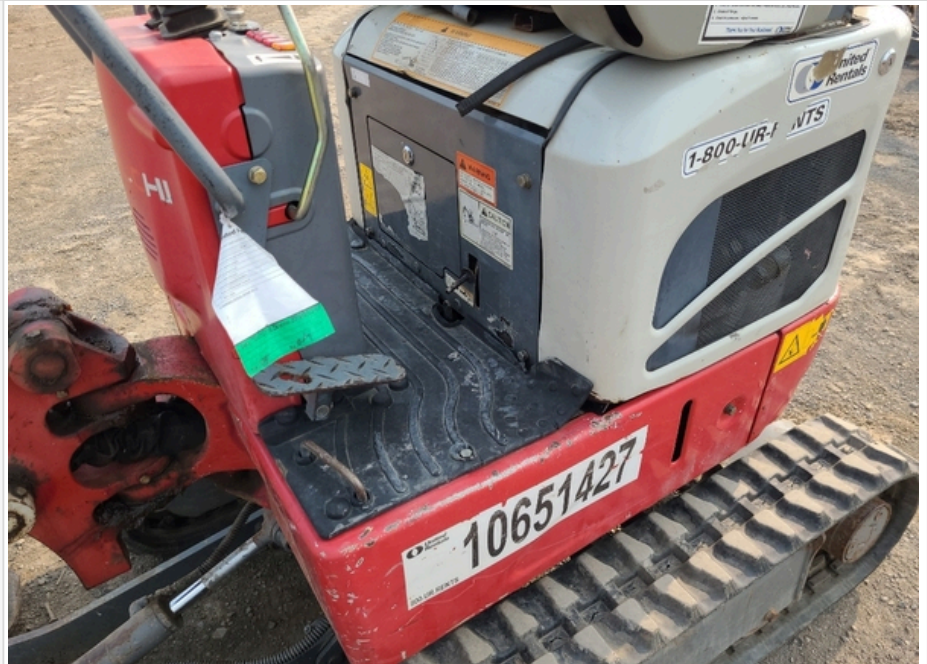
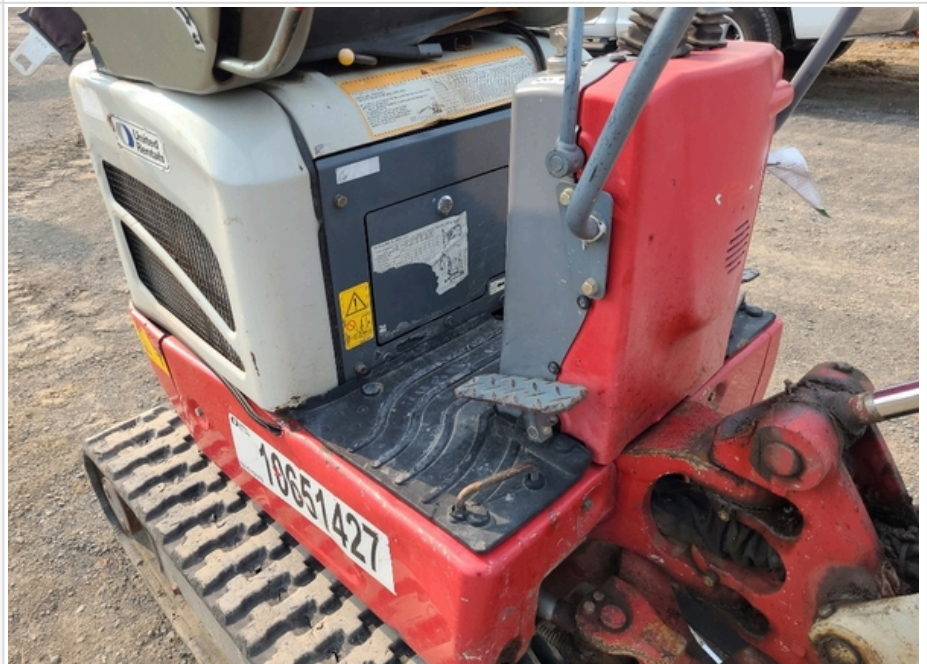
### Close-Up Exterior Photos

Exterior Rating	3 - Normal Wear & Tear
Exterior Comments	Exterior has some scuff marks and rear paint chipping on counterweight

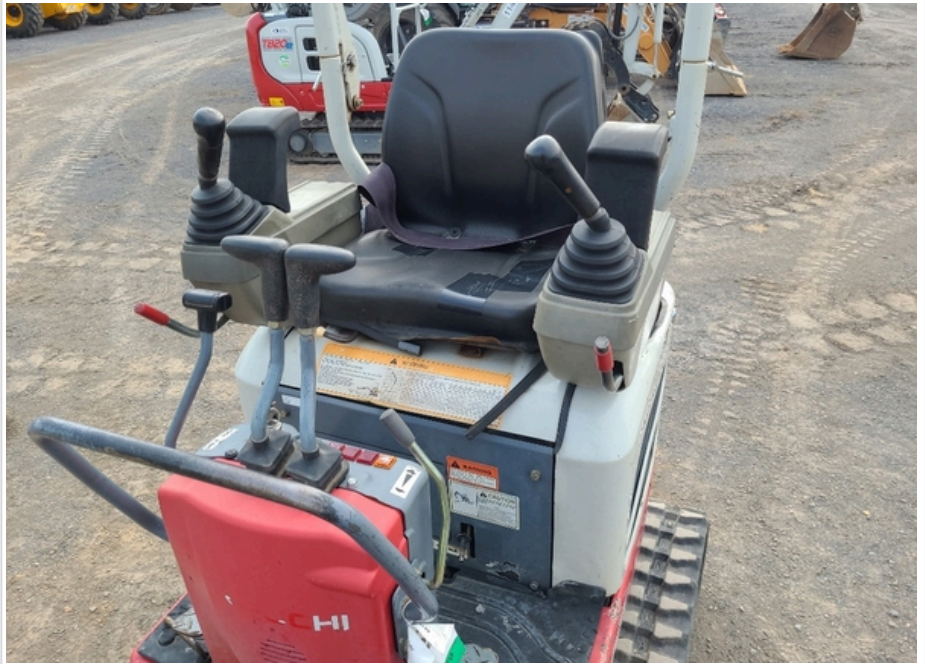
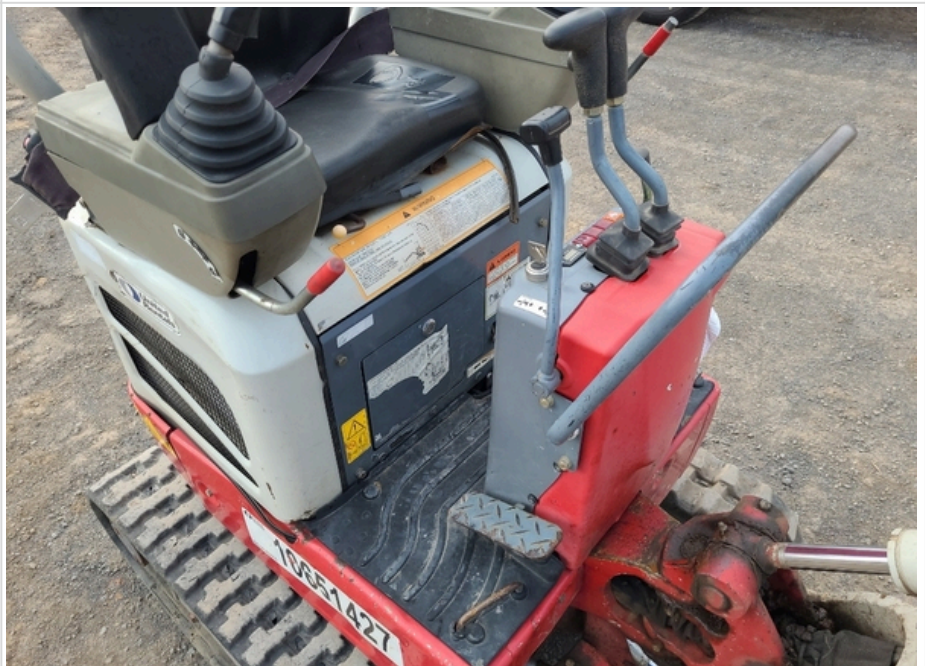
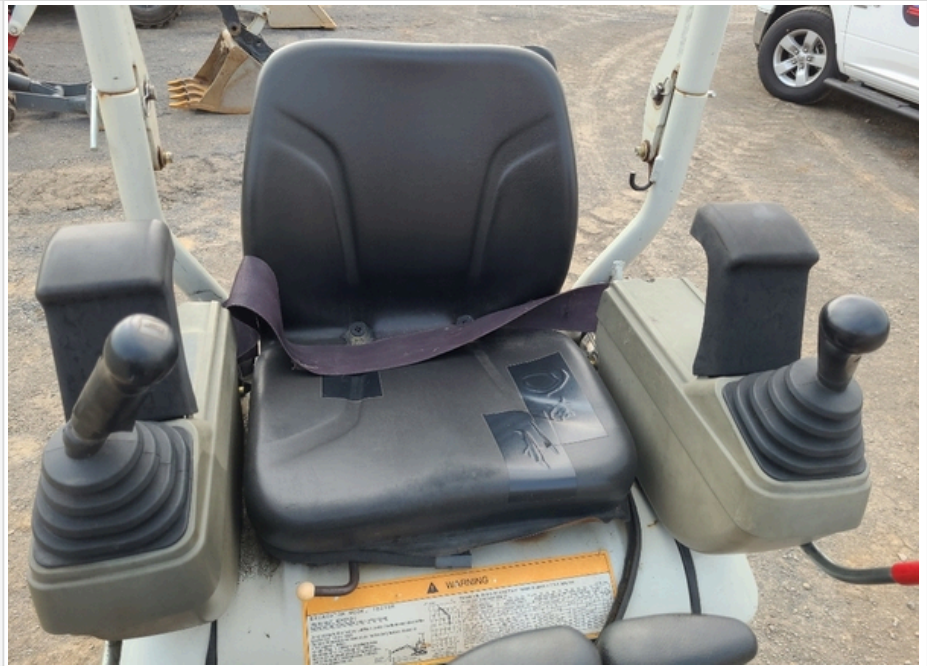
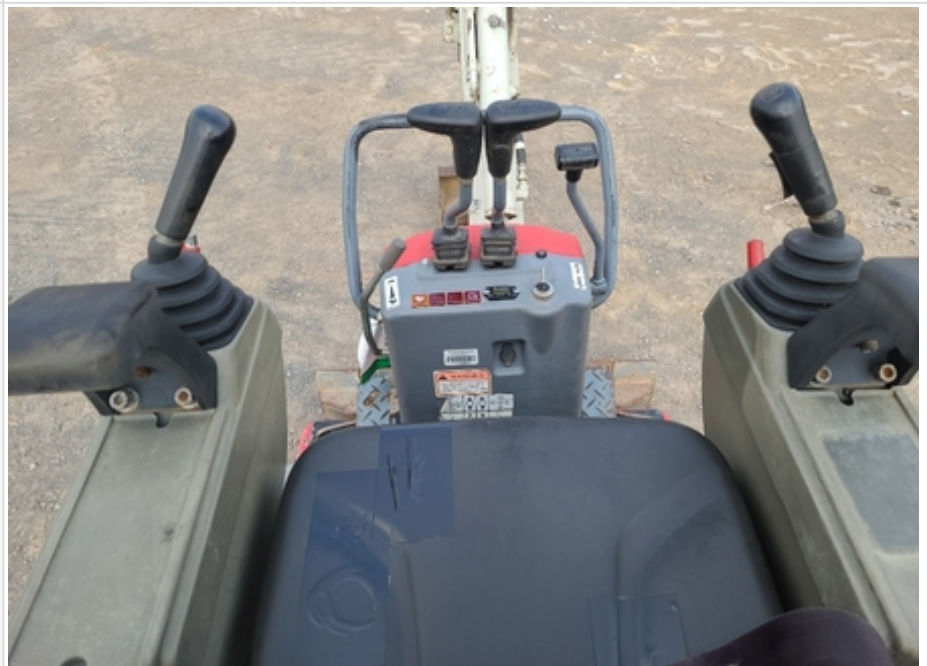
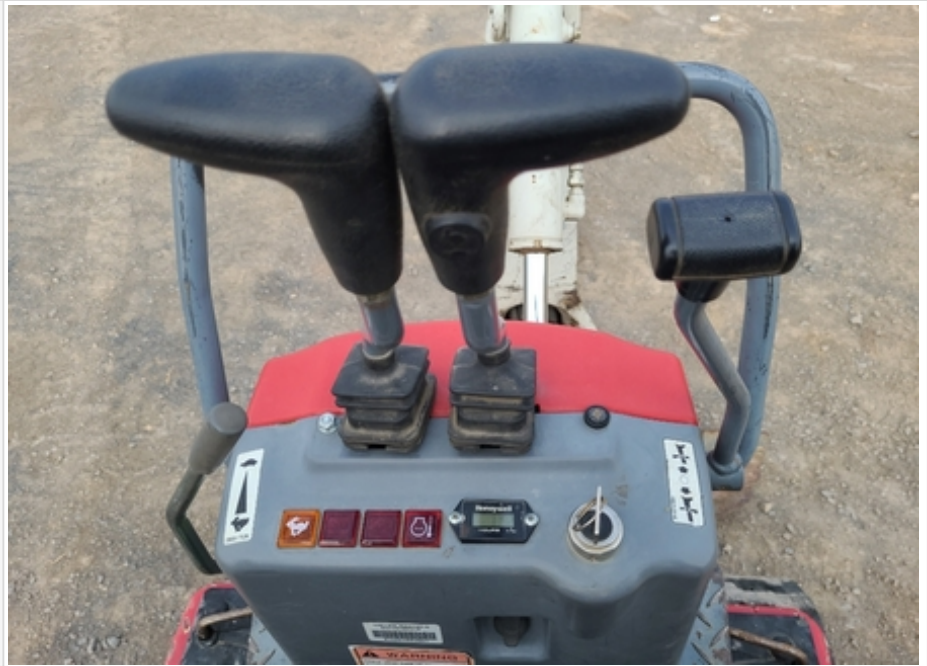
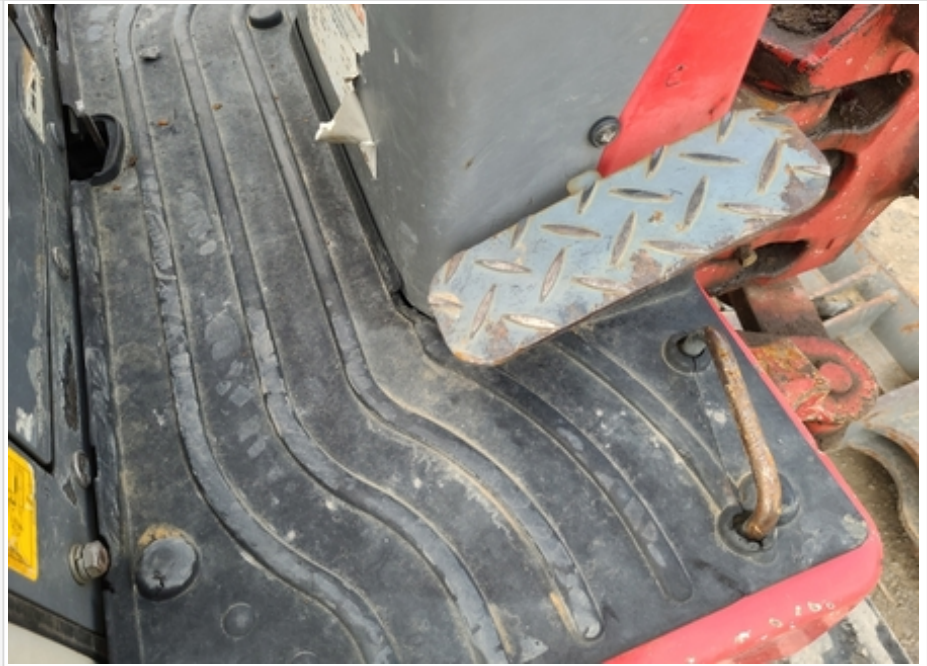
Control Station Rating	3 - Normal Wear & Tear
Control Station Overall Comments	Seat has some small tears and covered with tape.

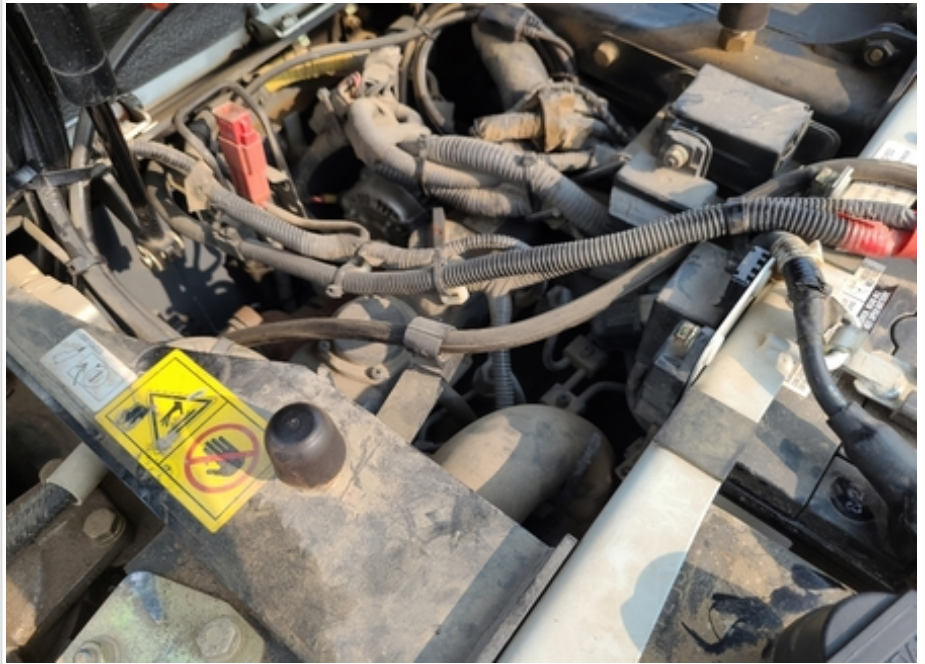
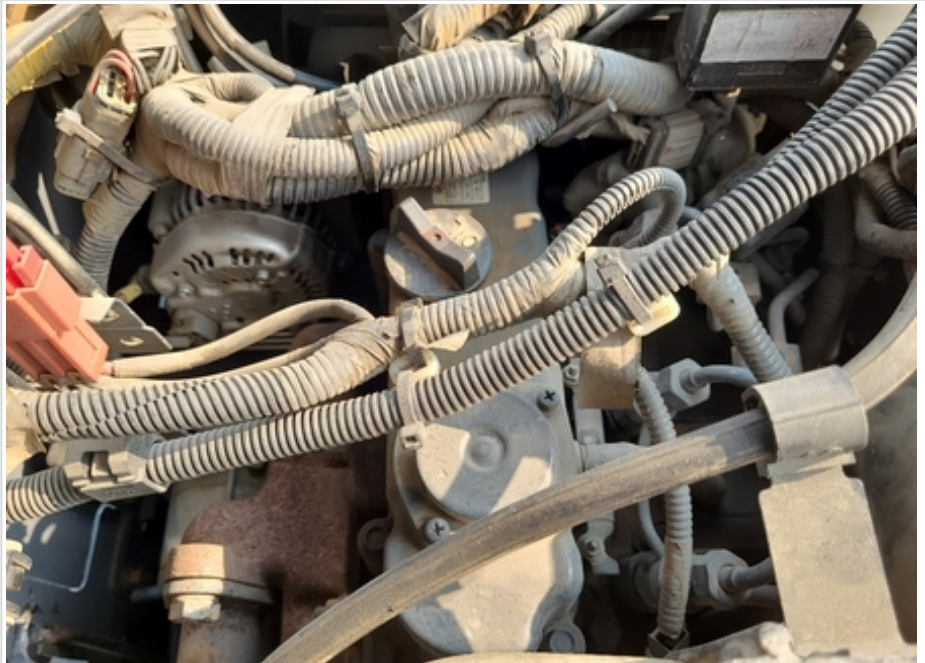
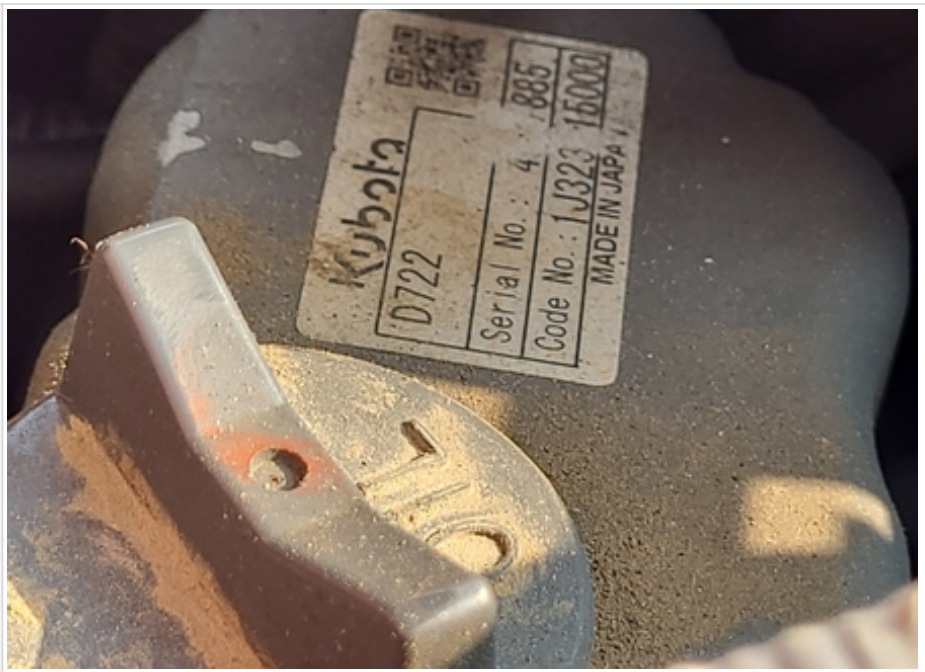
Engine Compartment

<b>Engine Type (Make, Model, Cylinders, Hp)</b>	Kubota - D722E4 - 3Cyl - 18.8HP
<b>Emissions Tier</b>	Tier 4F
<b>Engine Rating</b>	3 - Normal Wear & Tear
<b>Engine Overall Comments</b>	Engine smoked a little at startup after sitting for a while and cleared up after a minute to two minutes of running. Engine sounds healthy under load and no major active leaks observed.

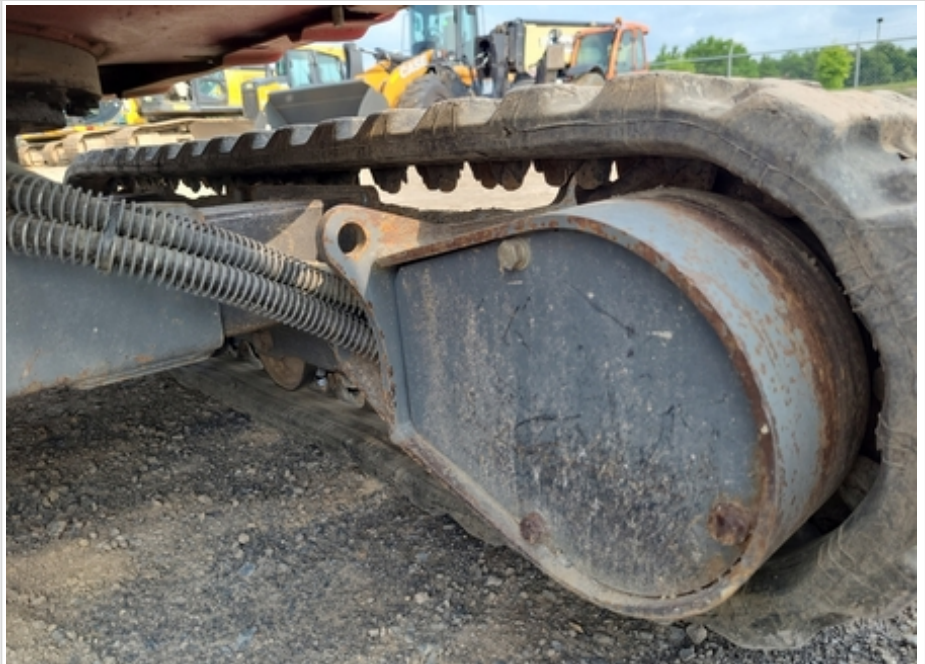
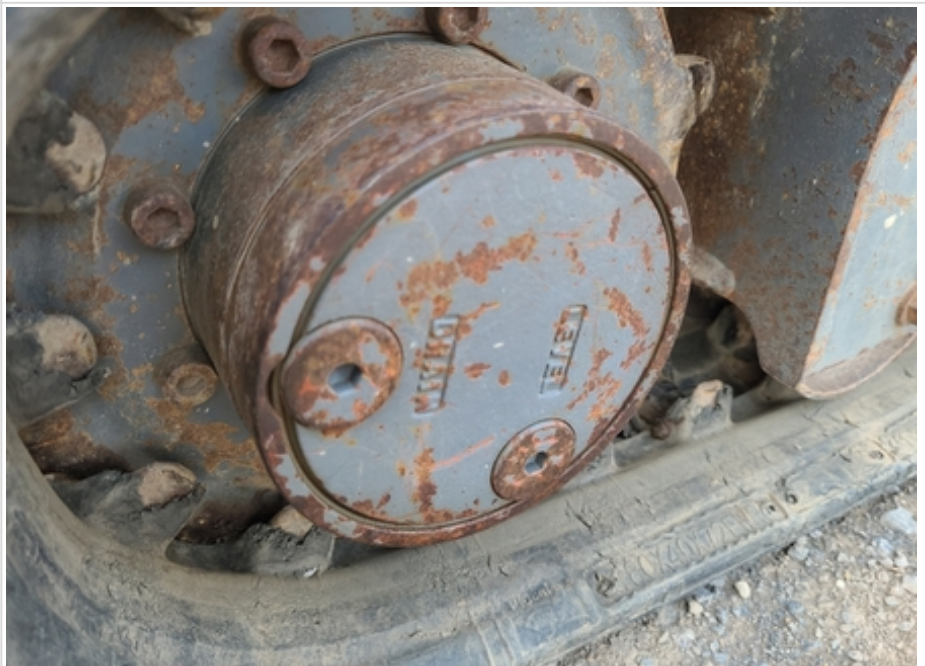
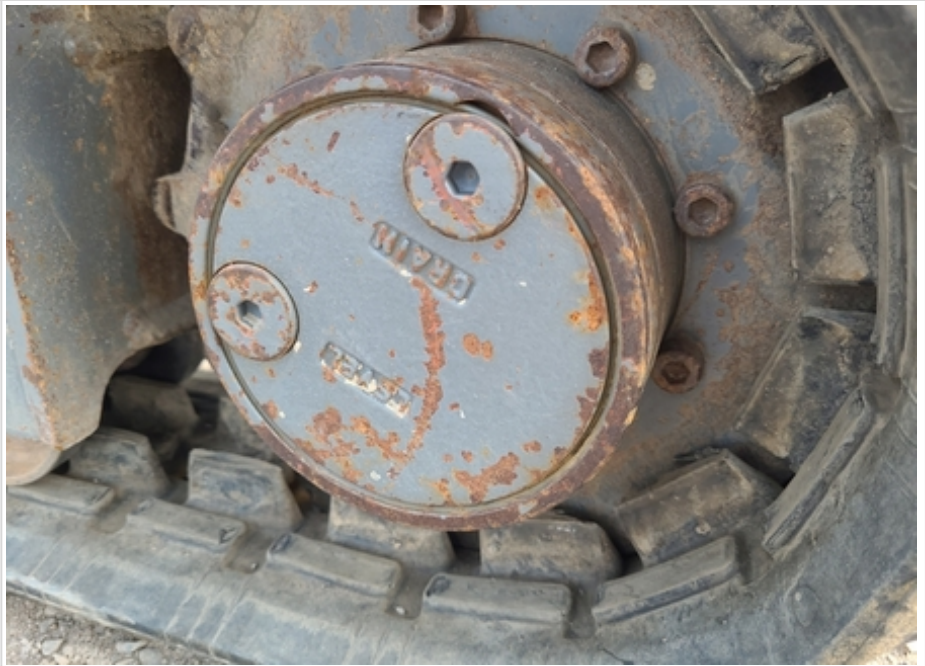
<b>Drivetrain Photos</b>	 
--------------------------	--

Hydrostatic Transmission?	Yes
2 Speed?	Yes
Hydrostatic Drive Configuration	Split Transmission
Comments	
Transmission Info (Make/Model/Speeds)	
Drivetrain Rating	3 - Normal Wear & Tear
Drivetrain Comments	Machine travels well in all directions.

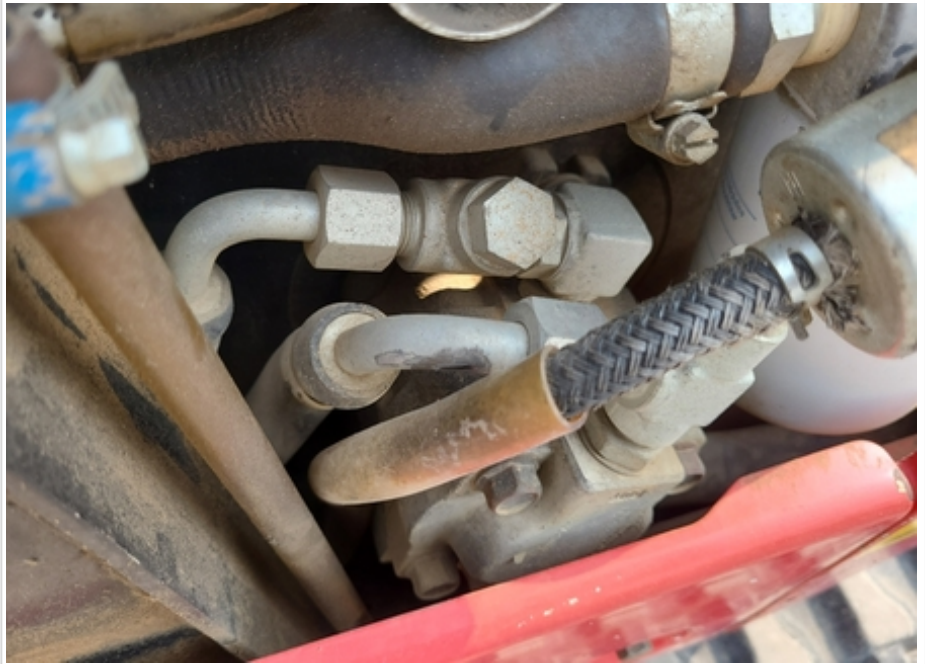
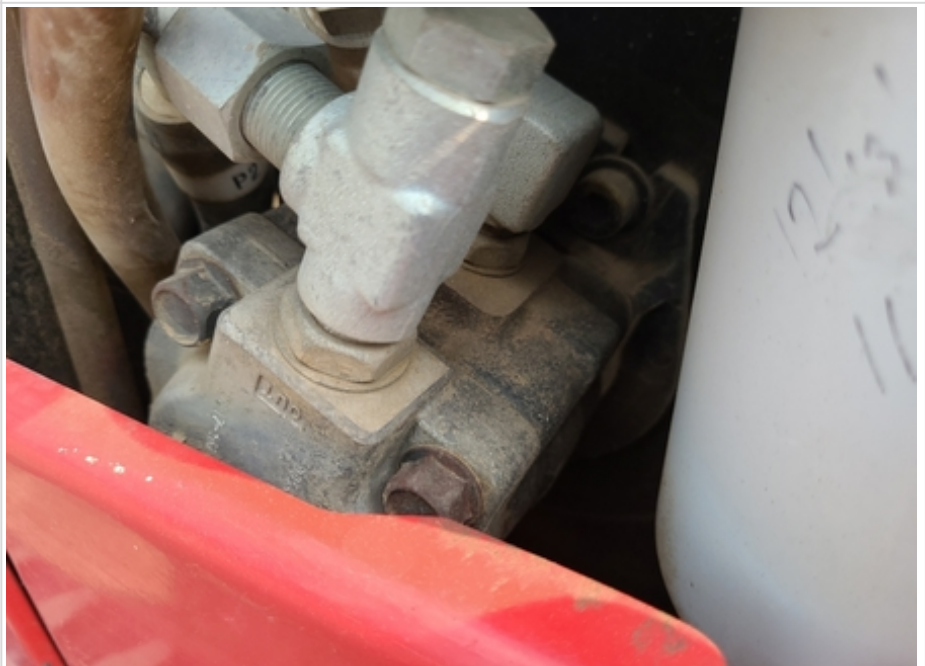
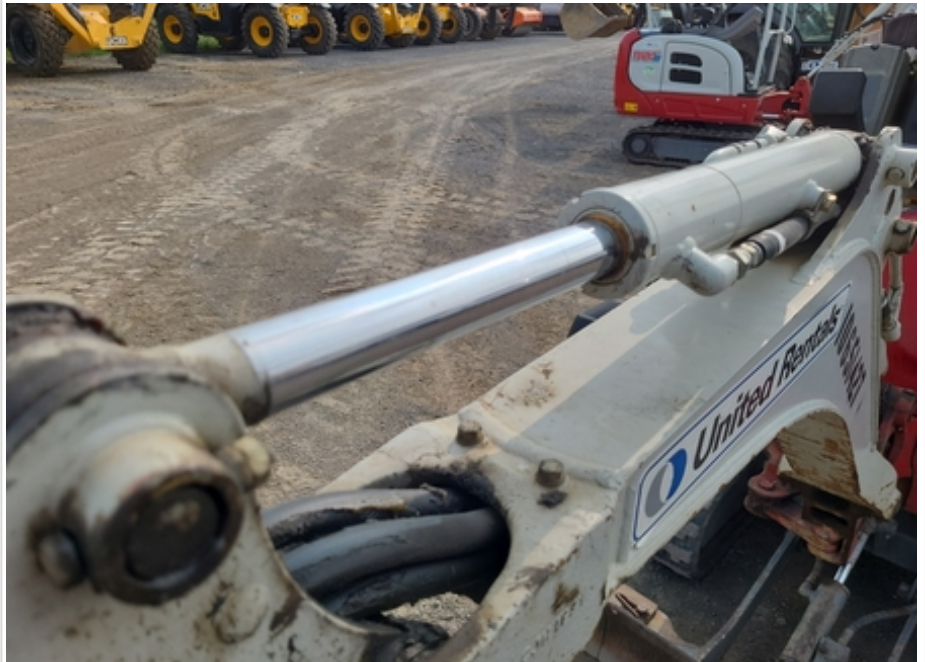
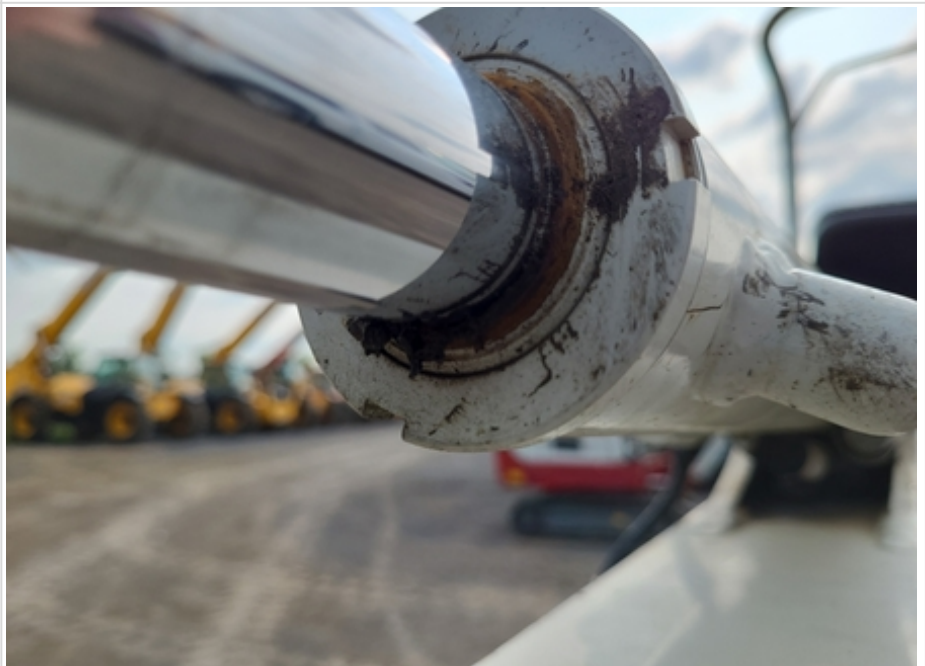
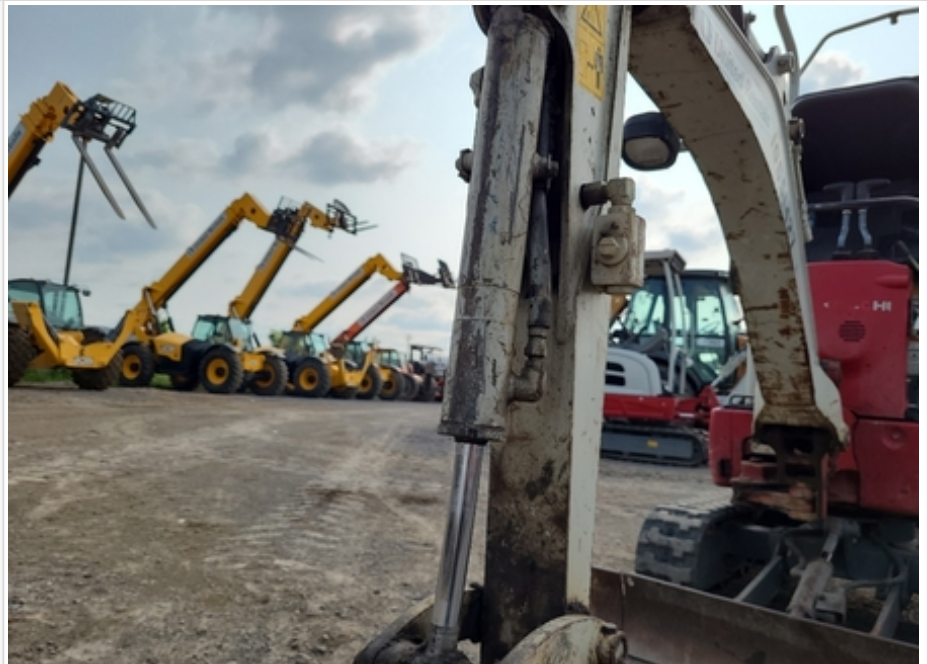
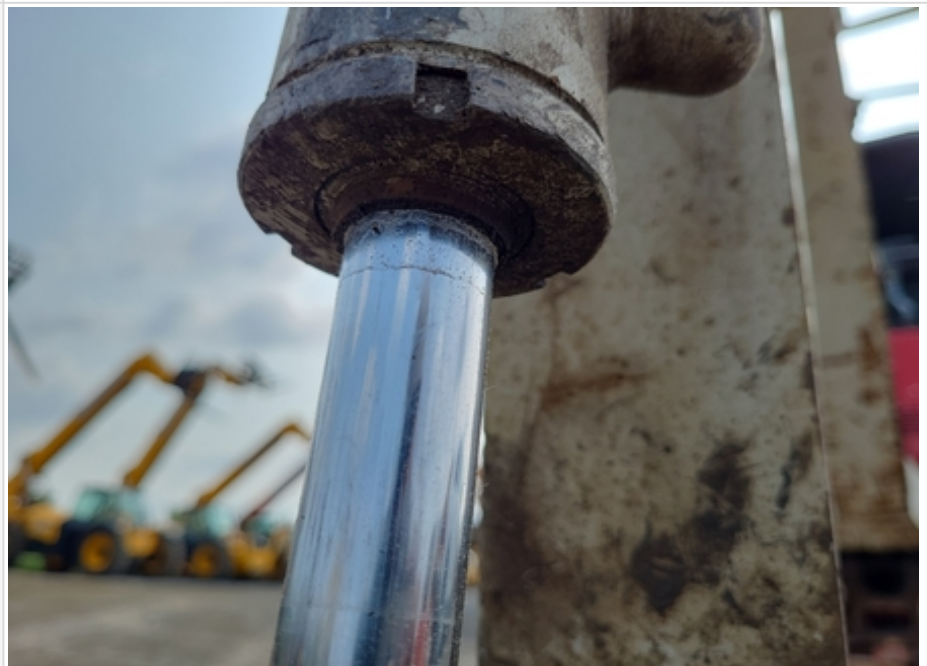
Hydraulic Pump/Fittings/Hoses

<b>Hydraulic System Rating</b>	3 - Normal Wear & Tear
<b>Hydraulic System Comments</b>	Hydraulic System is working well with no operating issues or active leaks observed.

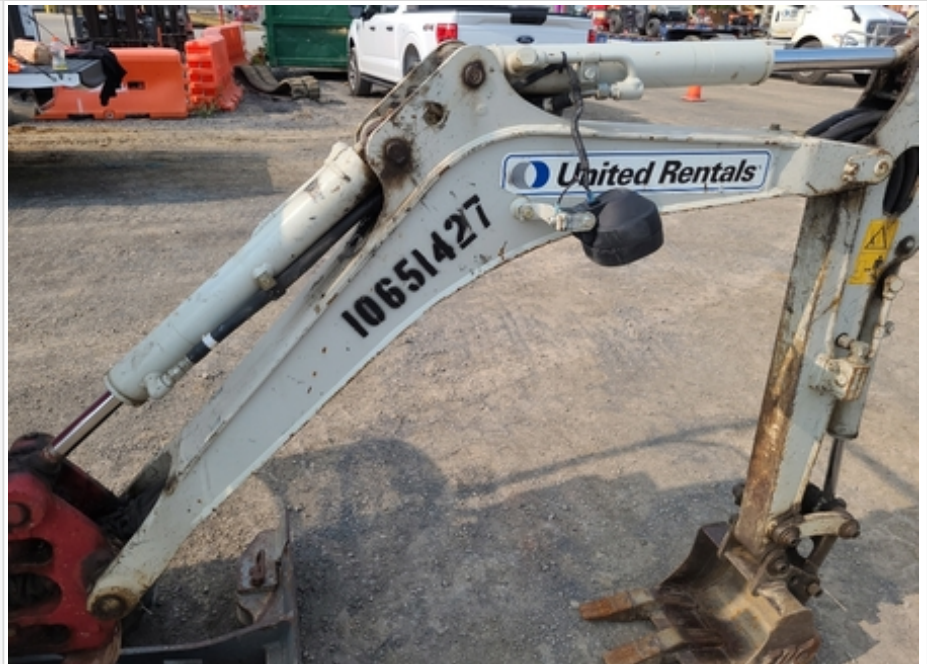
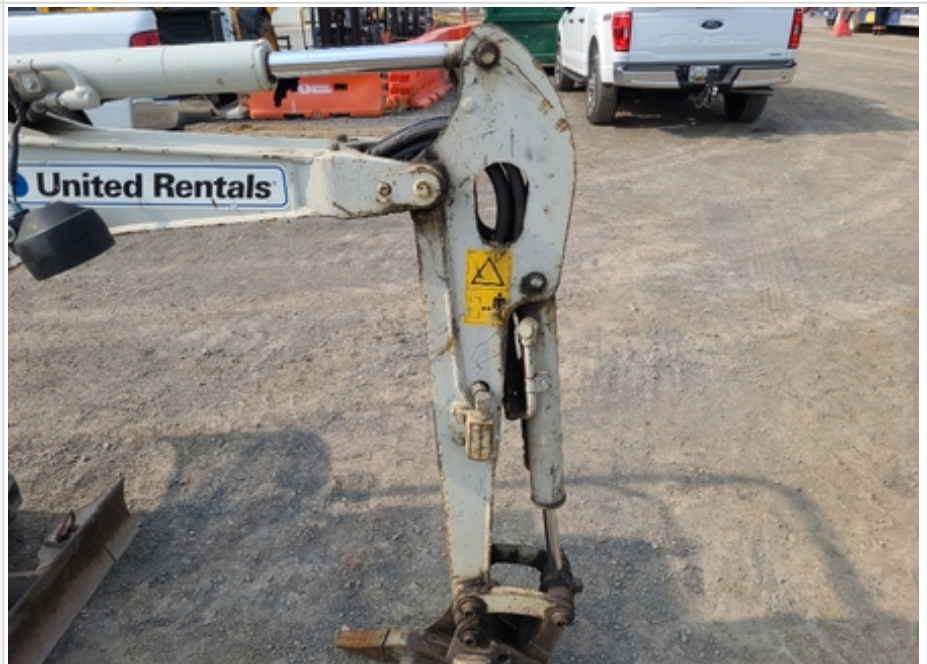
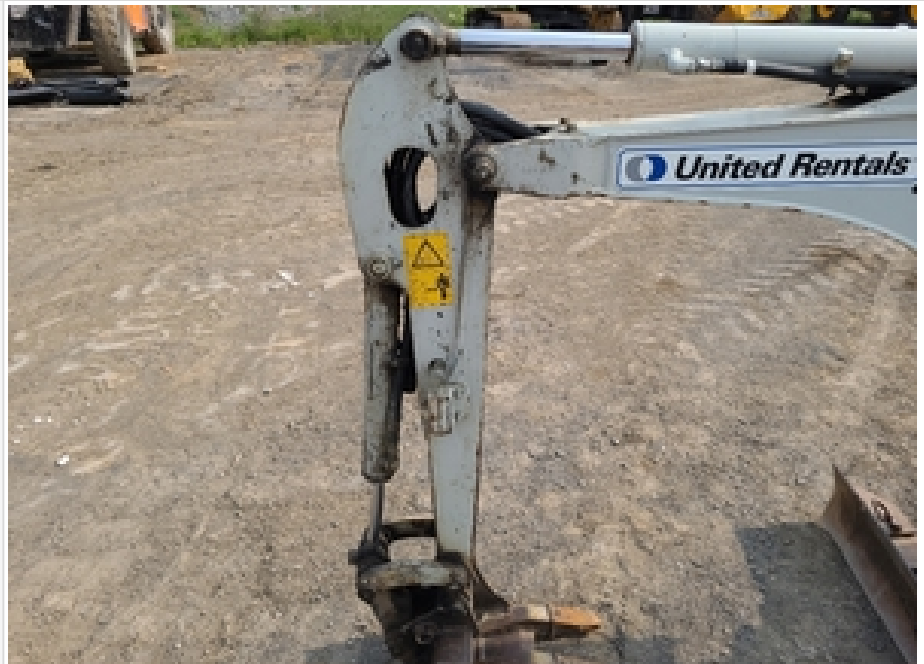
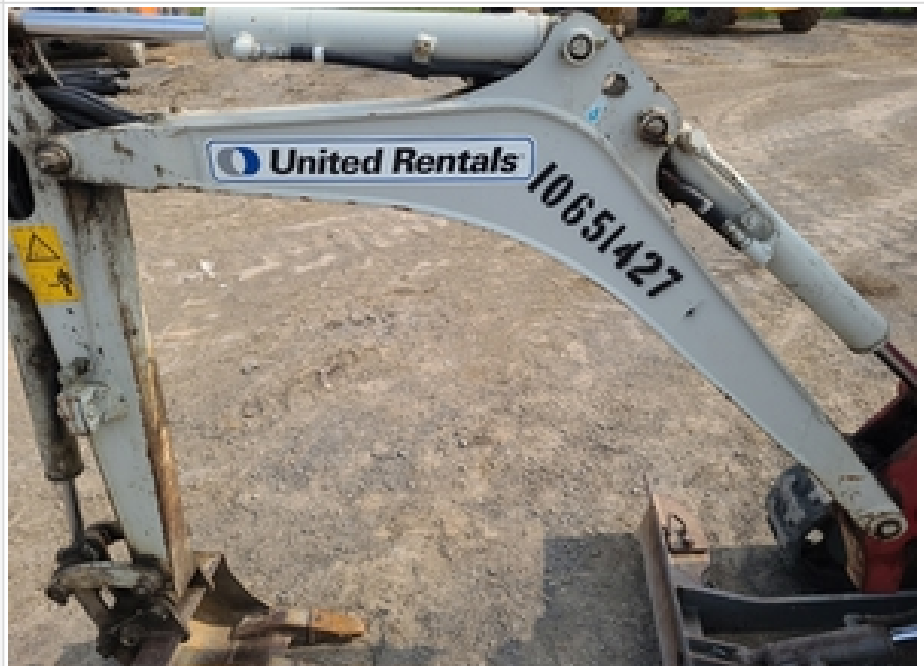
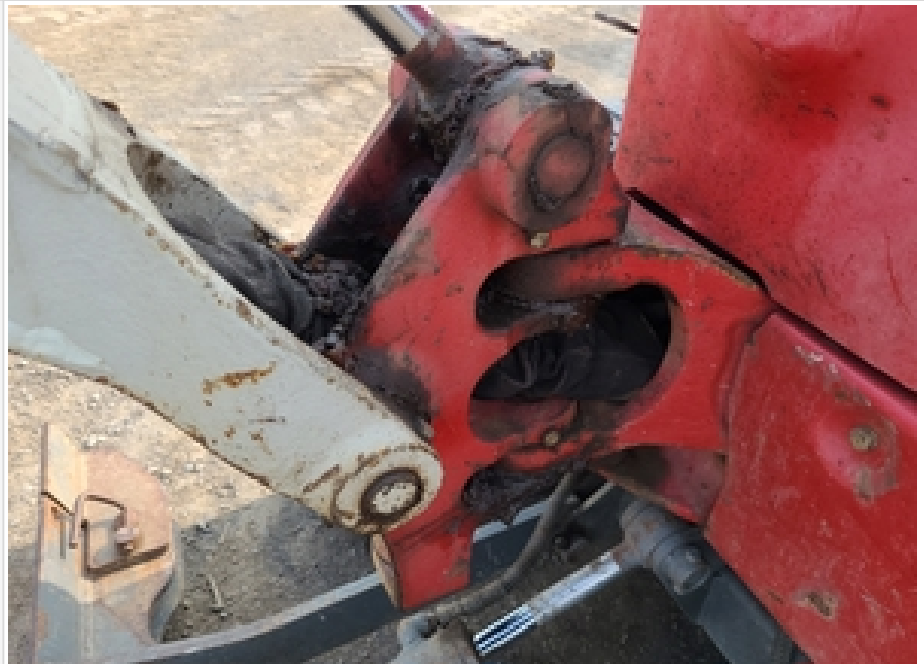
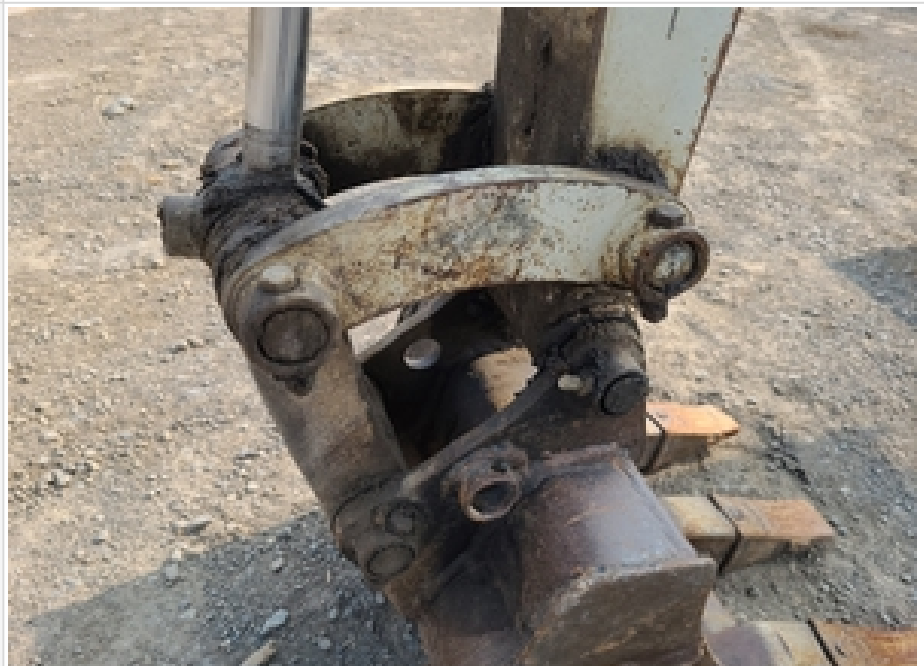
Chassis Photos

Chassis Rating	3 - Normal Wear & Tear
Comments	All implements in good working condition.
