## Enterprise Equipment Inspection

Category	Excavator
Travel System	Track Undercarriage
Comments	
Year	2017
Make	Takeuchi
Model	TB210R
Fleet ID	10651427
Serial Number	211001733
Serial Number Plate

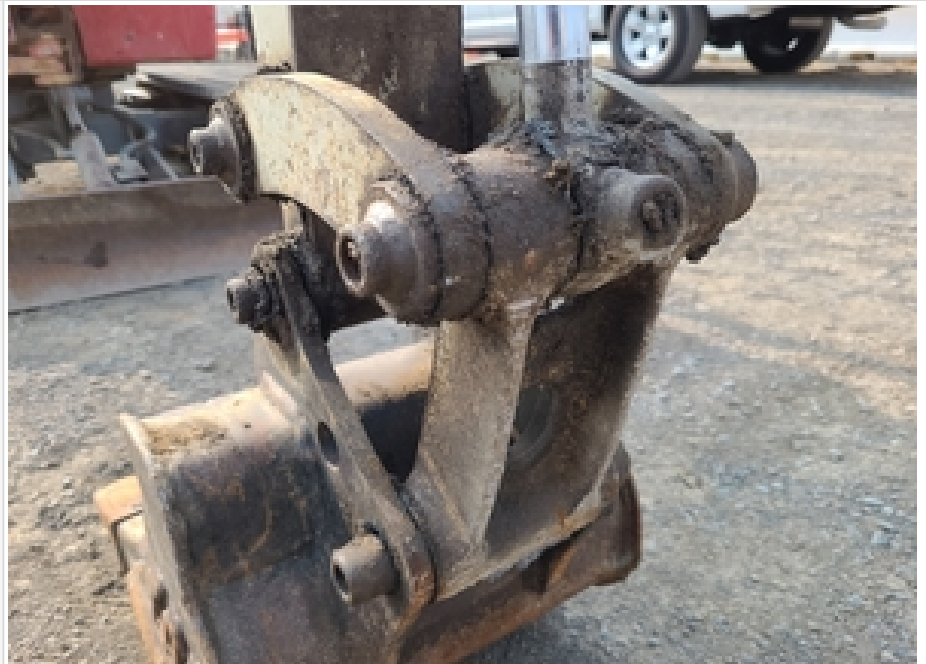
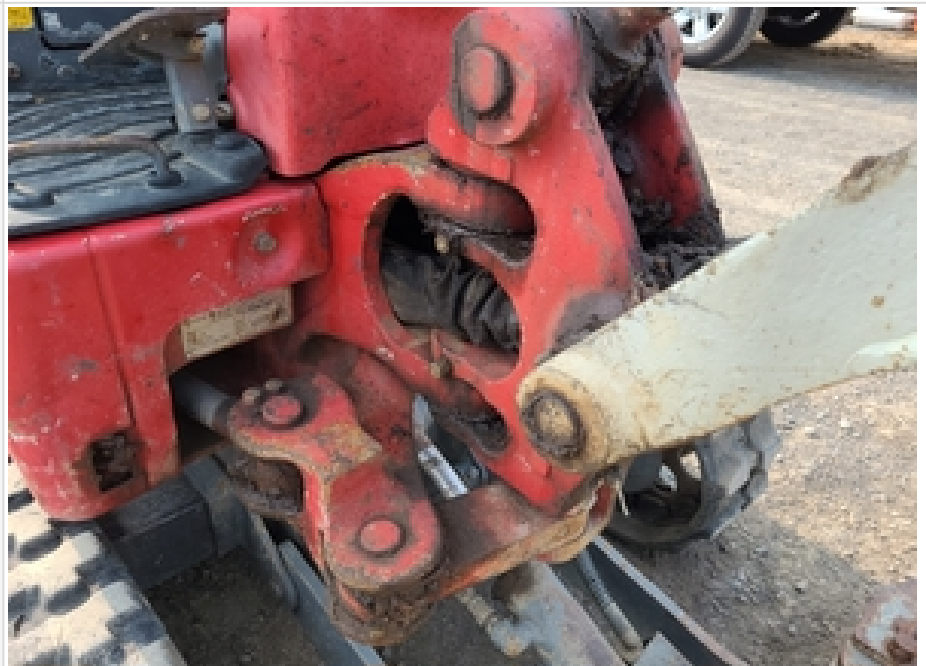
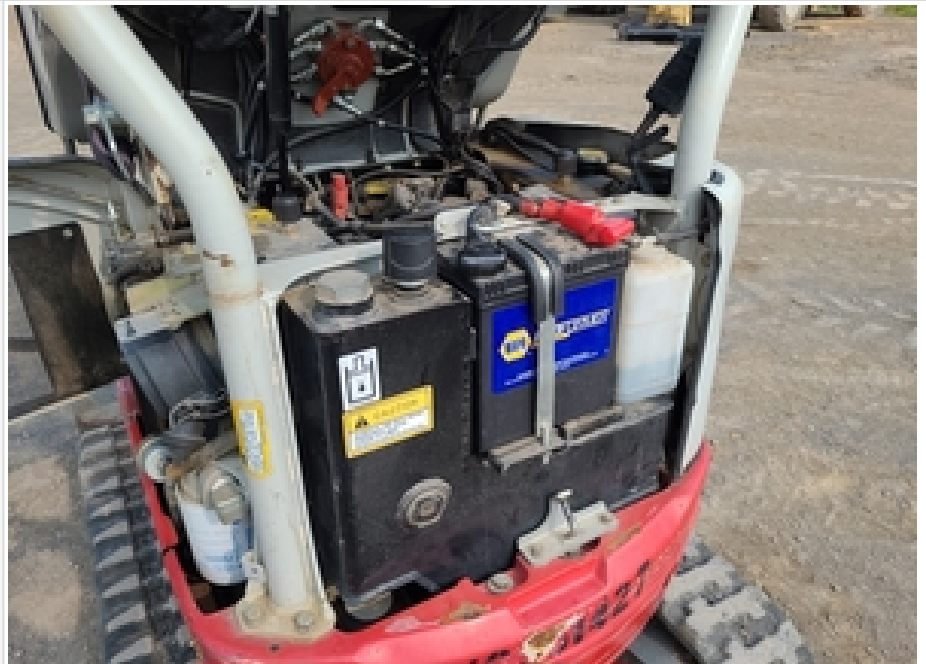
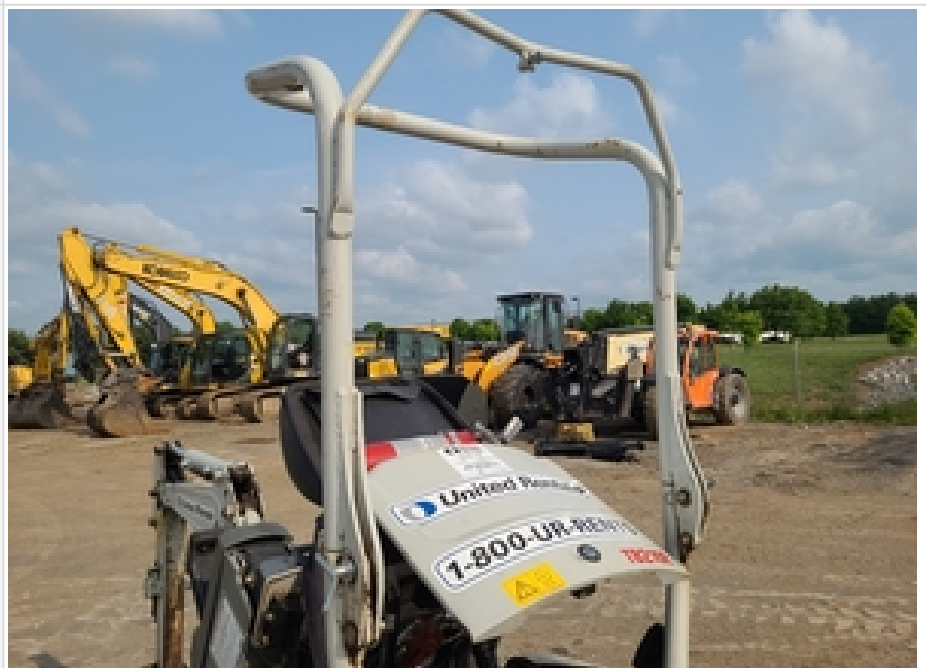
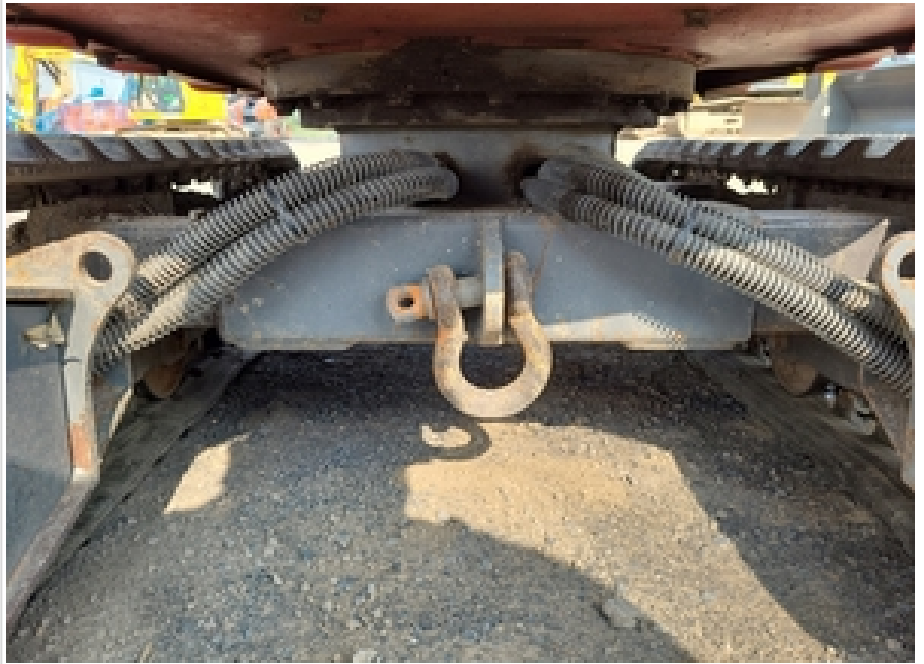
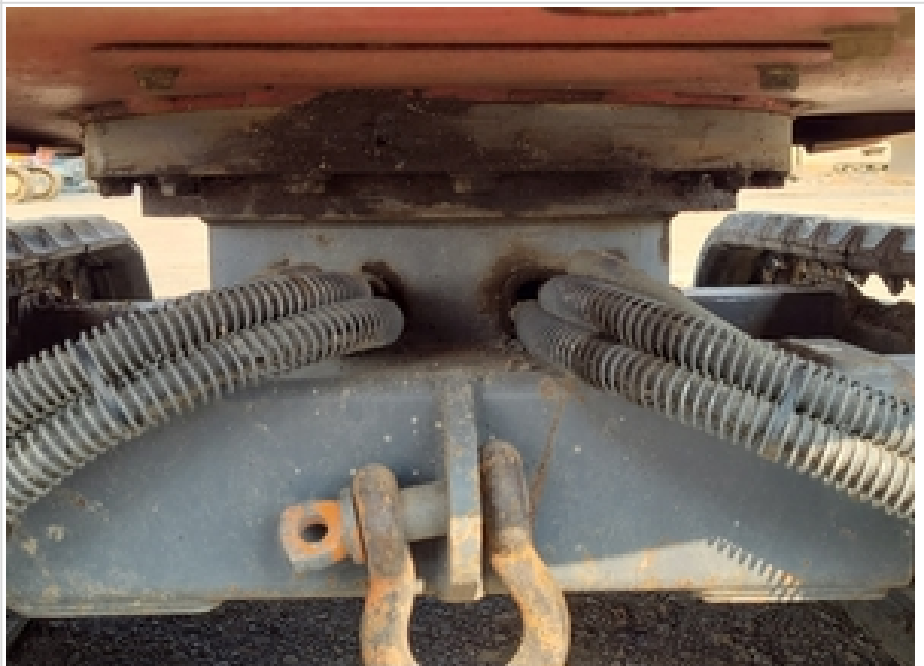
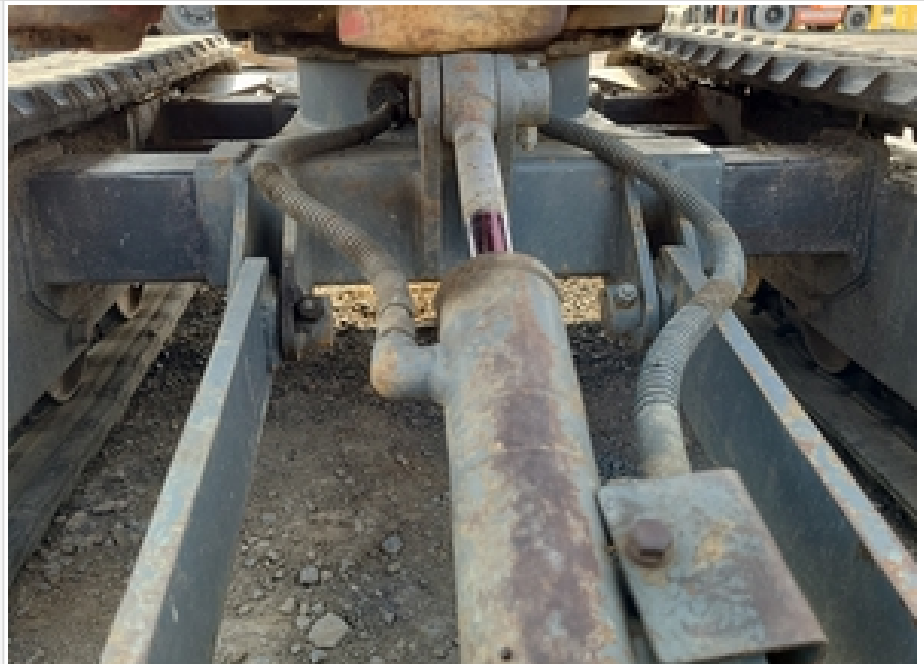
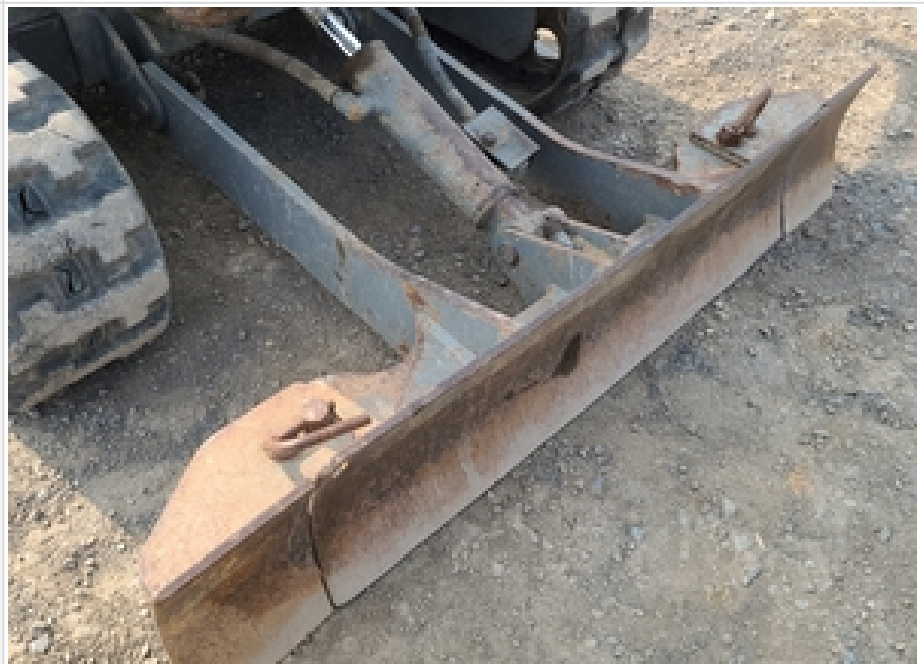
Chassis Photos

Chassis Rating	3 - Normal Wear & Tear
Comments	All implements in good working condition.

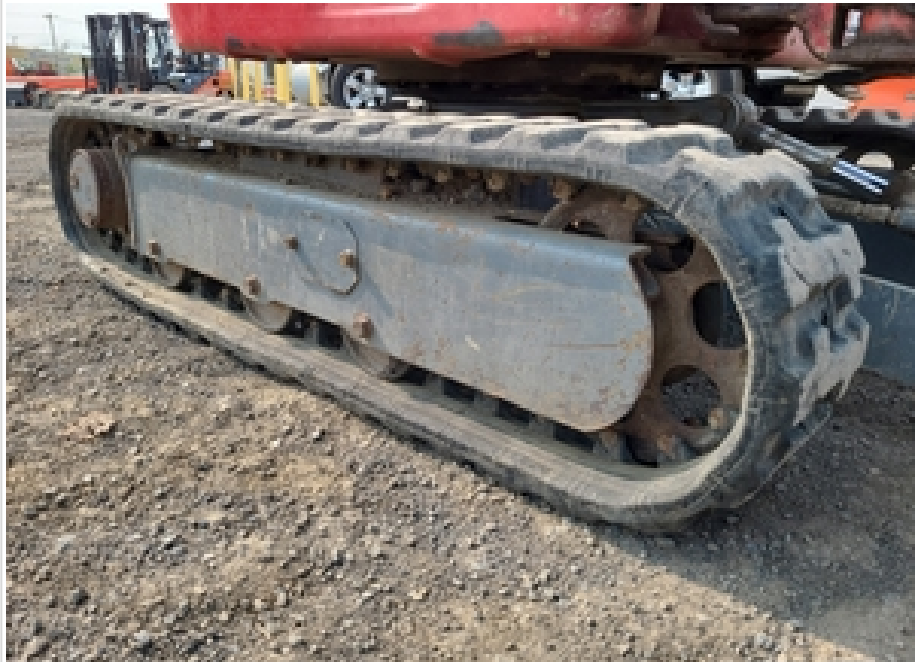
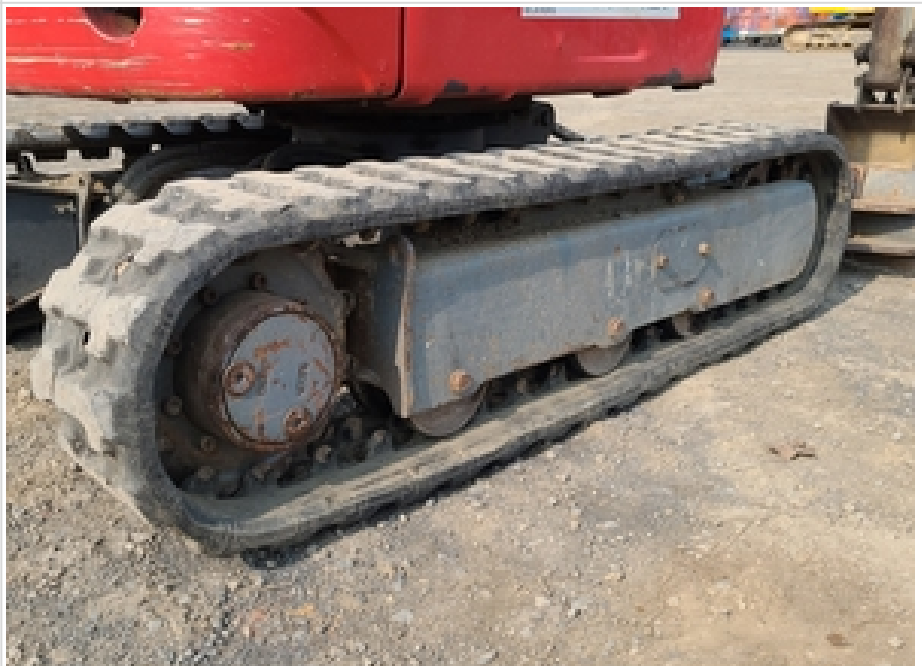
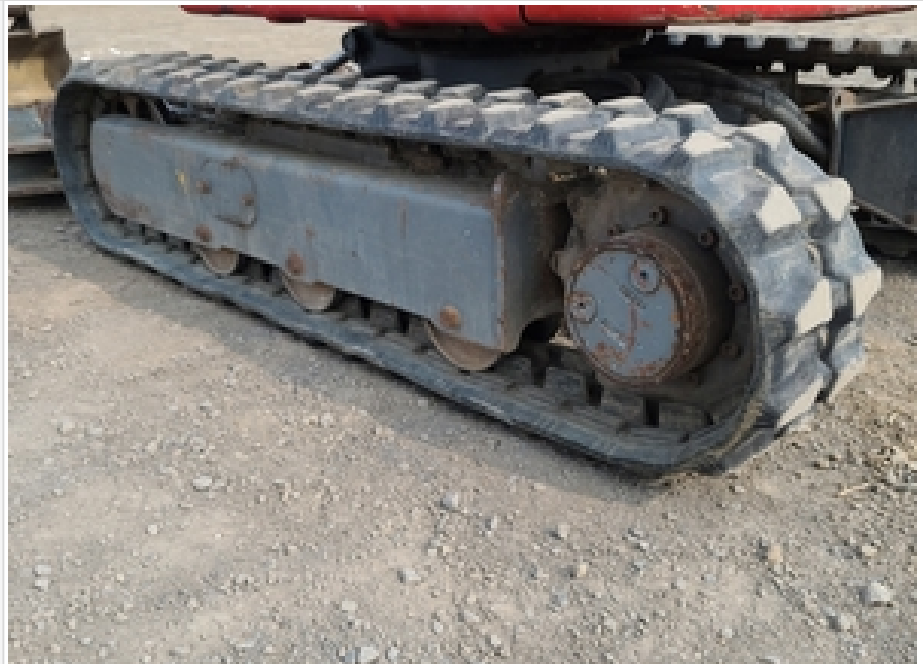
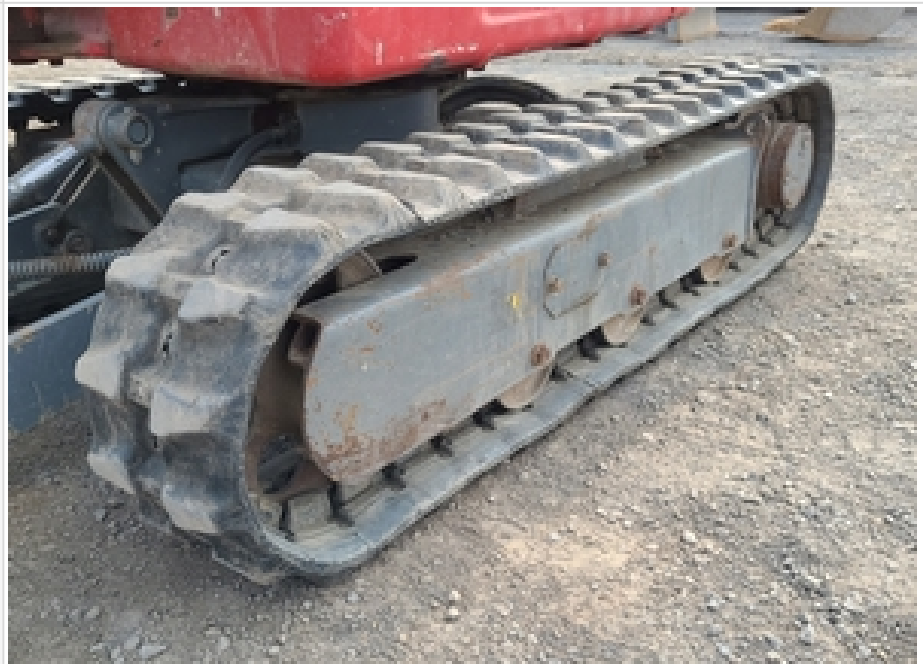
Undercarriage Photos

Undercarriage Rating	3 - Normal Wear & Tear
Undercarriage Comments	Undercarriage in low use, great condition
