Enterprise Equipment Inspection

Category	Skid Steer
Travel System	Wheels & Tires
Comments	
Year	2017
Make	John Deere
Model	320E
Fleet ID	51296BLA
Serial Number	1T0320EAKHJ313482
Serial Number Plate

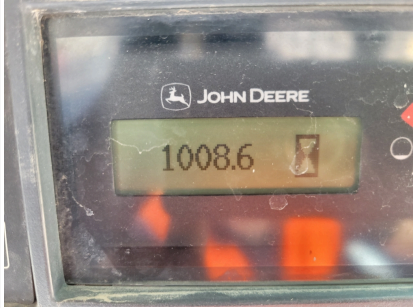
Hour Meter Reading	1008.6
Hour Meter Photo

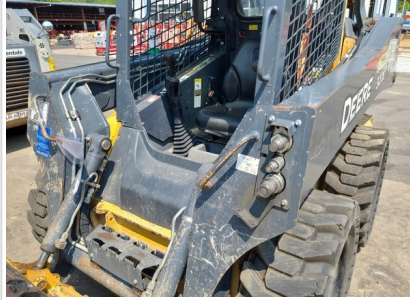
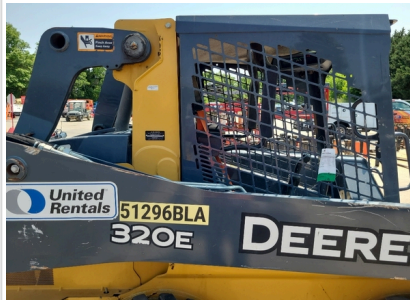
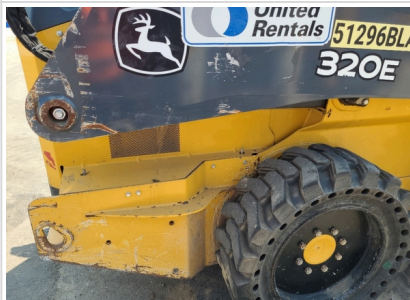
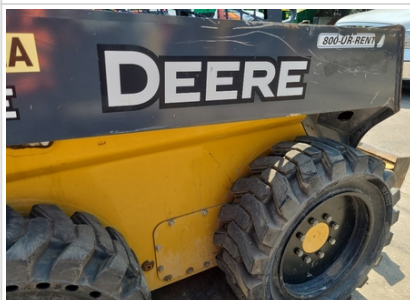
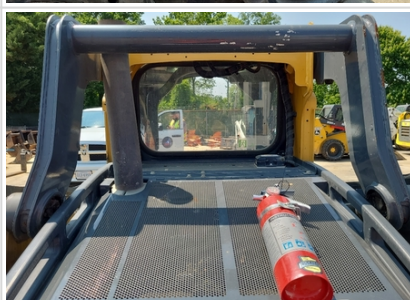
General Appearance

Exterior Rating	3 - Normal Wear & Tear	
Exterior Comments	Minor scuff marks all around.

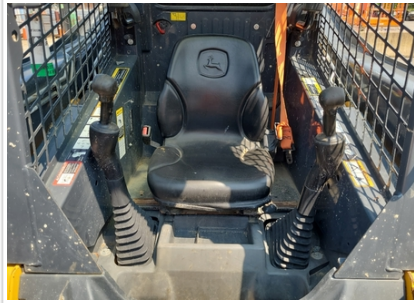
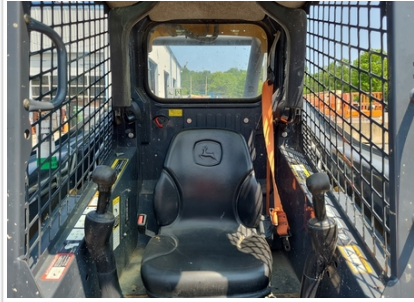
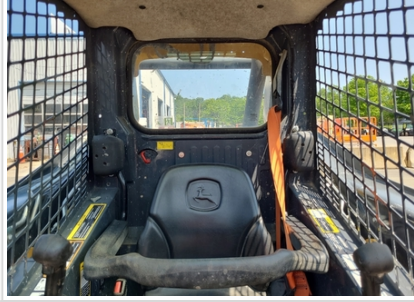
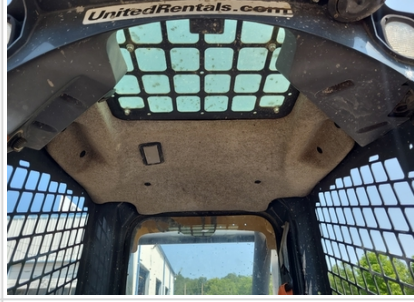
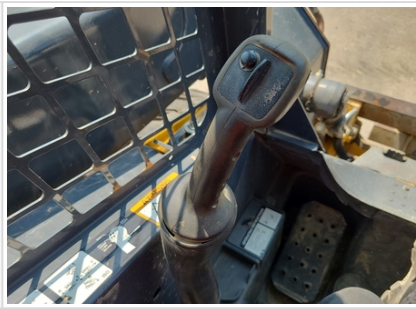
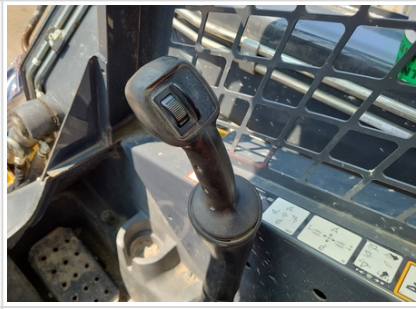
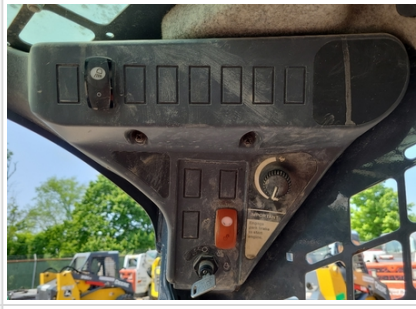
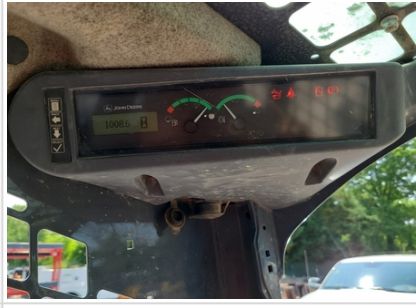
<p>Control Station</p>

Control Station Rating	3 - Normal Wear & Tear
Control Station Overall Comments	Operator Station in good condition.

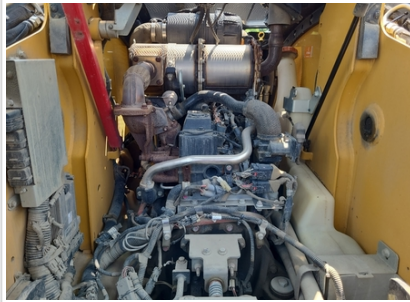
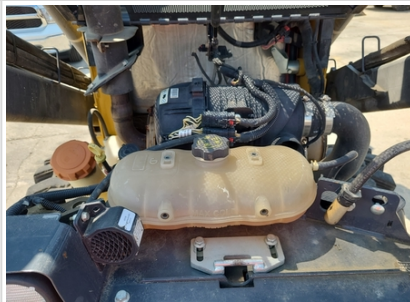
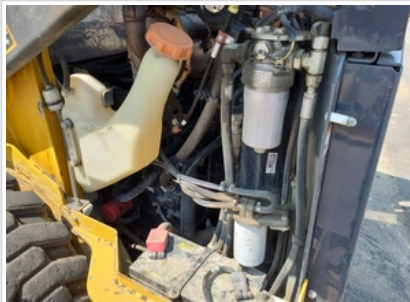
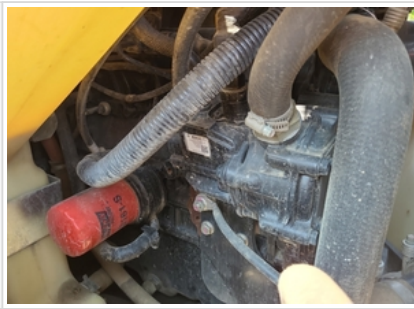
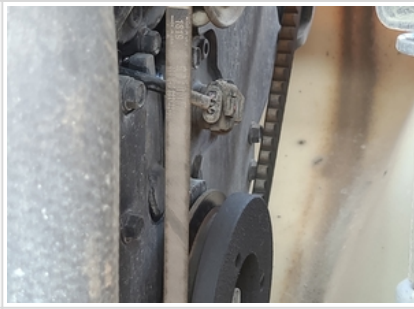
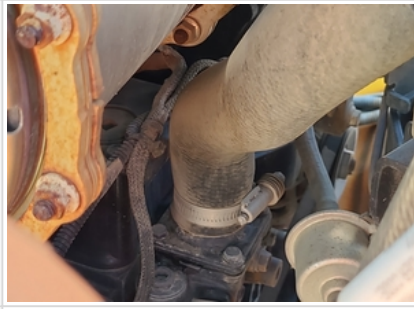
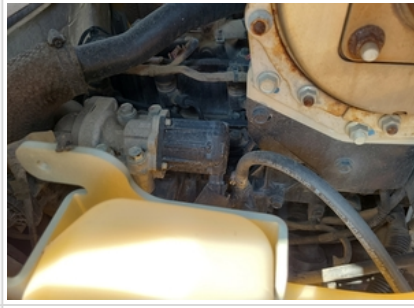
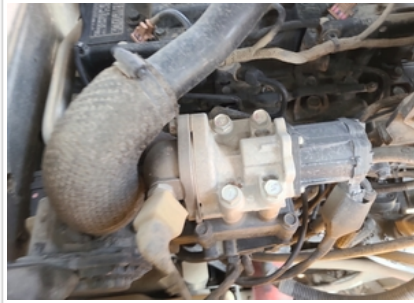
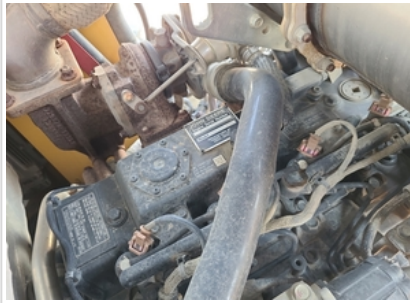
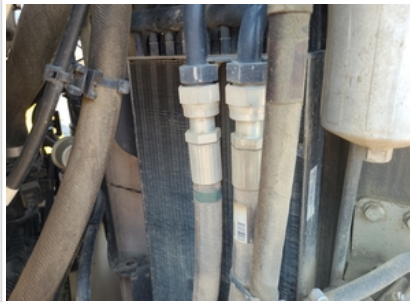
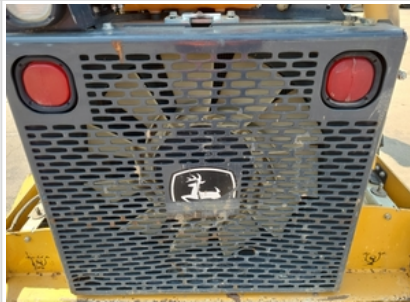
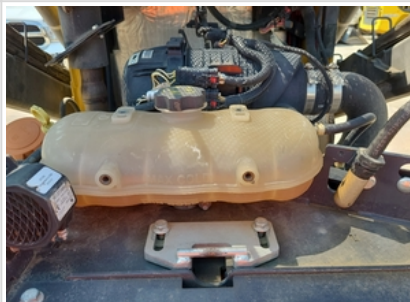
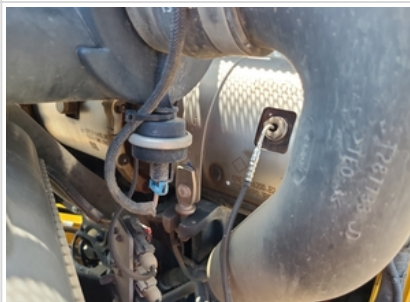
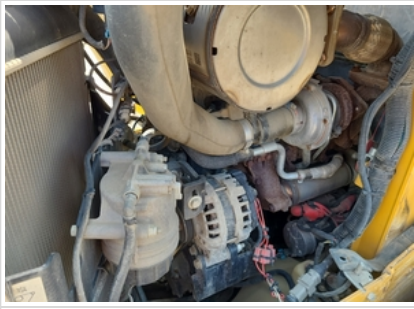
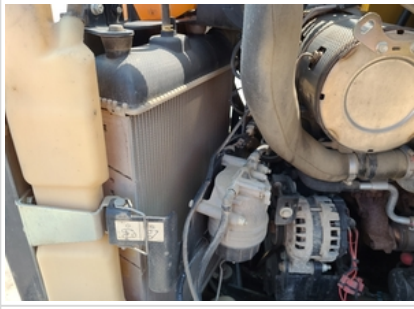
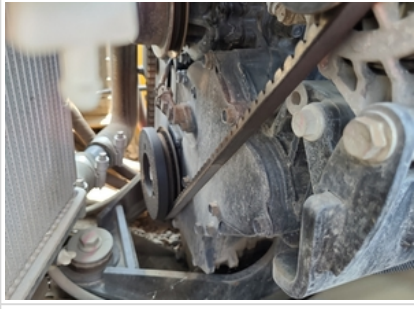
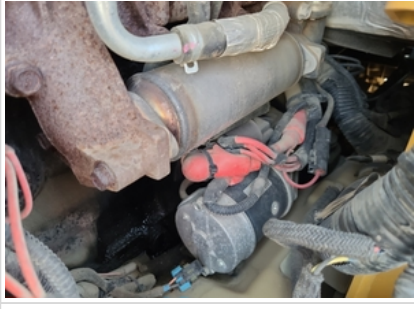
Engine Compartment

Engine Type (Make, Model, Cylinders, Hp)	Yanmar - 3.3L - 4Cyl - 74HP	
Emissions Tier	Tier 4F	
Engine Rating	4 - Very Light or Minimal Wear	
Engine Overall Comments	Engine running strong and has healthy appearance.

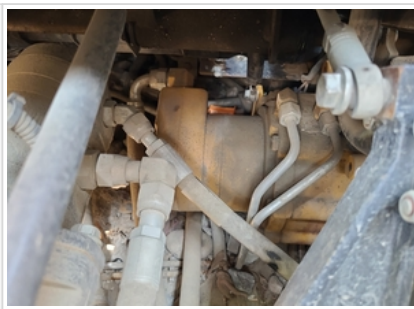
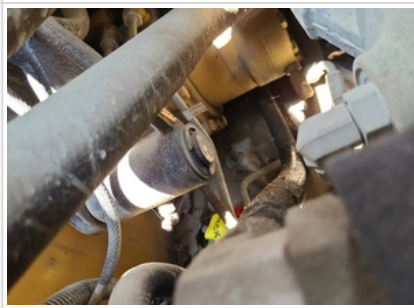
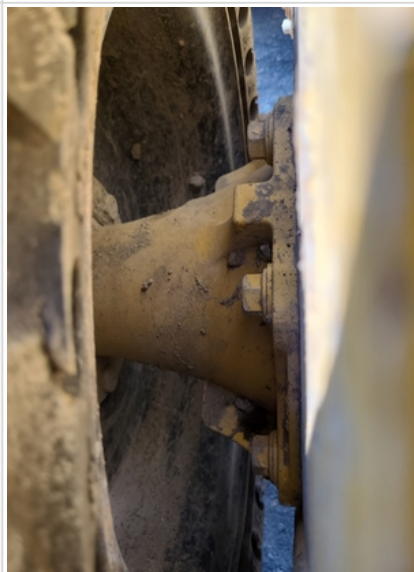
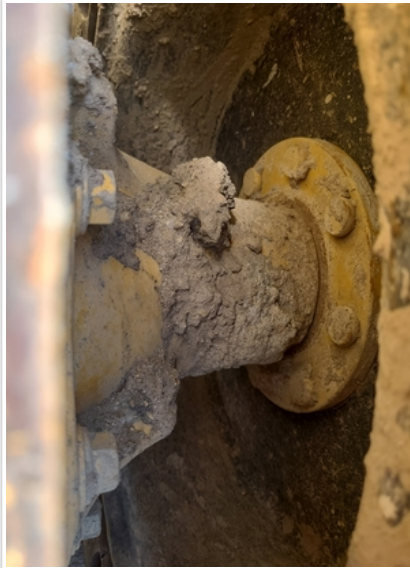
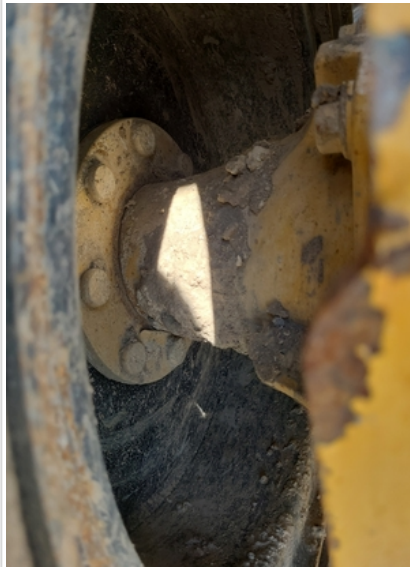
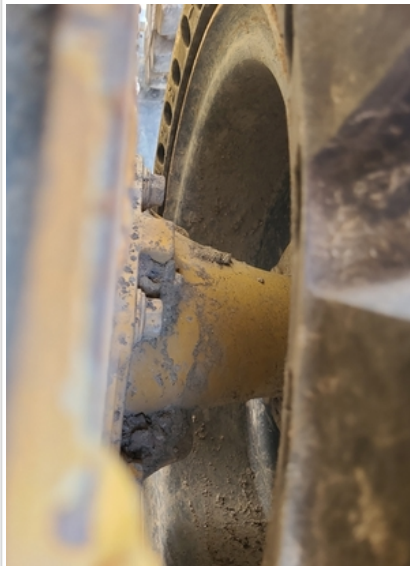
Drivetrain Photos

Hydrostatic Transmission?	Yes
2 Speed?	No
Hydrostatic Drive Configuration	Split Transmission
Comments	
Transmission Info (Make/Model/Speeds)	
Drivetrain Rating	4 - Very Light or Minimal Wear
Drivetrain Comments	Machine running well in all directions.

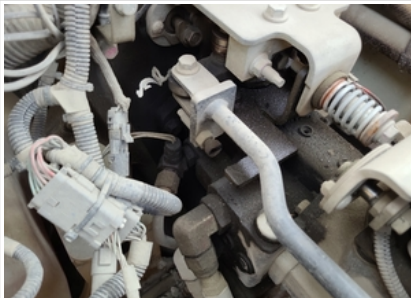
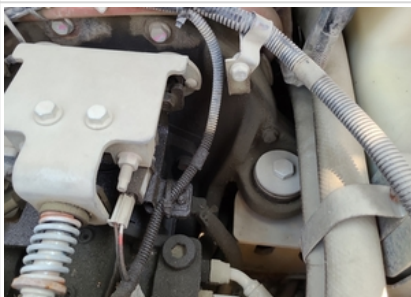
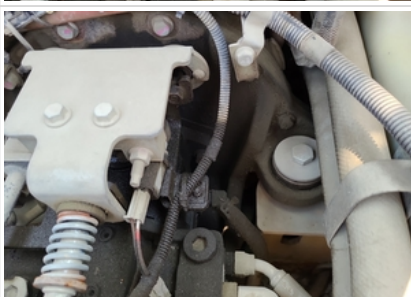
Hydraulic Pump/Fittings/Hoses

Hydraulic System Rating	3 - Normal Wear & Tear	
Hydraulic System Comments	Hydraulic System underneath cab has small seepage around pump and hose area.

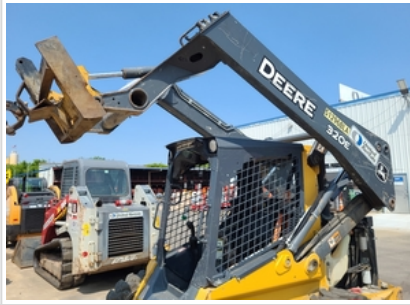
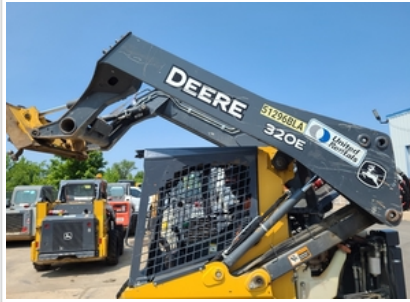
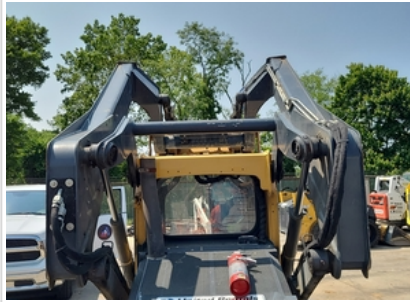
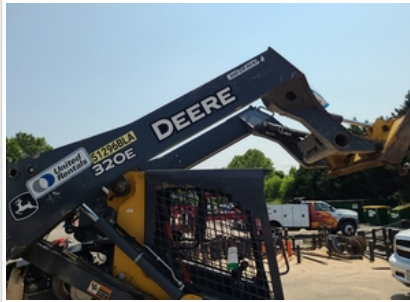
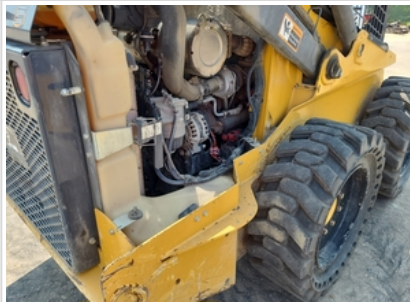
Chassis Photos	 
-----------------------	---

Chassis Rating	4 - Very Light or Minimal Wear
Comments	Main frame and implements in great condition.

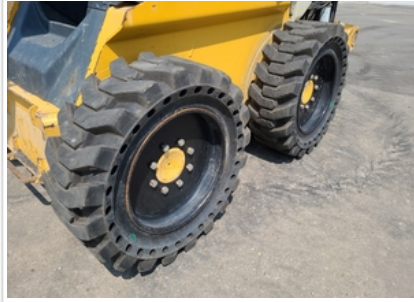
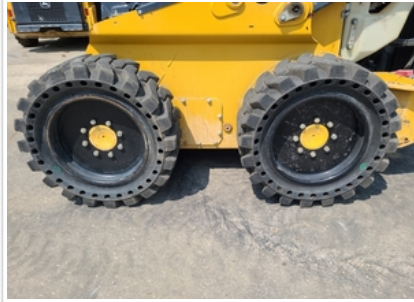
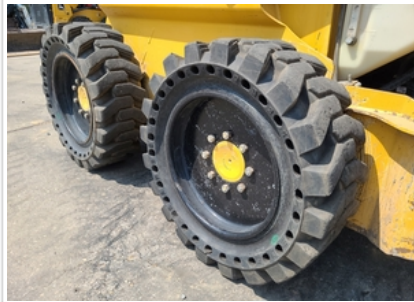
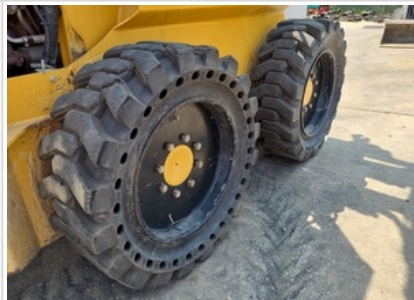
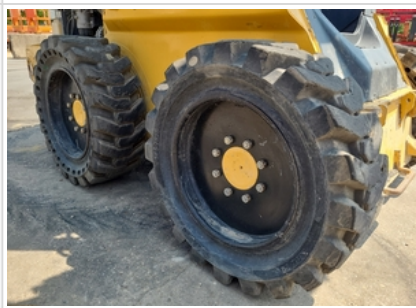
Undercarriage Photos

Undercarriage Rating	4 - Very Light or Minimal Wear	
Undercarriage Comments	Solid rubber wheels above 85% of life left

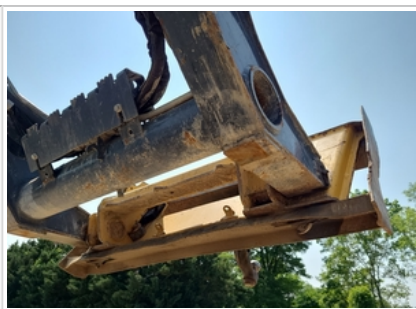
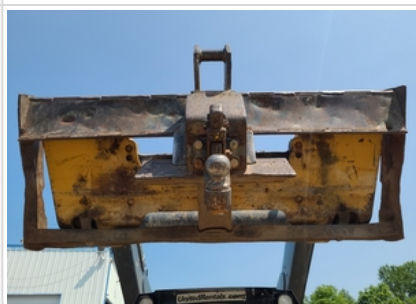
Attachment Photos

Attachment Rating	3 - Normal Wear & Tear
Attachment Comments	Hitch attachment in good condition
