Enterprise Equipment Inspection

Category	Compact Track Loader
Travel System	Track Undercarriage
Comments	
Year	2017
Make	Bobcat
Model	T450
Fleet ID	P13389NF
Serial Number	AUVP13389
Serial Number Plate

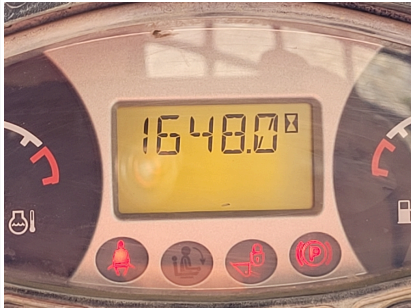
Hour Meter Reading	1,648 Hours
Hour Meter Photo

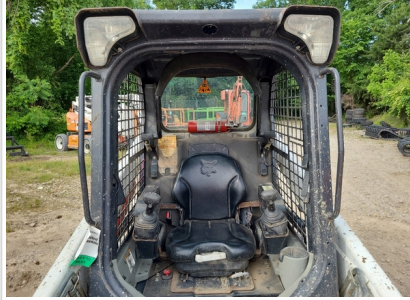
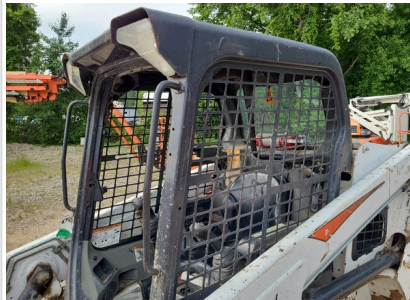
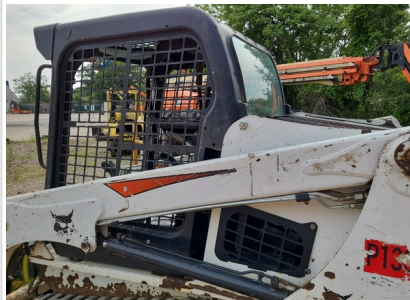
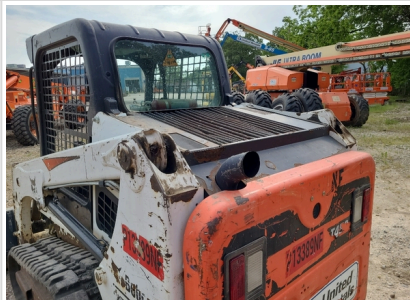
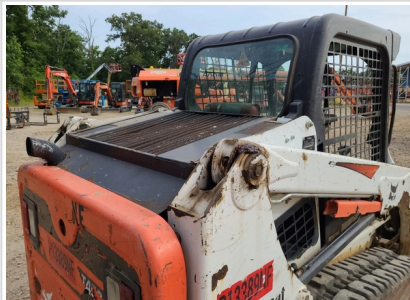
<p>Rear bumper dented at corners</p>

Exterior Rating	3 - Normal Wear & Tear
Exterior Comments	Scuff marks all around. Rear bumper corners dented.

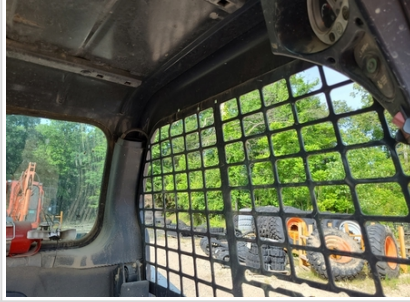
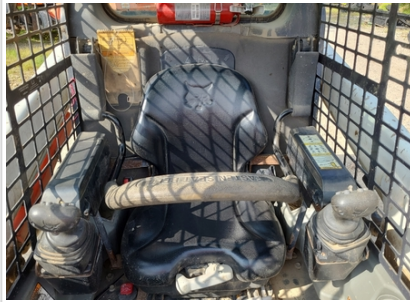
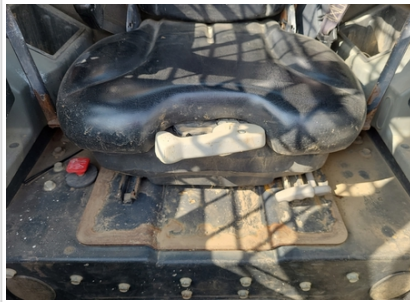
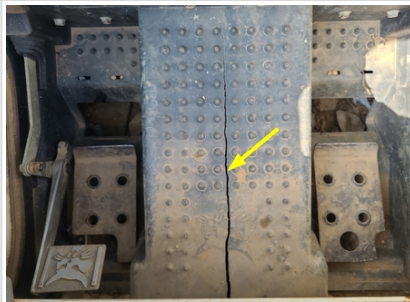
Cab floor cover cracked

Control Station Rating	3 - Normal Wear & Tear	
Control Station Overall Comments	Normal wear and tear interior. Bottom interior cover cracked down the middle.

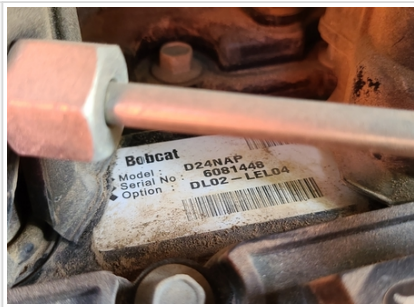
<p>Engine Compartment</p>

Engine Type (Make, Model, Cylinders, Hp)	Bobcat - 2.4L - 4Cyl. - 74HP	
Emissions Tier	Tier 4F	
Engine Rating	3 - Normal Wear & Tear	
Engine Overall Comments	Engine runs well under load and no active leaks observed.

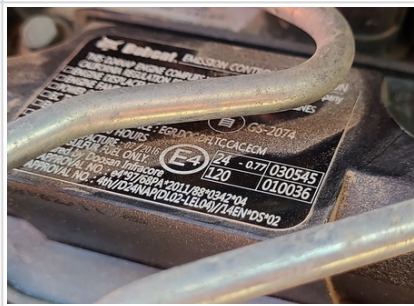
<p>Bobcat Model: D24NAP Serial No: 6001448 Option: DL02 - LE10A</p>

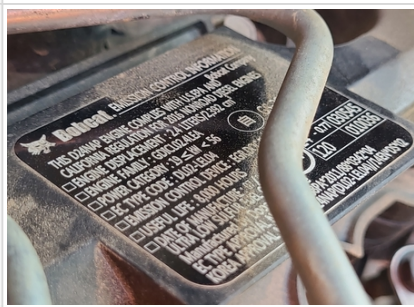
<p>Bobcat, EMISSION CONTROL GS-2074 E4 24 - 077 030545 L20 010036</p>

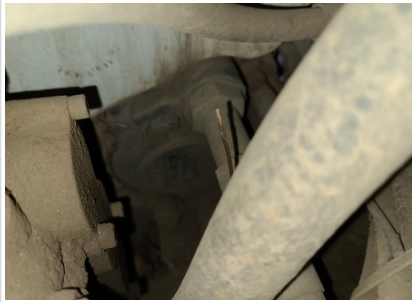
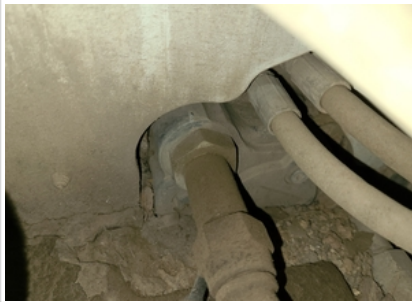
Drivetrain Photos

Transmission Info (Make/Model/Speeds)	
Drivetrain Rating	3 - Normal Wear & Tear
Drivetrain Comments	Machine travels well in all directions.

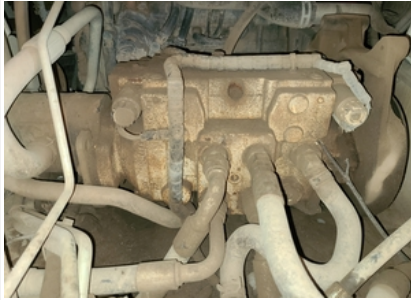
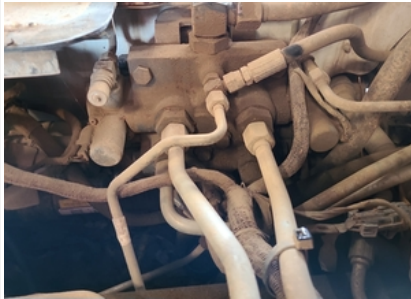
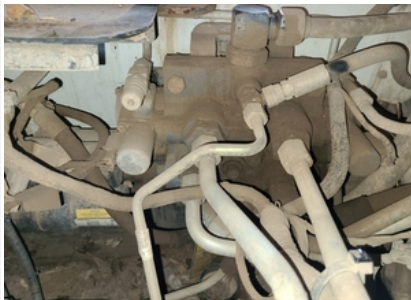
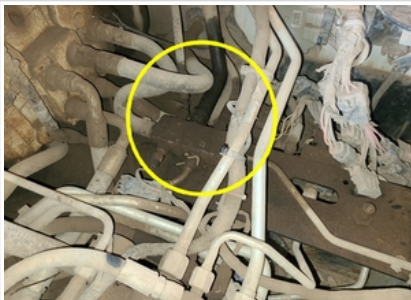
Hydraulic Pump/Fittings/Hoses

Hydraulic seepage buildup around pump and hoses

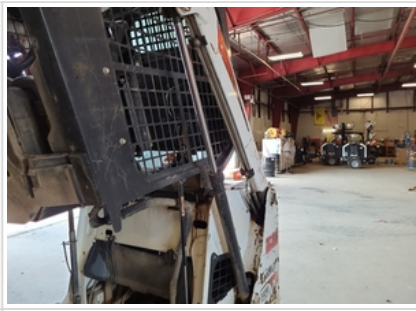
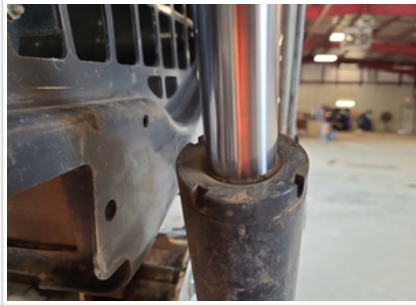
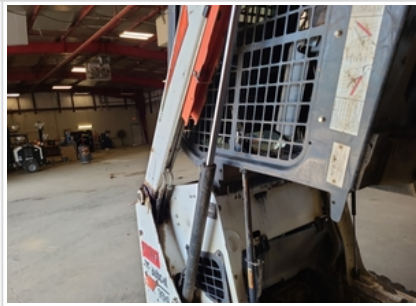
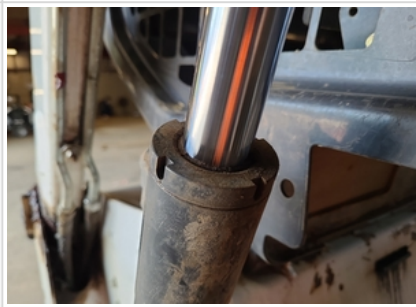
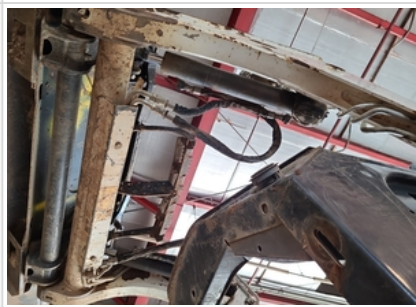
Hydraulic Cylinders & Mounting Pins

Hydraulic System Rating	3 - Normal Wear & Tear	
Hydraulic System Comments	Hydraulics working well and no active leaks observed from any cylinders.

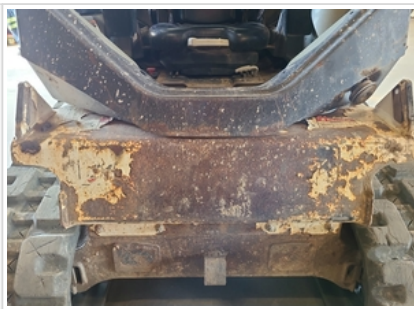
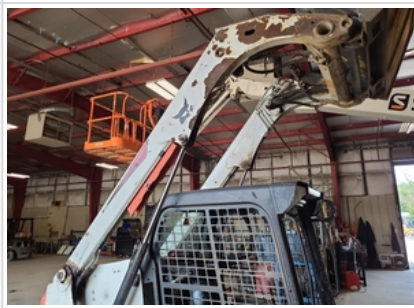
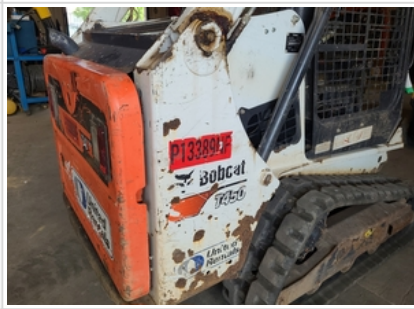
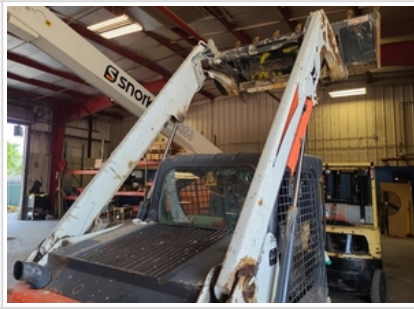
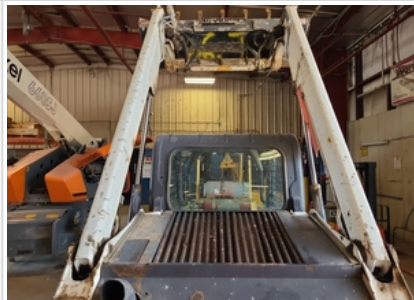
Chassis Photos

Chassis Rating	3 - Normal Wear & Tear	
Comments	Frame and Loader Arms in great shape

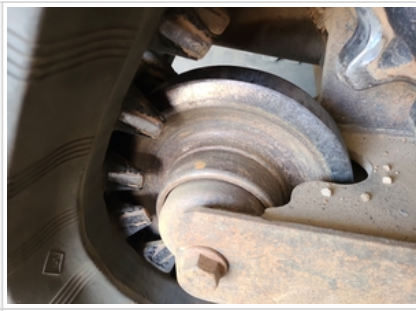
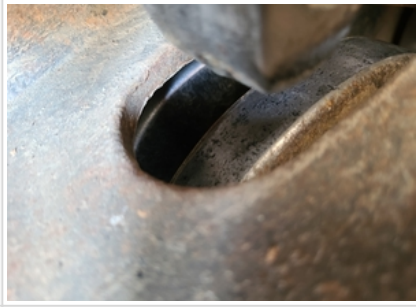
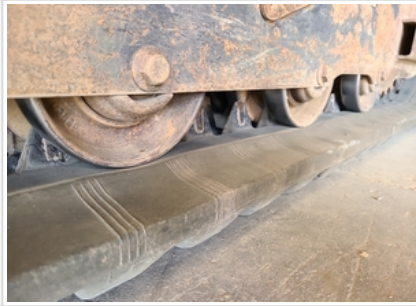
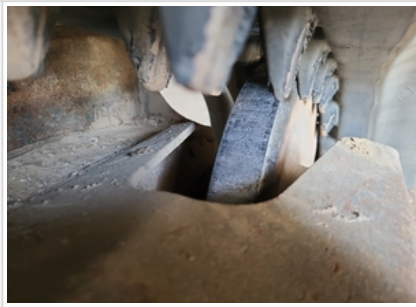
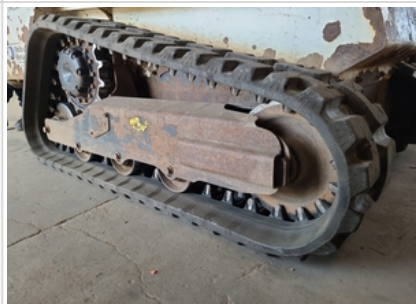
Undercarriage Photos

Undercarriage Rating	4 - Very Light or Minimal Wear	
Undercarriage Comments	Tracks have over 85% of life left. Rollers, bogies, and sprockets in great condition.
