Inspection Report (Compact Track Loader)

B&B Stock Number	1
Year	2016
Make	Bobcat
Model	T870
Serial Number	ASWT11629
Hour Meter Reading	1,835 Hrs.
Previous Application (e.g., earth moving, mining, demolition, etc)	Personal Use (Horse Property)

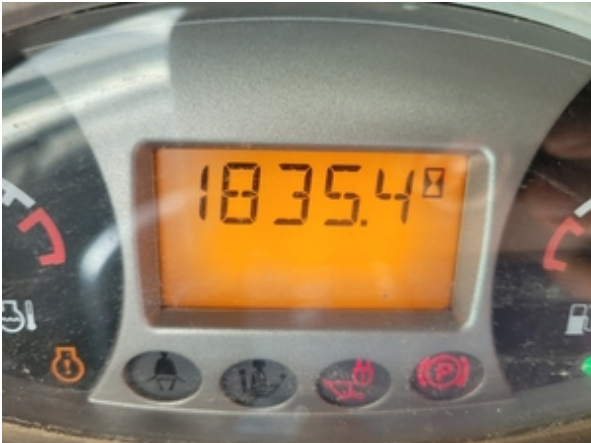
Hour Meter/Odometer

Hour Meter Activity	3 - Normal Wear & Tear
Hour Meter Condition	Hour meter is functional and in good condition
Other Gauge Activity	3 - Normal Wear & Tear
Other Gauge Condition	All cockpit gauges are functional and in good condition
Heater & A/C	3 - Normal Wear & Tear
Heater & A/C Condition	Heater and A/C work as expected
Travel Alarm	3 - Normal Wear & Tear
Travel Alarm Condition	Travel alarm is installed and functioning as expected
Horn	2 - Above Average Wear & Tear
Horn Condition	Horn installed but functioning improperly
Comments	Horn inop.
Backup Camera	0

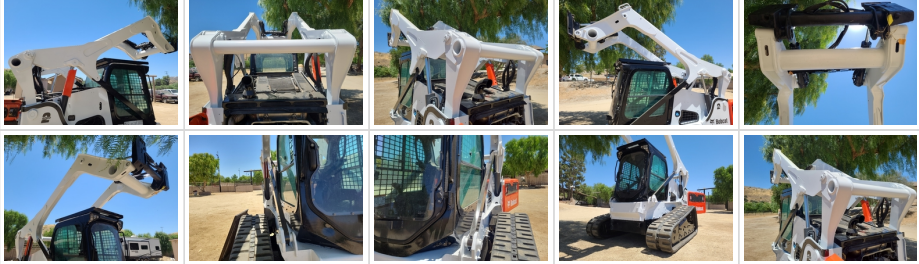
Chassis Photos

Frame	3 - Normal Wear & Tear
Stance	4 - Very Light or Minimal Wear
Lift Arm	3 - Normal Wear & Tear
Chassis to Arm Pins	3 - Normal Wear & Tear
Quick Coupler	3 - Normal Wear & Tear
Quick Coupler to Arms Pins	3 - Normal Wear & Tear
Overall Chassis	3 - Normal Wear & Tear
Overall Chassis Comments	Frame and implements in good condition with no issues observed during operation.

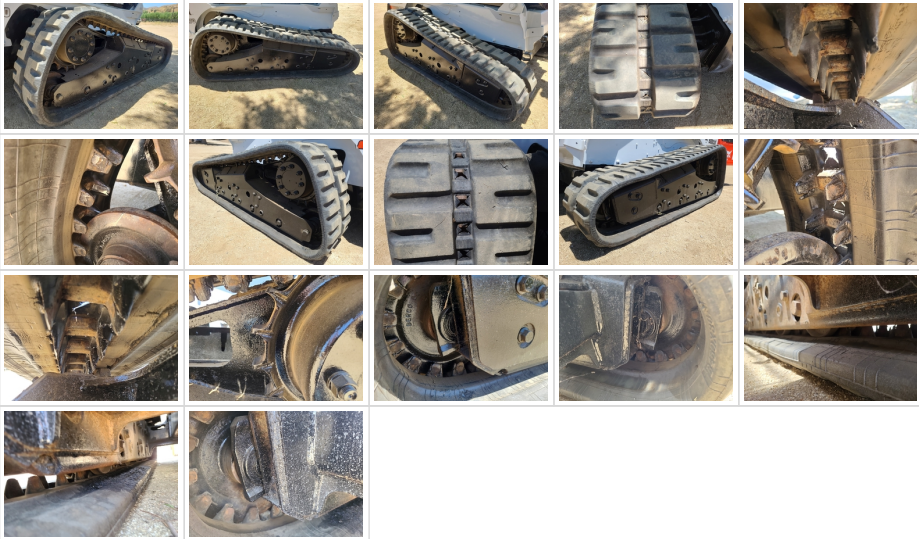
Undercarriage Photos

Track Width (inches)	18"
Track Length (inches)	7'
Roller Frames	3 - Normal Wear & Tear
Track Belt	5 - Like New, Recently Replaced
Rubber Belt Drive Lugs	5 - Like New, Recently Replaced
Track Tensioners	3 - Normal Wear & Tear

Front Idlers	3 - Normal Wear & Tear
Rear Idlers	3 - Normal Wear & Tear
Track Rollers	3 - Normal Wear & Tear
Sprockets	3 - Normal Wear & Tear
Overall Undercarriage Rating	4 - Very Light or Minimal Wear
Left Track Belt - Percent Remaining Estimate	90%
Right Track Belt - Percent Remaining Estimate	90%
Overall Comments	Tracks just replaced and are in "like new" condition.
