Inspection Report (Compact Track Loader)

B&B Stock Number	A2828956
Year	2020
Make	New Holland
Model	C232
Serial Number	NJM457833
Hour Meter Reading	1,575 Hrs.
Previous Application (e.g., earth moving, mining, demolition, etc)	Asphalt Paving Construction

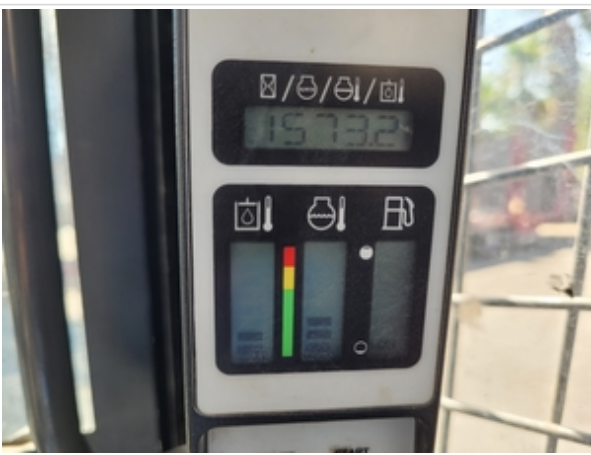
Hour Meter/Odometer

Hour Meter Activity	3 - Normal Wear & Tear
Hour Meter Condition	Hour meter is functional and in good condition
Other Gauge Activity	3 - Normal Wear & Tear
Other Gauge Condition	All cockpit gauges are functional and in good condition

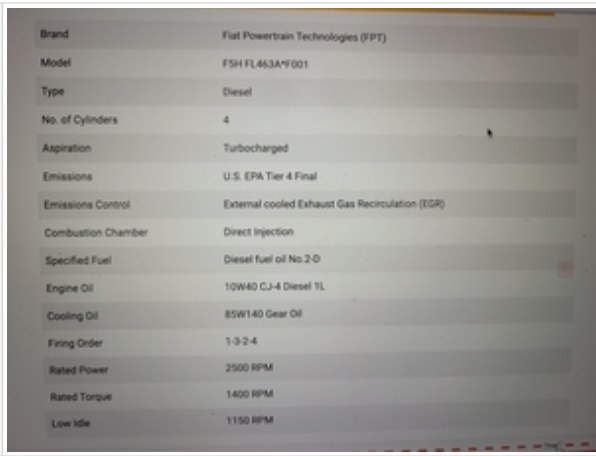
<p>Engine Data Plate</p>

<table><tr><td>Brand</td><td>Flat Powertrain Technologies (FPT)</td></tr><tr><td>Model</td><td>F5H FL463A*F001</td></tr><tr><td>Type</td><td>Diesel</td></tr><tr><td>No. of Cylinders</td><td>4</td></tr><tr><td>Aspiration</td><td>Turbocharged</td></tr><tr><td>Emissions</td><td>U.S. EPA Tier 4 Final</td></tr><tr><td>Emissions Control</td><td>External cooled Exhaust Gas Recirculation (EGR)</td></tr><tr><td>Combustion Chamber</td><td>Direct Injection</td></tr><tr><td>Specified Fuel</td><td>Diesel fuel oil No.2-D</td></tr><tr><td>Engine Oil</td><td>10W40 CJ-4 Diesel TL</td></tr><tr><td>Cooling Oil</td><td>85W140 Gear Oil</td></tr><tr><td>Firing Order</td><td>1-3-2-4</td></tr><tr><td>Rated Power</td><td>2500 RPM</td></tr><tr><td>Rated Torque</td><td>1400 RPM</td></tr><tr><td>Low Idle</td><td>1150 RPM</td></tr></table>
