## Inspection Report (Excavator)

B&B Stock Number	N/a
Year	2004
Make	Case
Model	Cx460
Serial Number	Dac461148
Hour Meter Reading	13548.6
Previous Application (e.g., earth moving, mining, demolition, etc)	Earth moving

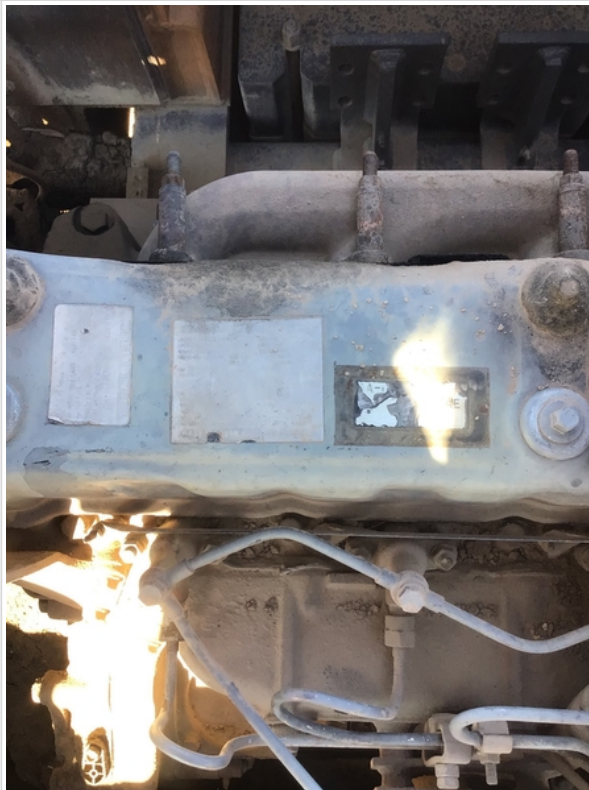
Engine Data Plate

Engine Type (Make, Model, Cylinders, Hp)	6cyl
Emissions Tier	Undetermined
Engine Serial Number	Not able to make it out
Engine Fuel Type	Diesel
Blow-by (Visual Observation Check)	Yes
Unusual Noises (Upon Start-up, Idle, Shutdown)	No
Engine Smoke (Upon Start-up, Idle, Shutdown)	Yes
Engine Smoke Notes	Engine smoke observed upon start up
Comments	Black smoke
Engine Exhaust Color	Black
Battery	1 - Service Required
Battery Condition	Inaccessible, unable to determine condition
Comments	Dead/ had to jump
Radiator	2 - Above Average Wear & Tear
Radiator Condition	Signs of corrosion on clamps & hoses
Belts	2 - Above Average Wear & Tear
Belt Condition	Frayed belt edges observed
Hoses	1 - Service Required
Hose Condition	Worn, cut, or damaged outer covering on one or more hoses
Water Pump	3 - Normal Wear & Tear
Water Pump Condition	Groaning, squealing, or squeaking noises heard at pump
Cooling System Leaks	Yes

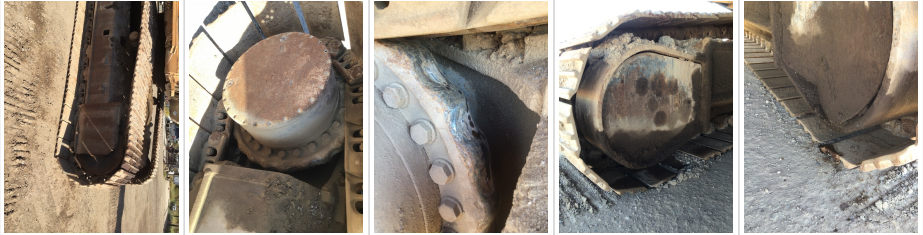
Drivetrain Photos

Hydrostatic Transmission?	Yes
2 Speed?	Yes
Hydrostatic Drive Configuration	Close Coupled Transmission
Transmission Components	1 - Service Required
Transmission Condition	Jerking, shaking, or grinding felt, Grinding, clunking, or whining sounds heard, Leaking transmission fluid observed
Drive Motors	1 - Service Required
Comments	Gears are worn out and unusable
Parking Brake	5 - Like New, Recently Replaced
Overall Drivetrain Rating	1 - Service Required
Overall Drivetrain Comments	Needs a lot of work

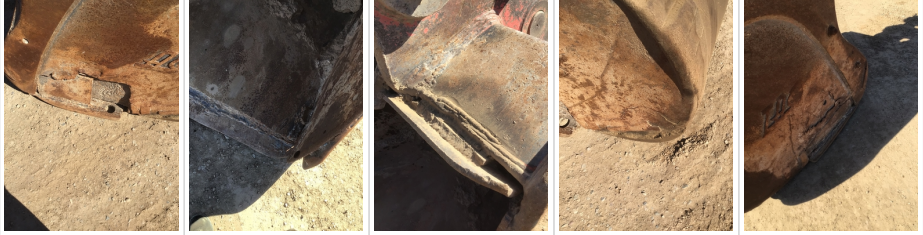
Attachment Photos

Bucket	1 - Service Required
Comments	Needs a lot of work , Almost not usable
Bucket Teeth	1 - Service Required
Comments	None are left
Blade	0
Blade Edge	0
