Inspection Report (Boom Lift)

B&B Stock Number	A7964563
Year	2022
Make	Genie
Model	S-85 XC
Serial Number	S85XCH-3140
Hour Meter Reading	82.0 Hrs.
Previous Application (e.g., earth moving, mining, demolition, etc)	Equipment Rental

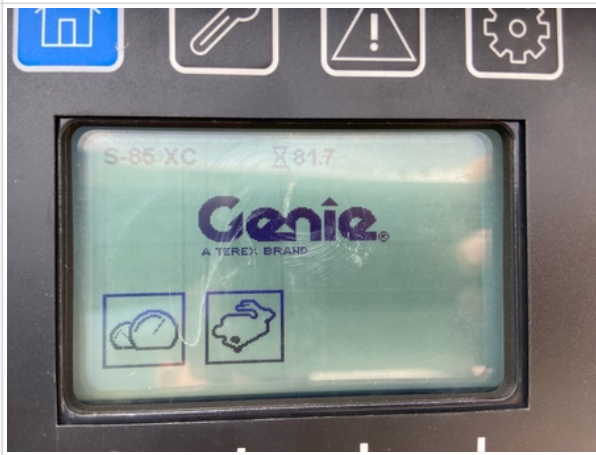
Hour Meter/Odometer

Seat	0
Cabin Lights	0
Safety Lock Out / Stop	4 - Very Light or Minimal Wear
Safety Lock Out / Stop Condition	Safety lock out device is present, in good condition, and functional
Controls & Switches	4 - Very Light or Minimal Wear
Controls & Switches Condition	All switches are installed and functional
Hour Meter Activity	4 - Very Light or Minimal Wear
Hour Meter Condition	Hour meter is functional and in good condition
Other Gauge Activity	4 - Very Light or Minimal Wear

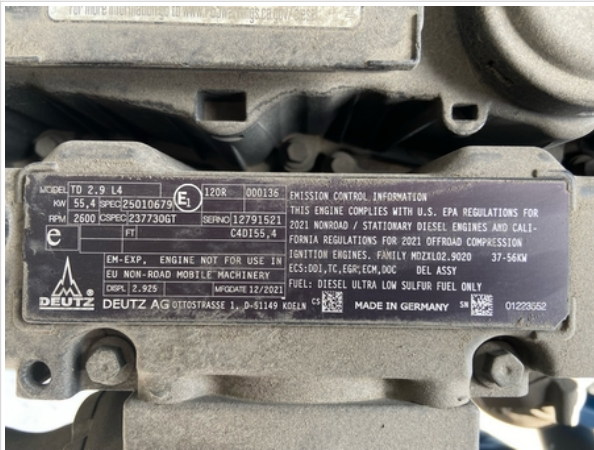
Engine Data Plate

Engine Type (Make, Model, Cylinders, Hp)	Deutz - TD2.9 - 4Cyl. - 74HP				
Emissions Tier	Tier 4F				
Engine Serial Number	12791521				
Engine Fuel Type	Diesel

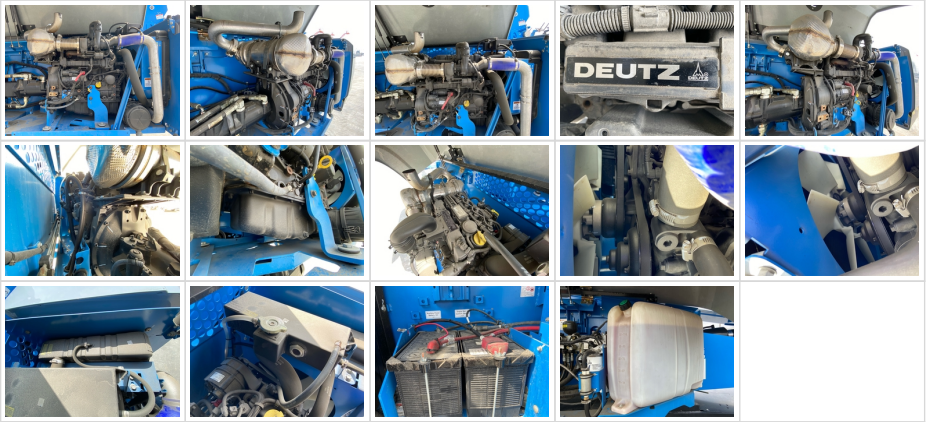
Engine Compartment Photos

Blow-by (Visual Observation Check)	No
Unusual Noises (Upon Start-up, Idle, Shutdown)	No
Engine Smoke (Upon Start-up, Idle, Shutdown)	No
Engine Exhaust Color	Clear
Battery	4 - Very Light or Minimal Wear
Battery Condition	Like new, recently replaced
Radiator	4 - Very Light or Minimal Wear
Radiator Condition	Radiator fins & components appear to be in good working order, no signs of damage or leaks
Belts	4 - Very Light or Minimal Wear
Belt Condition	Belts appear in good condition & alignment with proper tension
Hoses	4 - Very Light or Minimal Wear
Hose Condition	Firm, pliant hoses with no signs of wear or leaks
Water Pump	4 - Very Light or Minimal Wear
Water Pump Condition	No unusual pump noises heard
Cooling System Leaks	No
Coolant Appearance	4 - Very Light or Minimal Wear
Coolant Appearance Notes	Normal Translucent appearance, no visual signs of contamination
Oil Leaks	No
Oil Appearance	4 - Very Light or Minimal Wear

Oil Appearance Notes	Appropriate oil level, Clean oil appearance, no signs of cross contamination
Fuel Leaks	No
Equipped with DPF (Diesel Particulate Filter)	Yes
DPF Condition	4 - Very Light or Minimal Wear
DPF Condition Notes	Filter housing is intact with no signs of damage or malfunction, DPF indicator is not illuminated
Requires DEF (Diesel Exhaust Fluid)	No
Overall Engine Rating	4 - Very Light or Minimal Wear
Overall Engine Appearance	Clean & dry
Overall Engine Comments	Engine running great with only 82 hours of run time.
