Inspection Report (Directional Drill)

B&B Stock Number	A7077008
Year	2012
Make	Vermeer
Model	PD-10
Serial Number	1VRB100Z5D1000130
Hour Meter Reading	2,286 Hrs.
Previous Application (e.g., earth moving, mining, demolition, etc)	Renewable Energy General Construction

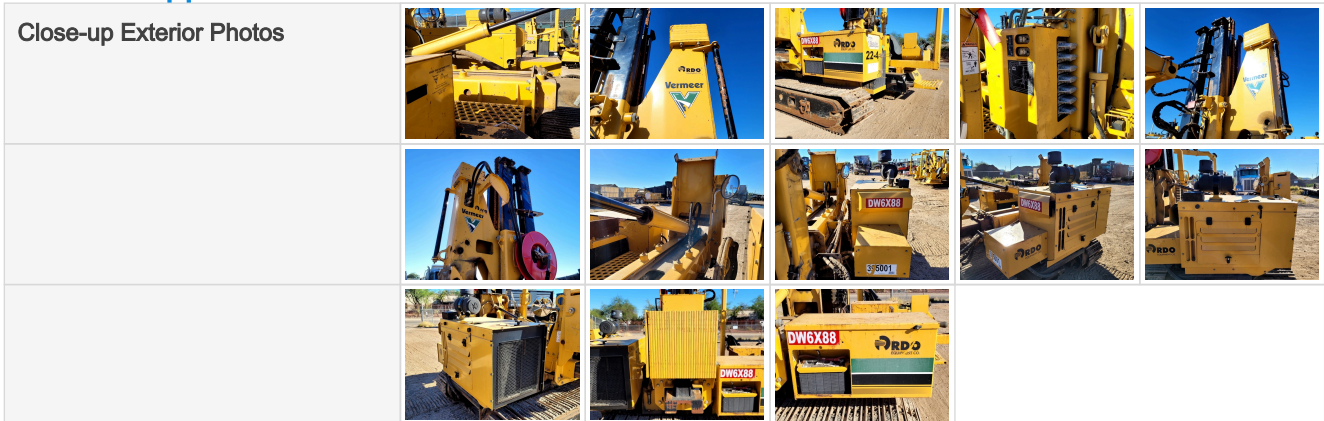
General Appearance Photos

Exterior Lights	3 - Normal Wear & Tear	
Exterior Lights Condition	No visible damage, lighting system is operational	
Overall Exterior	3 - Normal Wear & Tear	
Comments	Overall, the exterior is in good condition for its age. Normal wear and tear scuff marks present throughout machine.

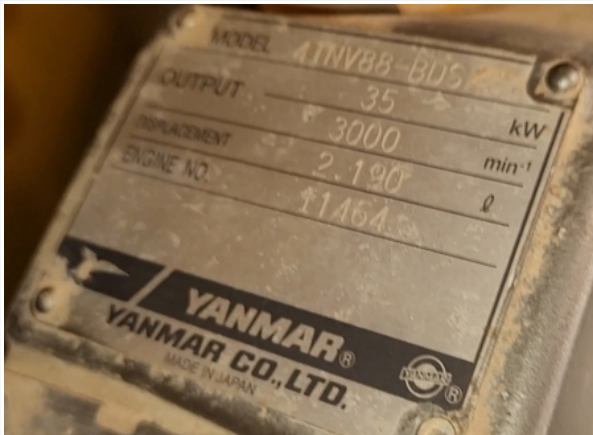
Engine Data Plate

Engine Type (Make, Model, Cylinders, Hp)	Yanmar - TNV88 - 4Cyl. - 2.2L - 47HP				
Emissions Tier	Tier 4i				
Engine Serial Number	11464				
Engine Fuel Type	Diesel				
Blow-by (Visual Observation Check)	No				
Unusual Noises (Upon Start-up, Idle, Shutdown)	No

Comments	Engine service recommended
Fuel Leaks	No
Equipped with DPF (Diesel Particulate Filter)	No
Requires DEF (Diesel Exhaust Fluid)	No
Overall Engine Rating	3 - Normal Wear & Tear
Overall Engine Appearance	Dusty & dry
Overall Engine Comments	The engine fired right up and ran fine at idle. Engine sounded strong under load. RPM Governor intermittently sticking at high idle.

What Needs Work	Engine governor linkage sticky and should be further evaluated as to why. The battery was not holding charge after engine was running and may need to be replaced. The operator seat should be replaced and some cosmetic scuff marks are present throughout exterior.	
Date/Time	09-26-2023	
Inspector Name	Mario Ramirez

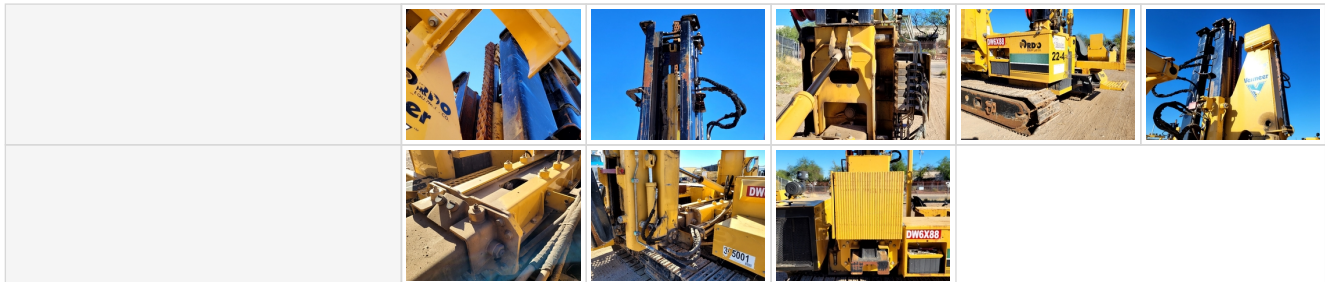
Chassis Photos

I recommend further examination of marked area for possible cracks.

Frame	3 - Normal Wear & Tear
Outrigger Frame(s)	0
Bottom Covers	0
Drill Stem	0
Drill Pipe	0
Drill Bit	0
Borehole	0
Steering System	0
Water/Mud Cleaning System	0
Overall Chassis	3 - Normal Wear & Tear
Overall Chassis Comments	Overall main frame and driver assembly in good condition.
