Inspection Report (Excavator)

B&B Stock Number	A8922904
Year	2017
Make	John Deere
Model	470G
Serial Number	1FF470GXEHF235143
Hour Meter Reading	7022
Previous Application (e.g., earth moving, mining, demolition, etc)	This machine was previously used in civil construction

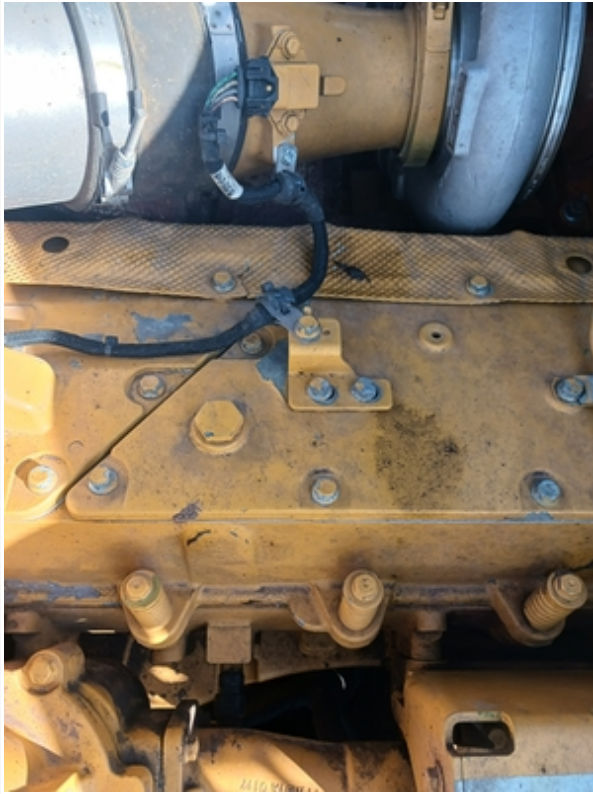
Engine Data Plate

Engine Type (Make, Model, Cylinders, Hp)	John deere Powe tech, 6 cylinder				
Emissions Tier	Tier 4F				
Engine Serial Number	unable to determine

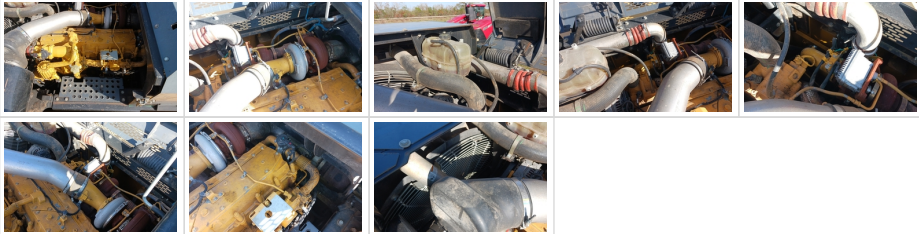
Engine Compartment Photos

Engine Fuel Type	Diesel
Blow-by (Visual Observation Check)	N/A
Unusual Noises (Upon Start-up, Idle, Shutdown)	No
Engine Smoke (Upon Start-up, Idle, Shutdown)	No
Engine Exhaust Color	Clear
Battery	3 - Normal Wear & Tear
Battery Condition	Dusty & dirty appearance
Radiator	3 - Normal Wear & Tear
Radiator Condition	Radiator fins & components appear to be in good working order, no signs of damage or leaks
Belts	3 - Normal Wear & Tear
Belt Condition	Belts appear in good condition & alignment with proper tension
Hoses	3 - Normal Wear & Tear
Hose Condition	Firm, pliant hoses with no signs of wear or leaks
Water Pump	3 - Normal Wear & Tear
Water Pump Condition	No unusual pump noises heard
Cooling System Leaks	No
Coolant Appearance	3 - Normal Wear & Tear
Coolant Appearance Notes	Normal Translucent appearance, no visual signs of contamination
Oil Leaks	No
Oil Appearance	3 - Normal Wear & Tear
Oil Appearance Notes	Appropriate oil level, Very dark, black & burnt oil appearance

Fuel Leaks	No
Equipped with DPF (Diesel Particulate Filter)	Yes
DPF Condition	3 - Normal Wear & Tear
DPF Condition Notes	Filter housing is intact with no signs of damage or malfunction, DPF indicator is not illuminated
Requires DEF (Diesel Exhaust Fluid)	Yes
DEF Tank	3 - Normal Wear & Tear
DEF Tank Condition	Area around DEF tank cap is clean, fluid is clear & appears free of contaminants
Overall Engine Rating	3 - Normal Wear & Tear
Overall Engine Appearance	Dusty & dry
Overall Engine Comments	The engine is in good working order

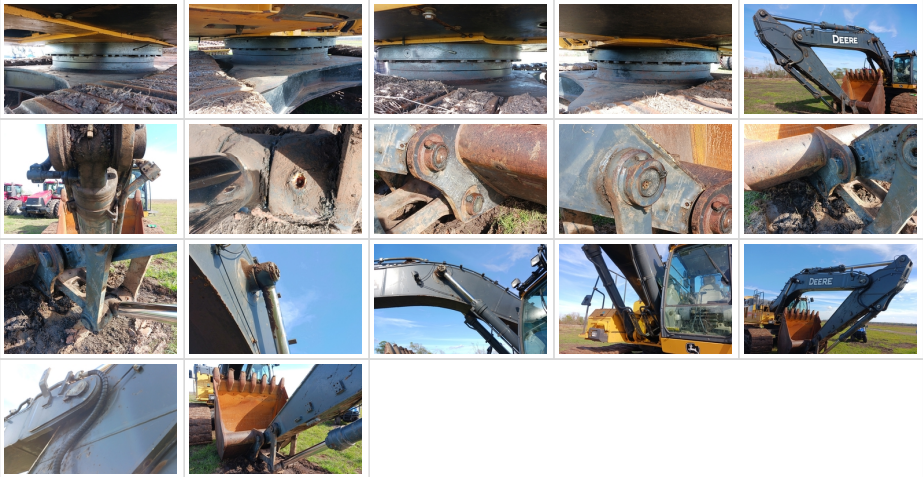
Chassis Photos

Boom Condition	3 - Normal Wear & Tear
Stick Condition	3 - Normal Wear & Tear
Boom Base Pin & Bushings	3 - Normal Wear & Tear
Boom to Stick Pin & Bushings	3 - Normal Wear & Tear
Stick to Bucket Pin & Bushings	3 - Normal Wear & Tear

Turntable Bearing	3 - Normal Wear & Tear
Bottom Covers	3 - Normal Wear & Tear
Overall Chassis	3 - Normal Wear & Tear
Overall Chassis Comments	The chassis is in good working order.

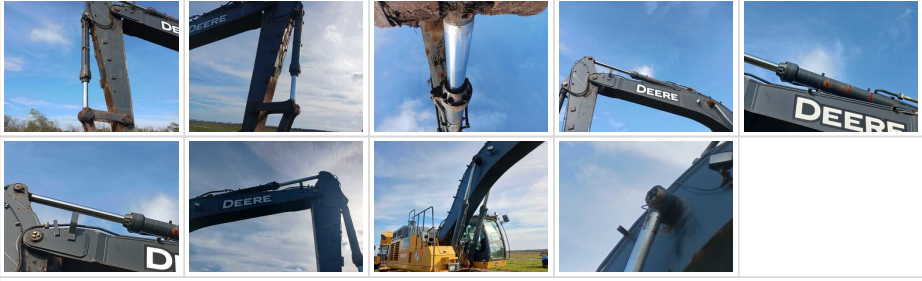
Hydraulic Cylinder Photos

Mounting Pins	3 - Normal Wear & Tear
Cylinder Oil Leaks	No
Comments	Some leaks were seen but overall the hydraulic cylinders are in good working order
Hydraulic System Overall	3 - Normal Wear & Tear

Comments	The overall hydraulic system is in good working order.
----------	--

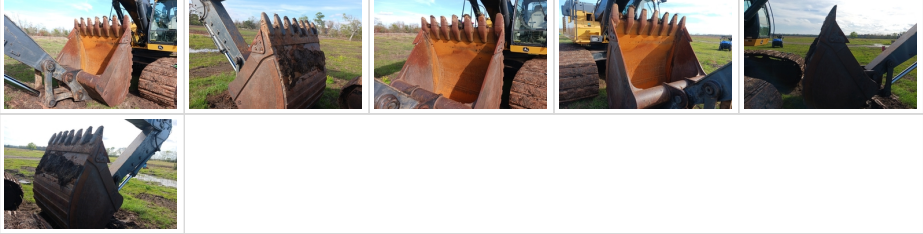
Attachment Photos

Bucket	3 - Normal Wear & Tear
Bucket Teeth	3 - Normal Wear & Tear
Blade	0
Blade Edge	0
