Inspection Report (Generator)

B&B Stock Number	A2527350
Year	2020
Make	Wanco
Model	WSP220-R
Serial Number	S786341
Hour Meter Reading	253 Hrs.
Previous Application (e.g., earth moving, mining, demolition, etc)	General Construction

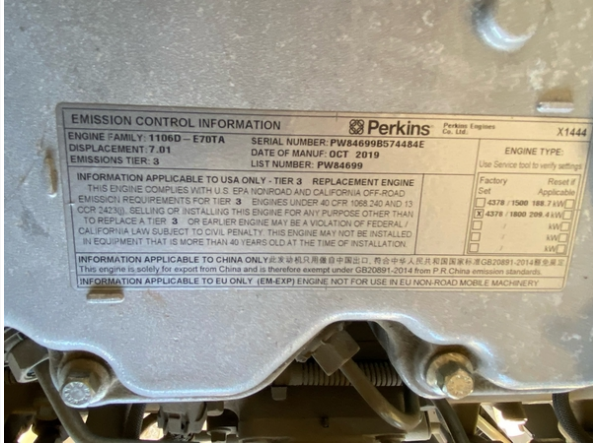
Engine Data Plate

Engine Type (Make, Model, Cylinders, Hp)	Perkins 1106D-E70TA, 6 Cylinder
Emissions Tier	Tier 3
Engine Serial Number	PW84699B581826F
Engine Fuel Type	Diesel
Blow-by (Visual Observation Check)	No
Unusual Noises (Upon Start-up, Idle, Shutdown)	No
Engine Smoke (Upon Start-up, Idle, Shutdown)	No
Engine Exhaust Color	Clear
Battery	4 - Very Light or Minimal Wear
Battery Condition	Like new, recently replaced
Radiator	4 - Very Light or Minimal Wear
Radiator Condition	Radiator fins & components appear to be in good working order, no signs of damage or leaks
Belts	4 - Very Light or Minimal Wear
Belt Condition	Belts appear in good condition & alignment with proper tension
Hoses	4 - Very Light or Minimal Wear
Hose Condition	Firm, pliant hoses with no signs of wear or leaks
Water Pump	4 - Very Light or Minimal Wear
Water Pump Condition	No unusual pump noises heard
Cooling System Leaks	No

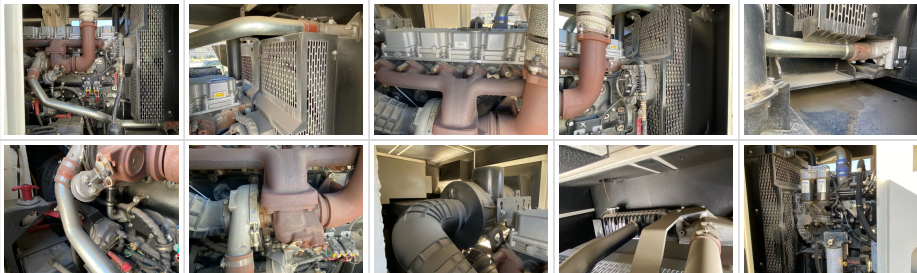
Engine Compartment Photos

Requires DEF (Diesel Exhaust Fluid)	No
Overall Engine Rating	4 - Very Light or Minimal Wear
Overall Engine Appearance	Clean & dry, Dusty & dry
Overall Engine Comments	The engine fired right up and sounded healthy at low/high RPM's. No active leaks observed during the inspection.

What's Great About the Machine	This generator has low usage and is in great shape. The overall condition of this generator is like new.	
What Needs Work	This generator does not come with power cables. The door locks may have to be rekeyed or replaced for proper operation. A basic engine oil service is recommended.	
Date/Time	01-11-2024	
Inspector Name	Mario Ramirez

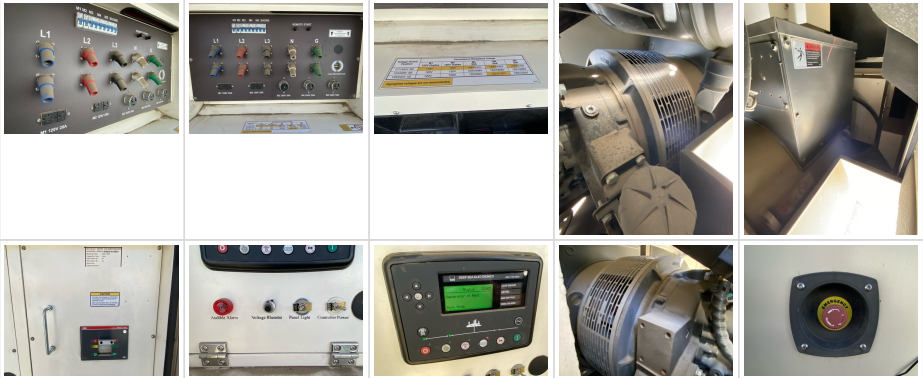
Electric Operating System Photos

Operating Voltage	Single Phase 120/240V, Three Phase 120/208V & 277/480V
Battery Condition	4 - Very Light or Minimal Wear
Comments	Both 12v batteries are new
Battery Charger	4 - Very Light or Minimal Wear
Cables & Connections	4 - Very Light or Minimal Wear
Tight Connections?	Yes
Solenoids	4 - Very Light or Minimal Wear
Wire Harness	4 - Very Light or Minimal Wear
Fuse Panel(s)	4 - Very Light or Minimal Wear
Computer Appearance	4 - Very Light or Minimal Wear
Screen Discoloration?	No
Electric Operating System Overall Rating	4 - Very Light or Minimal Wear
Overall Electric Operating System Comments	All electrical components are in great shape with no obvious issues observed. The gen. set was not load tested but all visible electrical readings from monitor control panel were normal.
