Inspection Report (Bulldozer)

B&B Stock Number	A0374671
Year	2017
Make	John Deere
Model	700K XLT
Serial Number	1T0700KXEHF316329
Hour Meter Reading	1828.6
Previous Application (e.g., earth moving, mining, demolition, etc)	Earth moving

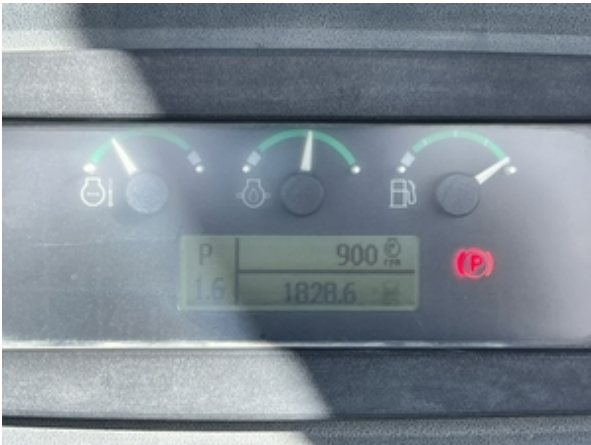
Hour Meter/Odometer

Control Station Type	Open Cab (OROPS)
Seat	2 - Above Average Wear & Tear
Seat Condition	Seat(s) have minor surface staining or small tears, Seat belt secures properly
Comments	Rips to seat bottom and backrest
Cabin Lights	0
Safety Lock Out / Stop	3 - Normal Wear & Tear
Safety Lock Out / Stop Condition	Safety lock out device is present, in good condition, and functional
Controls & Switches	3 - Normal Wear & Tear
Controls & Switches Condition	All switches are installed and functional
Hour Meter Activity	3 - Normal Wear & Tear
Hour Meter Condition	Hour meter is functional and in good condition

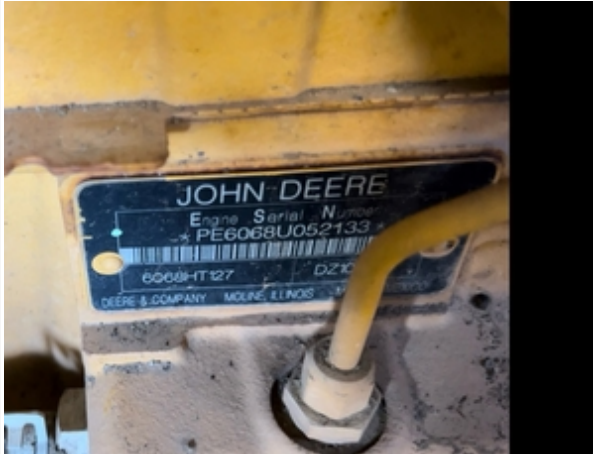
Engine Data Plate

Engine Type (Make, Model, Cylinders, Hp)	John Deere
Emissions Tier	Tier 4F
Engine Serial Number	PE6068U052133
Engine Fuel Type	Diesel
Blow-by (Visual Observation Check)	No
Unusual Noises (Upon Start-up, Idle, Shutdown)	No
Engine Smoke (Upon Start-up, Idle, Shutdown)	No
Engine Exhaust Color	Clear
Battery	3 - Normal Wear & Tear
Battery Condition	Dusty & dirty appearance
Radiator	3 - Normal Wear & Tear
Radiator Condition	Radiator fins & components appear to be in good working order, no signs of damage or leaks
Belts	3 - Normal Wear & Tear
Belt Condition	Belts appear in good condition & alignment with proper tension
Hoses	3 - Normal Wear & Tear
Hose Condition	Firm, pliant hoses with no signs of wear or leaks
Water Pump	3 - Normal Wear & Tear
Water Pump Condition	No unusual pump noises heard
Cooling System Leaks	No
Coolant Appearance	3 - Normal Wear & Tear

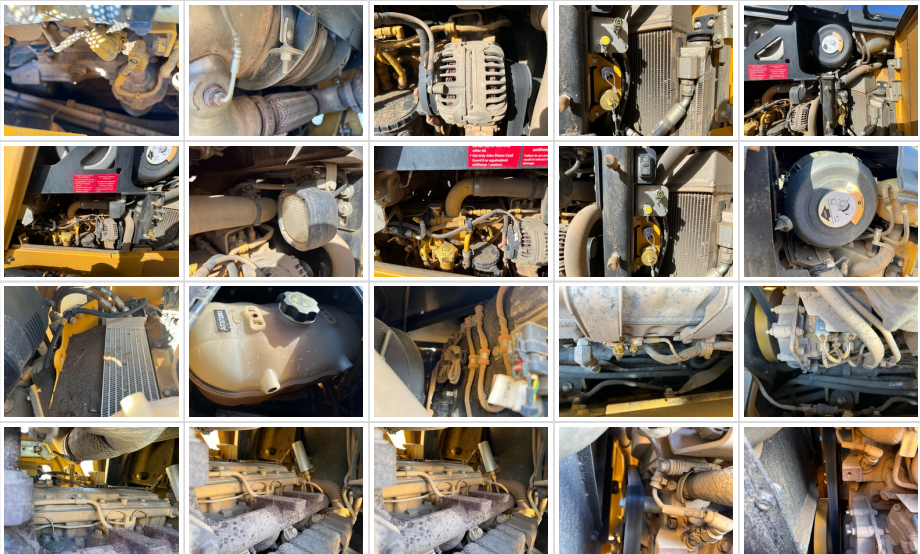
Engine Compartment Photos

Oil Appearance Notes	Clean oil appearance, no signs of cross contamination
Fuel Leaks	No
Equipped with DPF (Diesel Particulate Filter)	Yes
DPF Condition	3 - Normal Wear & Tear
DPF Condition Notes	Filter housing is intact with no signs of damage or malfunction, DPF indicator is not illuminated
Requires DEF (Diesel Exhaust Fluid)	Yes
DEF Tank	3 - Normal Wear & Tear
Overall Engine Rating	3 - Normal Wear & Tear
Overall Engine Appearance	Dusty & dry
Overall Engine Comments	Normal wear and tear no major issues to report

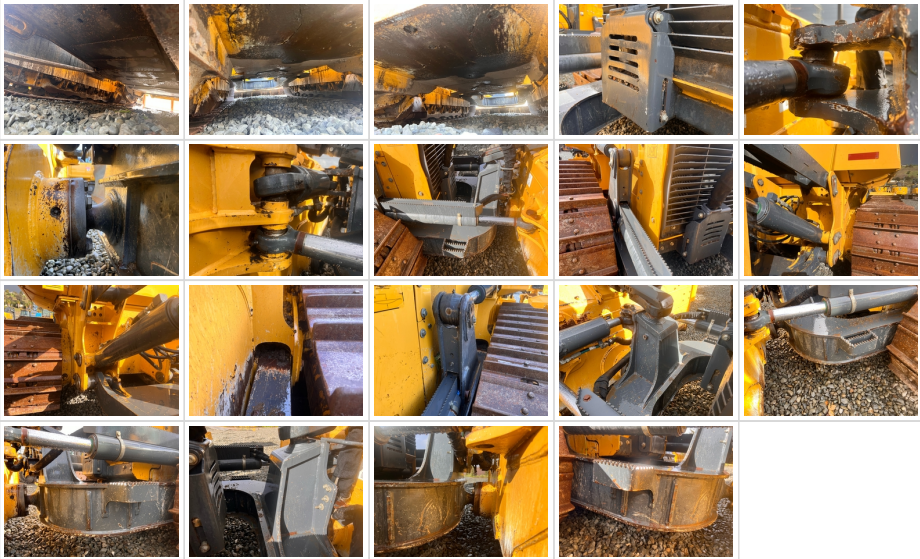
Chassis Photos

Push Arm / C-Frame Condition	3 - Normal Wear & Tear				
Push Arm Pivot / C-Frame Trunnions Condition	3 - Normal Wear & Tear				
Tilt Linkage Pin & Bushings	3 - Normal Wear & Tear				
Angle Linkage Pin & Bushings	3 - Normal Wear & Tear				
Blade Trunnions / Bushings	3 - Normal Wear & Tear				
Frame Condition	3 - Normal Wear & Tear				
Belly Pans	3 - Normal Wear & Tear				
Overall Chassis	3 - Normal Wear & Tear				
Overall Chassis Comments	Normal wear and tear no major issues to report
