Inspection Report (Excavator)

B&B Stock Number	A4583362
Year	2022
Make	John Deere
Model	50G
Serial Number	1FF050GXHNH296621
Hour Meter Reading	178.3
Previous Application (e.g., earth moving, mining, demolition, etc)	Earth moving

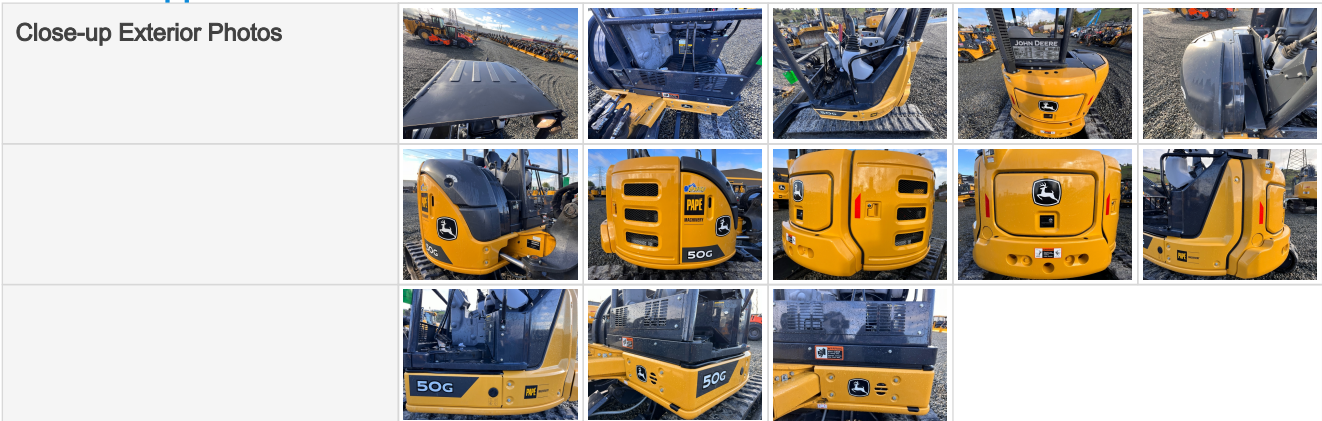
General Appearance Photos

Handrails Condition	Handrails are fully intact and appear structurally sound	
Glass	0	
Mirrors	0	
Exterior Lights	4 - Very Light or Minimal Wear	
Exterior Lights Condition	No visible damage, lighting system is operational	
Overall Exterior	4 - Very Light or Minimal Wear	
Comments	Like new appearance No major issues to report

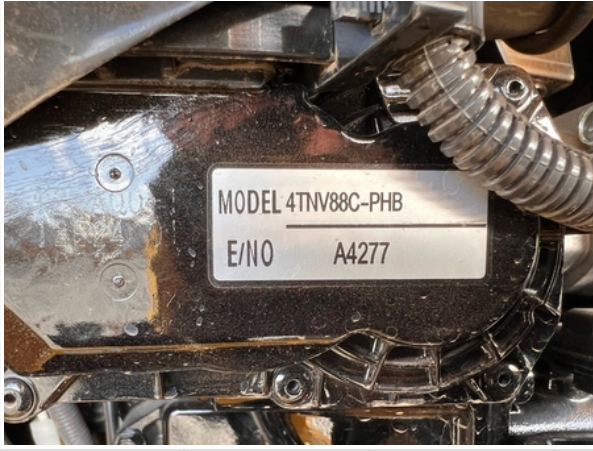
Engine Data Plate

Engine Type (Make, Model, Cylinders, Hp)	John Deere, 4TNV88C-PHB				
Emissions Tier	Undetermined				
Engine Fuel Type	Diesel				
Blow-by (Visual Observation Check)	No				
Unusual Noises (Upon Start-up, Idle, Shutdown)	No				
Engine Smoke (Upon Start-up, Idle, Shutdown)	No

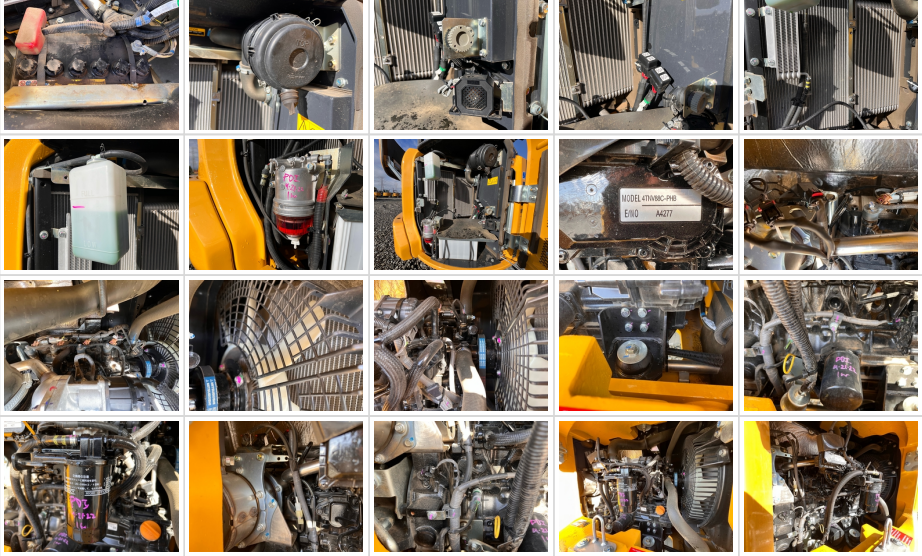
Engine Compartment Photos

Engine Exhaust Color	Clear
Battery	3 - Normal Wear & Tear
Battery Condition	Dusty & dirty appearance
Radiator	4 - Very Light or Minimal Wear
Radiator Condition	Radiator fins & components appear to be in good working order, no signs of damage or leaks
Belts	4 - Very Light or Minimal Wear
Belt Condition	Belts appear in good condition & alignment with proper tension
Hoses	4 - Very Light or Minimal Wear
Hose Condition	Firm, pliant hoses with no signs of wear or leaks
Water Pump	4 - Very Light or Minimal Wear
Water Pump Condition	No unusual pump noises heard
Cooling System Leaks	No
Coolant Appearance	4 - Very Light or Minimal Wear
Coolant Appearance Notes	Normal Translucent appearance, no visual signs of contamination
Oil Leaks	No
Oil Appearance	4 - Very Light or Minimal Wear
Oil Appearance Notes	Appropriate oil level
Fuel Leaks	No
Equipped with DPF (Diesel Particulate Filter)	Yes
DPF Condition	3 - Normal Wear & Tear

DPF Condition Notes	Filter housing is intact with no signs of damage or malfunction, DPF indicator is not illuminated
Requires DEF (Diesel Exhaust Fluid)	No
Overall Engine Rating	4 - Very Light or Minimal Wear
Overall Engine Appearance	Clean & dry
Overall Engine Comments	Like new appearance OEM filters still installed

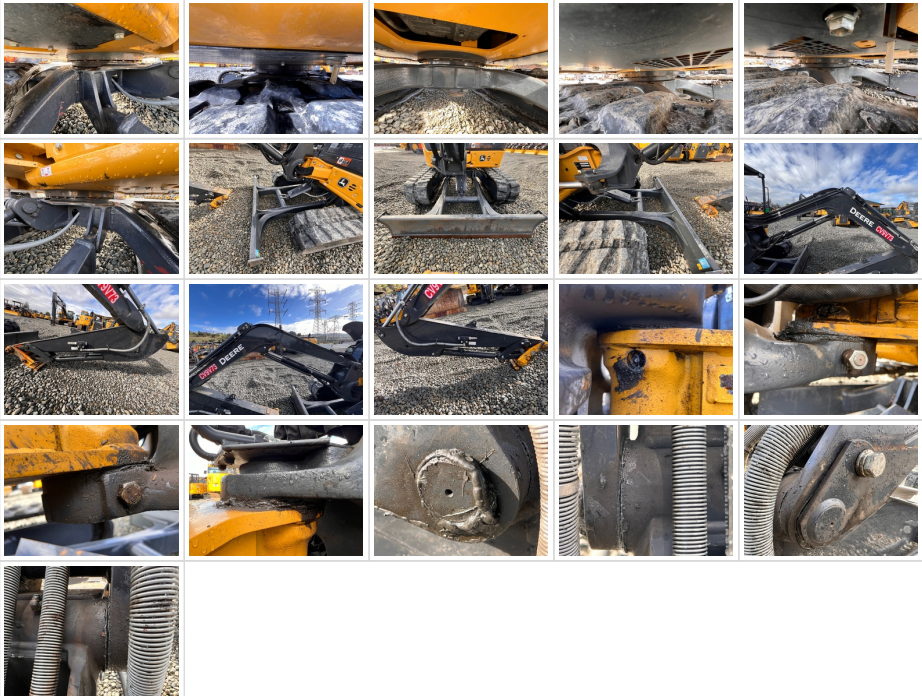
Chassis Photos

Boom Condition	4 - Very Light or Minimal Wear
Stick Condition	4 - Very Light or Minimal Wear
Boom Base Pin & Bushings	4 - Very Light or Minimal Wear
Boom to Stick Pin & Bushings	4 - Very Light or Minimal Wear
Stick to Bucket Pin & Bushings	4 - Very Light or Minimal Wear
Turntable Bearing	4 - Very Light or Minimal Wear
Bottom Covers	4 - Very Light or Minimal Wear
Overall Chassis	4 - Very Light or Minimal Wear
Overall Chassis Comments	Like new appearance No major issues to report

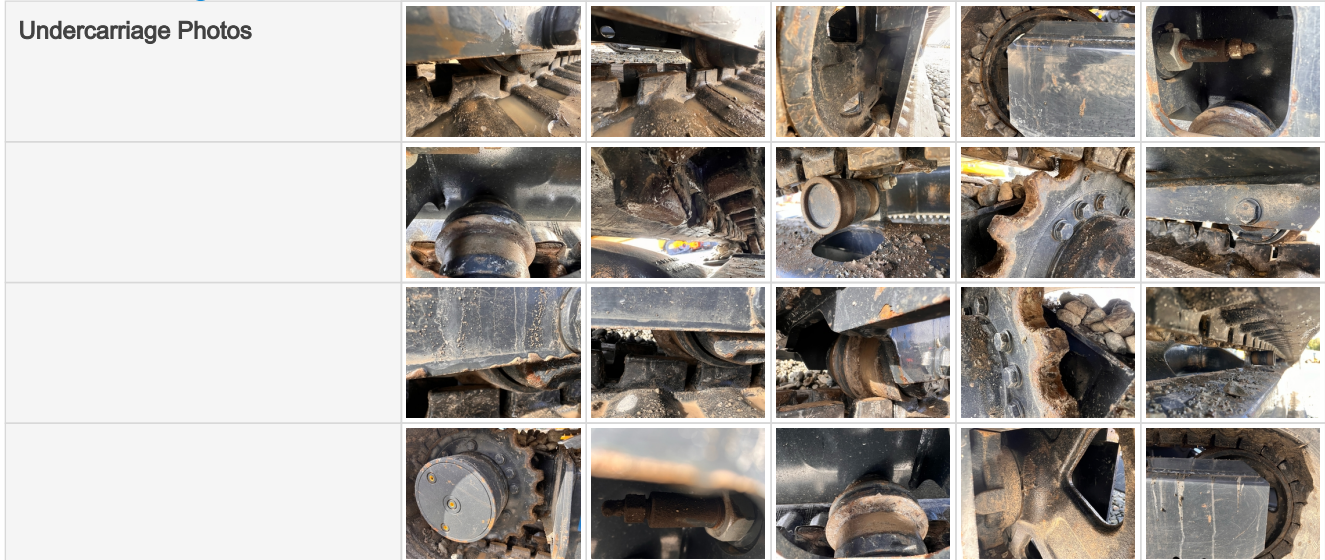
Undercarriage Photos

Track Width (inches)	16"
Track Length (inches)	85"
Roller Frames	4 - Very Light or Minimal Wear
Track Belt	4 - Very Light or Minimal Wear
Rubber Belt Drive Lugs	4 - Very Light or Minimal Wear
Track Tensioners	4 - Very Light or Minimal Wear
Front Idlers	4 - Very Light or Minimal Wear
Rear Idlers	0
Track Rollers	4 - Very Light or Minimal Wear
Sprockets	4 - Very Light or Minimal Wear
Overall Undercarriage Rating	4 - Very Light or Minimal Wear
Left Track Belt - Percent Remaining Estimate	90%
Right Track Belt - Percent Remaining Estimate	90%
Overall Comments	Like new appearance No major issues to report

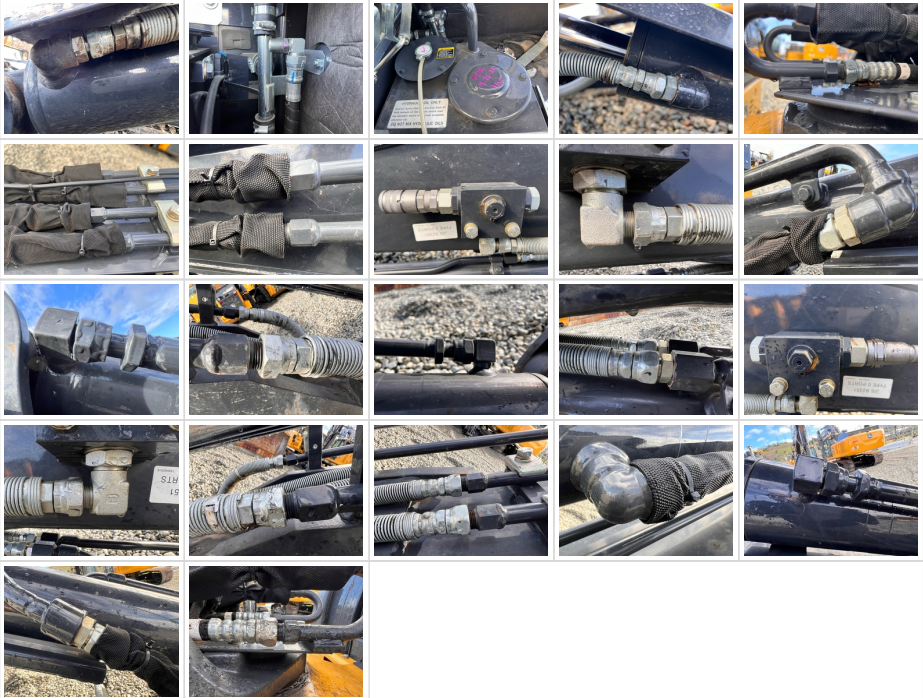
Hydraulic System Photos

Wet or Damp Hydraulic Lines / Fittings	No
Hydraulic Lines/Fittings	4 - Very Light or Minimal Wear
Hydraulic Lines / Fittings Condition	Hydraulic lines & fittings are clean and in good condition
Hydraulic Pump(s)	4 - Very Light or Minimal Wear
Unusual Noises	No
Hydraulic Pump Notes	No unusual noises heard during operation

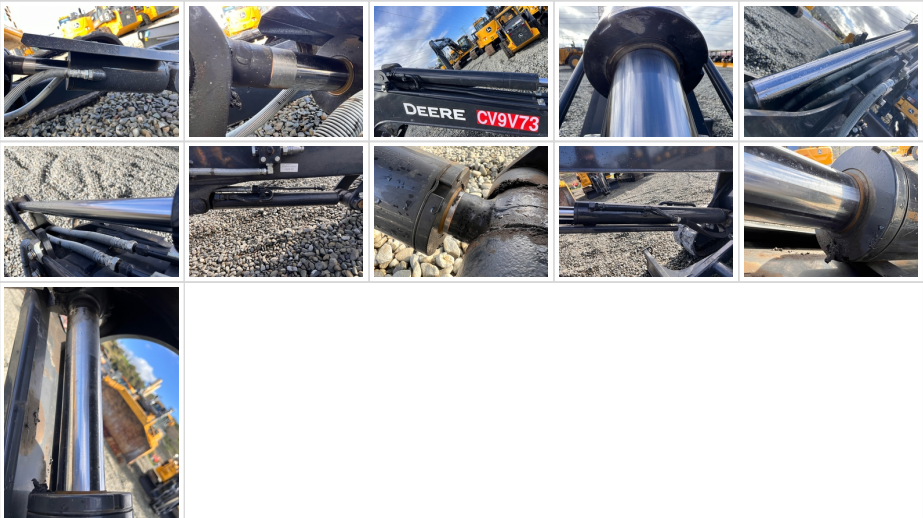
Hydraulic Cylinder Photos

Mounting Pins	4 - Very Light or Minimal Wear
Cylinder Oil Leaks	No
