Inspection Report (Excavator)

B&B Stock Number	A2316553
Year	2021
Make	John Deere
Model	50G
Serial Number	1FF050GXKMH295136
Hour Meter Reading	515.7
Previous Application (e.g., earth moving, mining, demolition, etc)	Earth moving

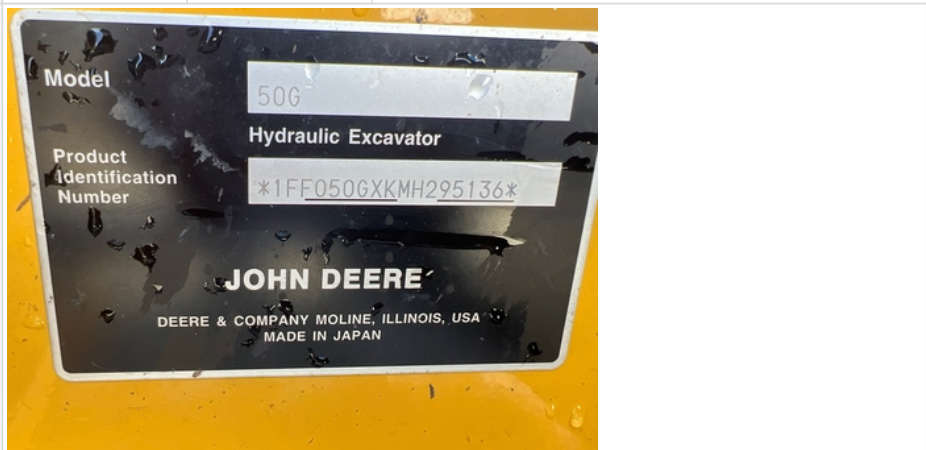
Serial Number Plate

<p>Model 50G Hydraulic Excavator Product Identification Number *1FF050GXKMH295136*</p> <p>JOHN DEERE DEERE & COMPANY MOLINE, ILLINOIS, USA MADE IN JAPAN</p>

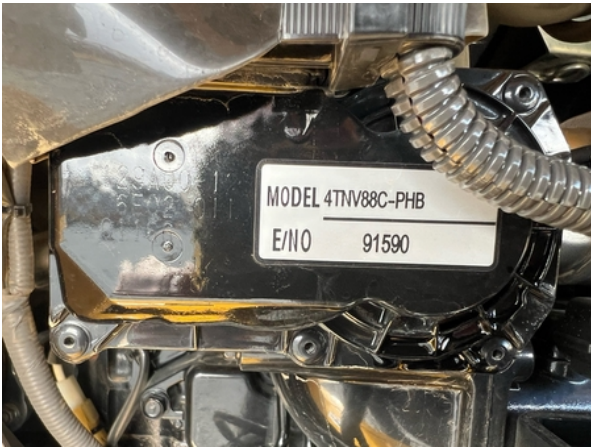
Engine Data Plate

Engine Type (Make, Model, Cylinders, Hp)	Yanmar, 4TNV88C-PHB				
Emissions Tier	Undetermined				
Engine Serial Number	91590				
Engine Fuel Type	Diesel				
Blow-by (Visual Observation Check)	No				
Unusual Noises (Upon Start-up, Idle, Shutdown)	No				
Engine Smoke (Upon Start-up, Idle, Shutdown)	No				
Engine Exhaust Color	Clear				
Battery	4 - Very Light or Minimal Wear				
Battery Condition	Clean & dry appearance, tight connections

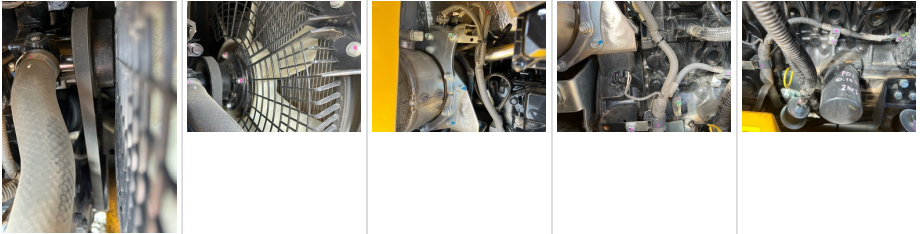
Engine Compartment Photos

Radiator	4 - Very Light or Minimal Wear
Radiator Condition	Radiator fins & components appear to be in good working order, no signs of damage or leaks
Belts	4 - Very Light or Minimal Wear
Belt Condition	Belts appear in good condition & alignment with proper tension
Hoses	4 - Very Light or Minimal Wear
Hose Condition	Firm, pliant hoses with no signs of wear or leaks
Water Pump	4 - Very Light or Minimal Wear
Water Pump Condition	No unusual pump noises heard
Cooling System Leaks	No
Coolant Appearance	4 - Very Light or Minimal Wear
Coolant Appearance Notes	Normal Translucent appearance, no visual signs of contamination
Oil Leaks	No
Oil Appearance	4 - Very Light or Minimal Wear
Oil Appearance Notes	Appropriate oil level
Fuel Leaks	No
Equipped with DPF (Diesel Particulate Filter)	Yes
DPF Condition	4 - Very Light or Minimal Wear
DPF Condition Notes	Filter housing is intact with no signs of damage or malfunction, DPF indicator is not illuminated

Requires DEF (Diesel Exhaust Fluid)	No
Overall Engine Rating	4 - Very Light or Minimal Wear
Overall Engine Appearance	Clean & dry
Overall Engine Comments	Like new appearance, no major issues to report

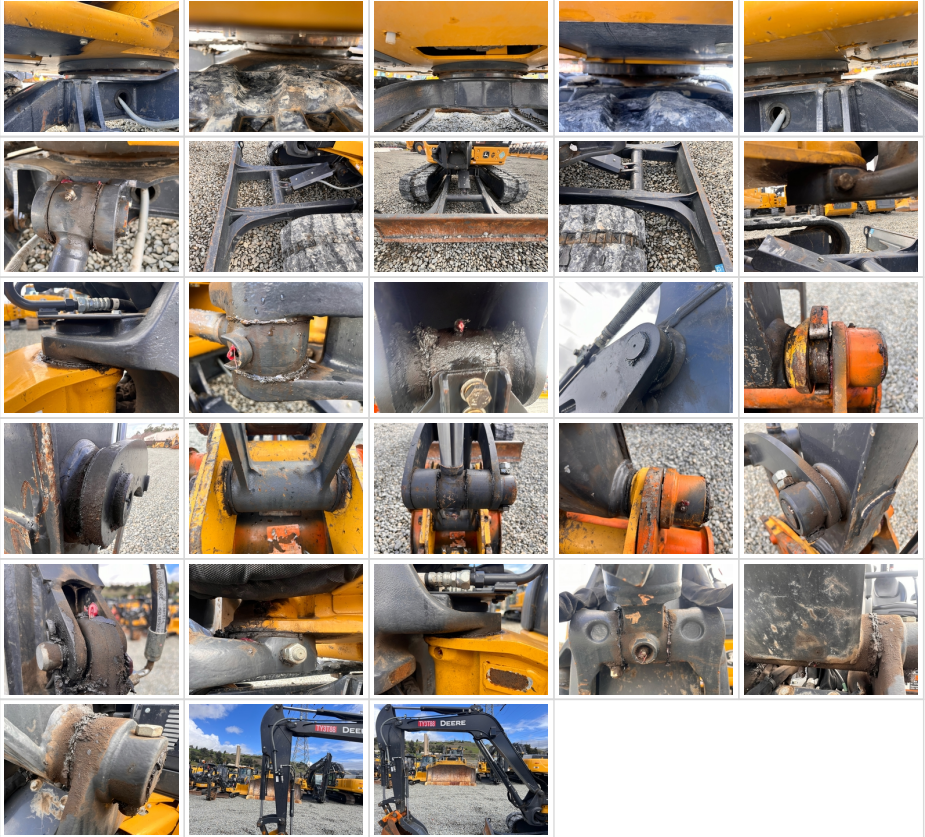
Chassis Photos

Boom Condition	4 - Very Light or Minimal Wear				
Stick Condition	4 - Very Light or Minimal Wear				
Boom Base Pin & Bushings	4 - Very Light or Minimal Wear				
Boom to Stick Pin & Bushings	4 - Very Light or Minimal Wear				
Stick to Bucket Pin & Bushings	4 - Very Light or Minimal Wear				
Turntable Bearing	4 - Very Light or Minimal Wear				
Bottom Covers	4 - Very Light or Minimal Wear				
Overall Chassis	4 - Very Light or Minimal Wear

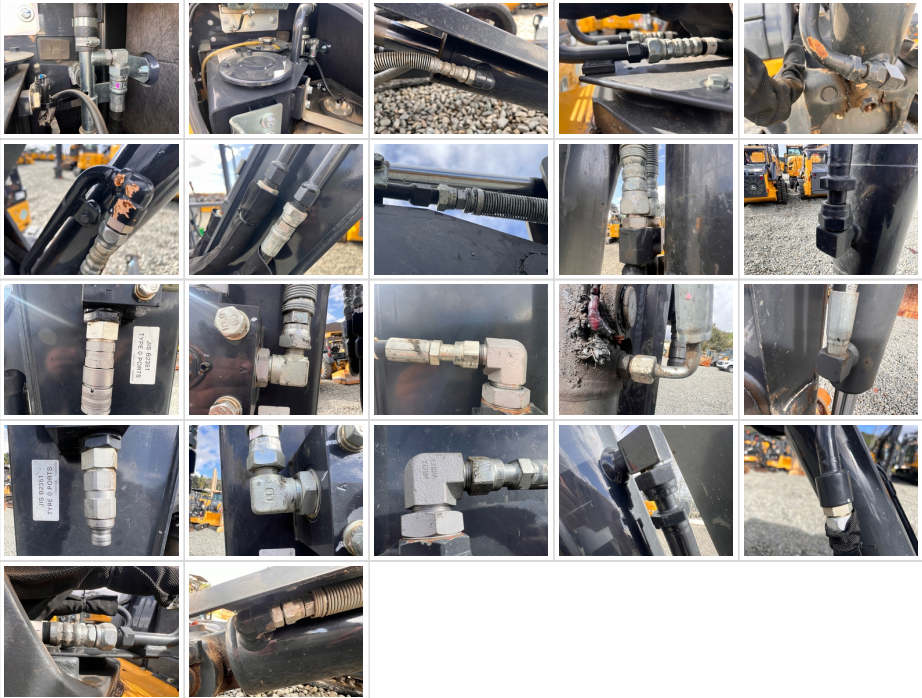
Hydraulic System Photos

Wet or Damp Hydraulic Lines / Fittings	No
Hydraulic Lines/Fittings	3 - Normal Wear & Tear
Hydraulic Lines / Fittings Condition	Hydraulic lines & fittings are clean and in good condition
Hydraulic Pump(s)	4 - Very Light or Minimal Wear
Unusual Noises	No
Hydraulic Pump Notes	No unusual noises heard during operation

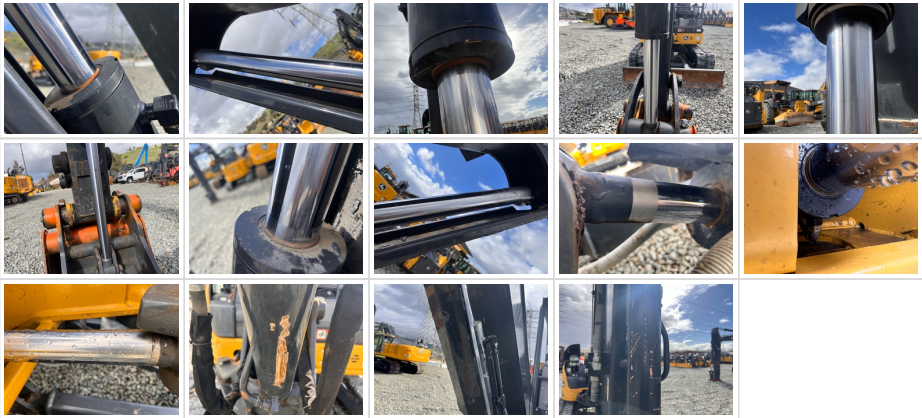
Hydraulic Cylinder Photos

Mounting Pins	4 - Very Light or Minimal Wear
Cylinder Oil Leaks	No
Hydraulic System Overall	4 - Very Light or Minimal Wear
