Inspection Report (Excavator)

B&B Stock Number	A0295573
Year	2005
Make	CAT
Model	330CL
Serial Number	DKY02712
Hour Meter Reading	10,015 Hrs.
Previous Application (e.g., earth moving, mining, demolition, etc)	Underground Utility Construction

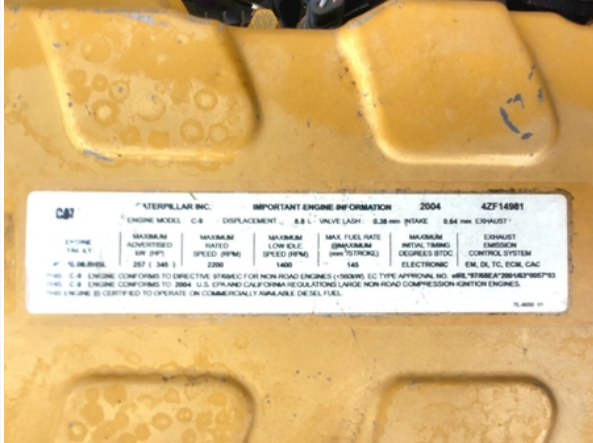
Engine Data Plate

Engine Type (Make, Model, Cylinders, Hp)	CAT - 6Cyl. - C9 - 8.8L - 345HP
Emissions Tier	Tier 2
Engine Serial Number	4ZF14981
Engine Fuel Type	Diesel
Blow-by (Visual Observation Check)	Yes
Comments	Minor blowby seen
Unusual Noises (Upon Start-up, Idle, Shutdown)	No
Engine Smoke (Upon Start-up, Idle, Shutdown)	Yes
Engine Smoke Notes	Engine smoke observed upon start up, Continuous engine smoke observed during operation
Comments	Normal engine exhaust smoke was observed
Engine Exhaust Color	Black puffs observed under throttle
Battery	3 - Normal Wear & Tear
Battery Condition	Like new, recently replaced, Clean & dry appearance, tight connections
Radiator	3 - Normal Wear & Tear
Radiator Condition	Radiator fins & components appear to be in good working order, no signs of damage or leaks
Belts	3 - Normal Wear & Tear
Belt Condition	Belts appear in good condition & alignment with proper tension
Hoses	3 - Normal Wear & Tear

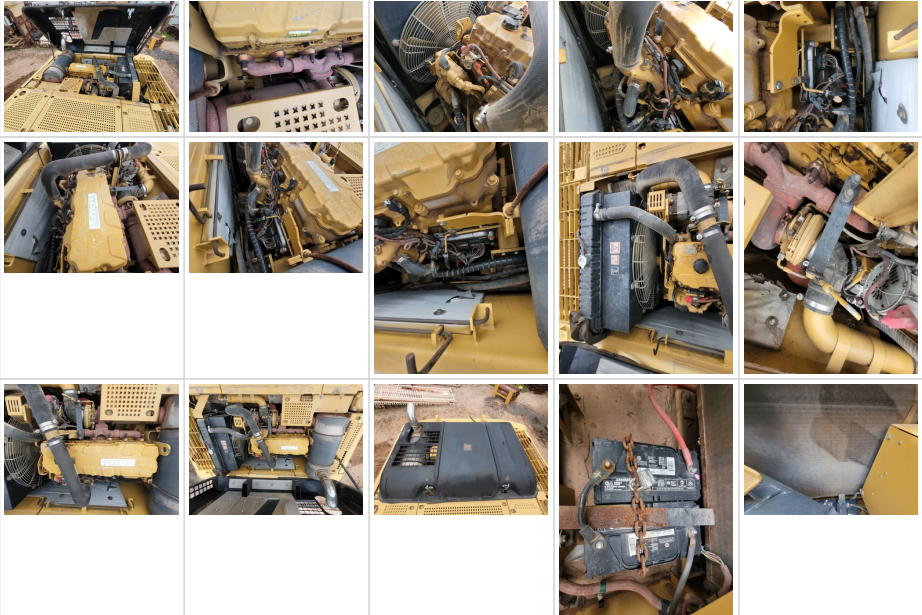
Engine Compartment Photos

Equipped with DPF (Diesel Particulate Filter)	No
Requires DEF (Diesel Exhaust Fluid)	No
Overall Engine Rating	3 - Normal Wear & Tear
Overall Engine Appearance	Clean & dry, Areas of dried seepage seen on engine hoses & components
Overall Engine Comments	Minor, dried up, residual engine oil buildup was seen around valve cover.

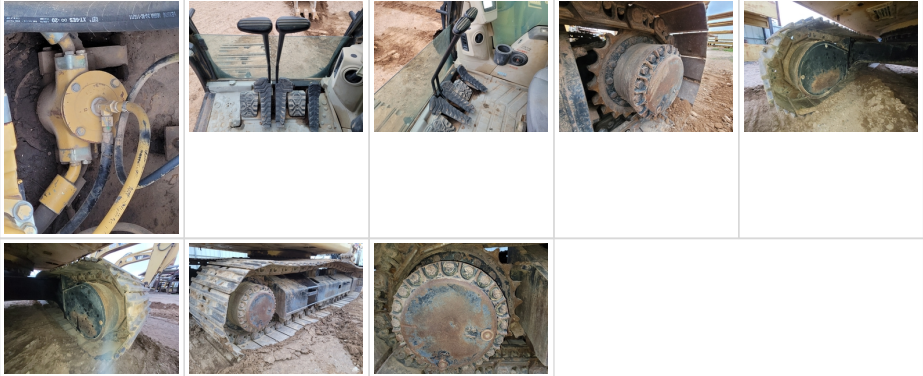
Drivetrain Photos

Hydrostatic Transmission?	Yes
Speeds	2 Speed
Drive Type	N/A (Track Undercarriage)
Transmission Components	3 - Normal Wear & Tear
Transmission Condition	Good forward and reverse function, No unusual noises or vibrations, Other (see comments)
Comments	Machine was tested at low speeds and in short distances.
Drive Motors	3 - Normal Wear & Tear
Parking Brake	3 - Normal Wear & Tear
Parking Brake Function	Good brake function
Overall Drivetrain Rating	3 - Normal Wear & Tear
Overall Drivetrain Comments	The drive system was operating normal in low speed and in the short distances that were available during the inspection.

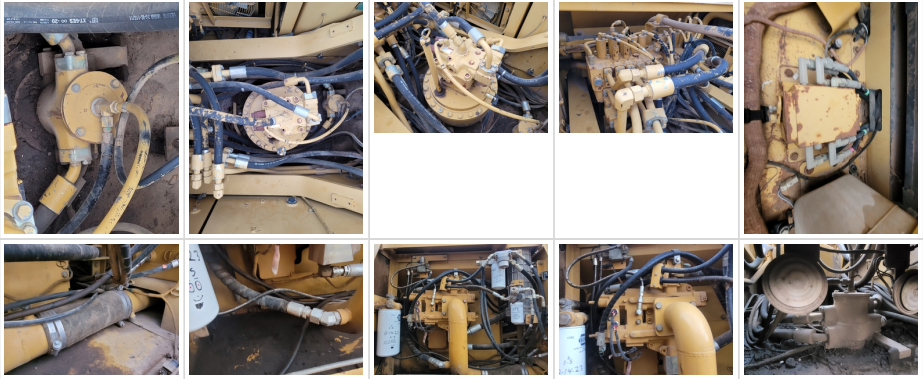
Hydraulic System Photos

Wet or Damp Hydraulic Lines / Fittings	No
Hydraulic Lines/Fittings	3 - Normal Wear & Tear
Hydraulic Lines / Fittings Condition	Hydraulic lines & fittings are clean and in good condition
Hydraulic Pump(s)	3 - Normal Wear & Tear
Unusual Noises	No
Hydraulic Pump Notes	No unusual noises heard during operation

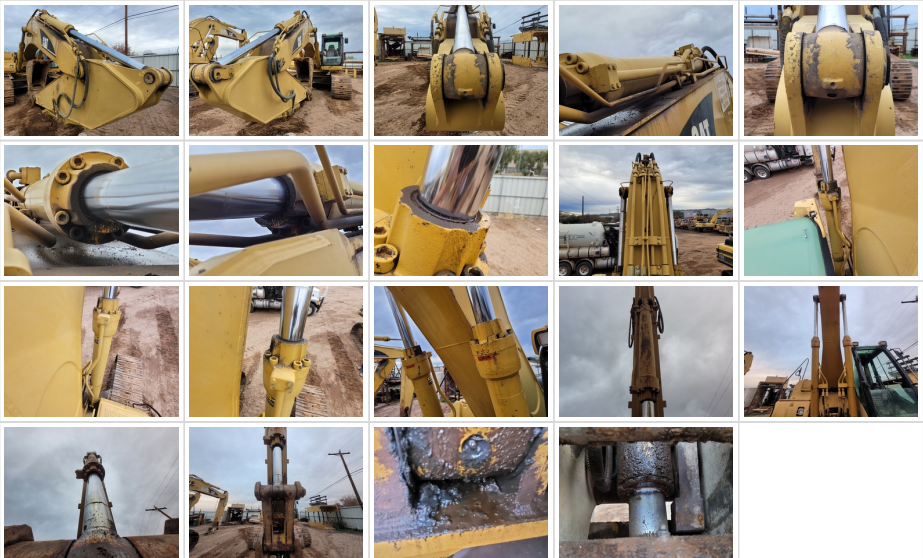
Hydraulic Cylinder Photos

Mounting Pins	3 - Normal Wear & Tear
Cylinder Oil Leaks	Yes
Comments	Boom cylinders, Stick cylinder, Bucket cylinder & Quick coupler cylinder are possibly leaking at rod seals.
Hydraulic System Overall	3 - Normal Wear & Tear
Comments	The hydraulic system was operating normal with no abnormal sounds heard during the inspection.
