Inspection Report (Forklift)

B&B Stock Number	A7574493
Year	2012
Make	Raymond
Model	425-C40TT
Serial Number	425-12-34885
Serial Plate Photo

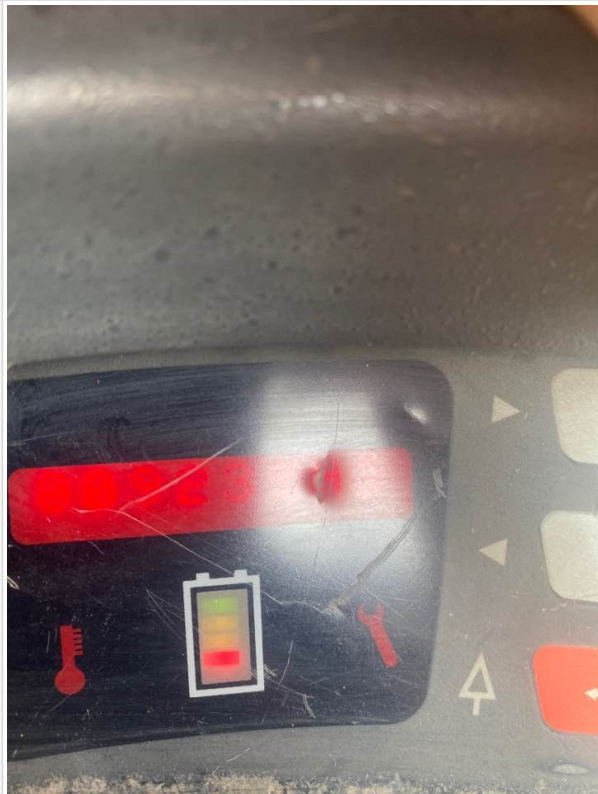
Hour Meter Photo

Hour Meter Reading	9239

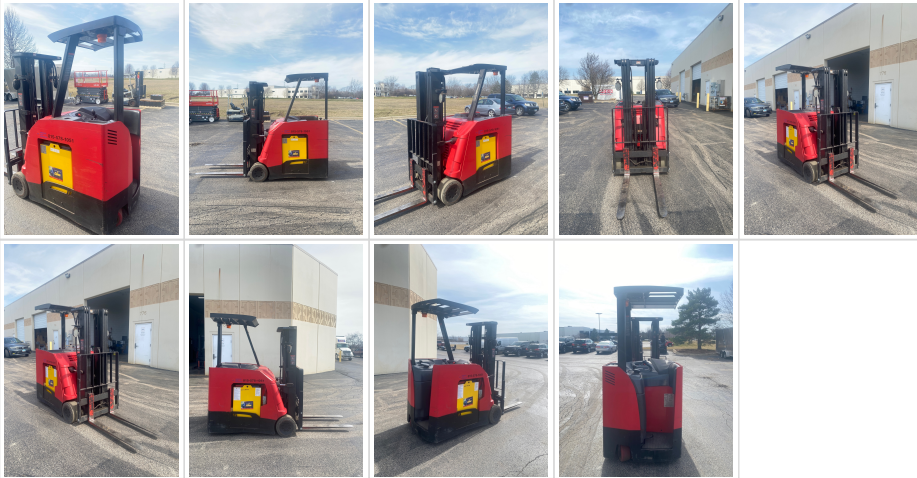
Exterior Walkaround Photos

Mirrors	-1	
Exterior Lights	5 - Like New, Recently Replaced	
Overall Exterior	4 - Very Light or Minimal Wear	
Comments	Many scratches on the machines body panel on each side. Nothing deeper than those scratches. Exterior in good shape with minimal west outside scratches.

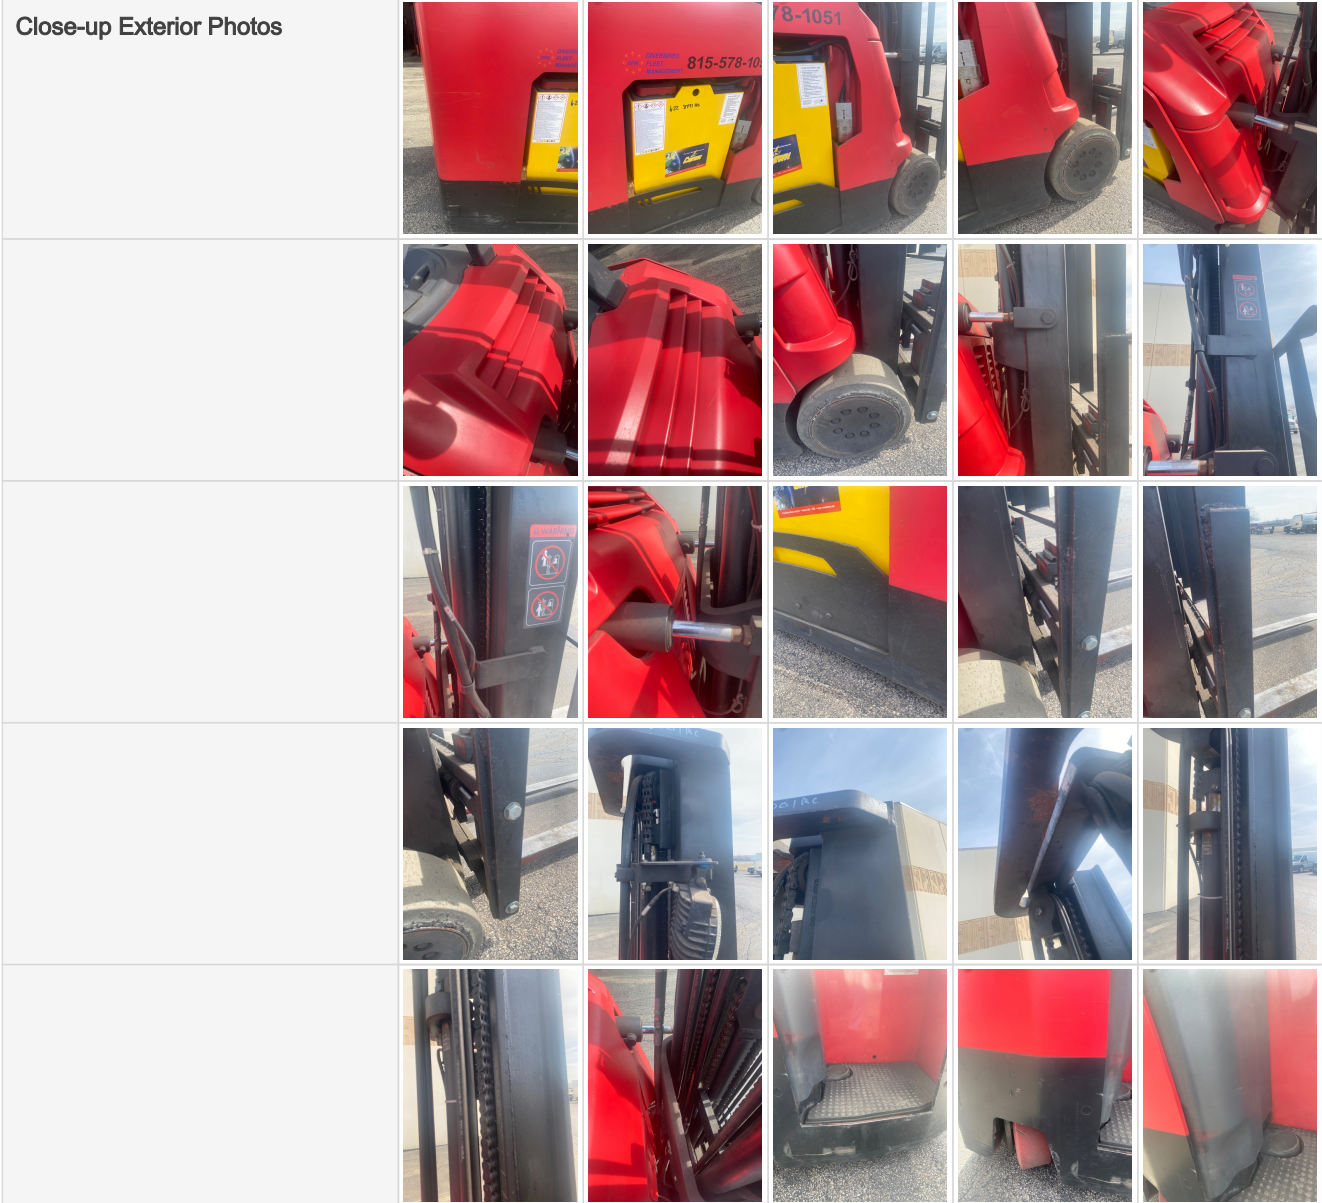
General Appearance Photos

This is the battery(engine). Comes with a water cord attachment for appropriate operation of the battery.

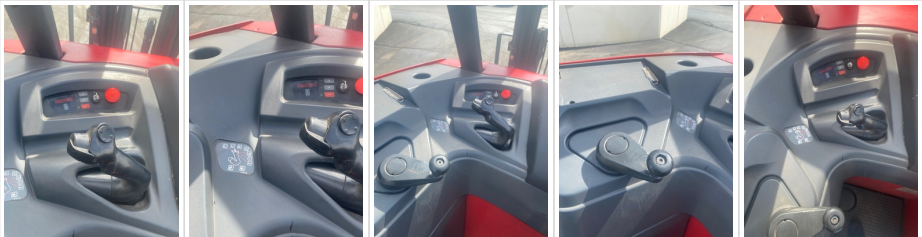
Control Station Photos

Control Station Type	Open Cab (OROPS), Canopy				
Control Type	Pilot Controls				
Control Configuration	N/A				
Comments	No wear and tear at all at the control station				
Seat	-1				
Cabin Lights	3 - Normal Wear & Tear				
Safety Lock Out / Stop	3 - Normal Wear & Tear

Controls & Switches	3 - Normal Wear & Tear
Controls & Switches Condition	Switches have good functionality, minor cosmetic damage observed
Hour Meter Activity	3 - Normal Wear & Tear
Hour Meter Condition	Hour meter is functional, with some minor wear and/or cosmetic damage
Other Gauge Activity	-1
Heater & A/C	-1
Travel Alarm	0
Horn	5 - Like New, Recently Replaced
Backup Camera	0
Control Station Overall Rating	5 - Like New, Recently Replaced

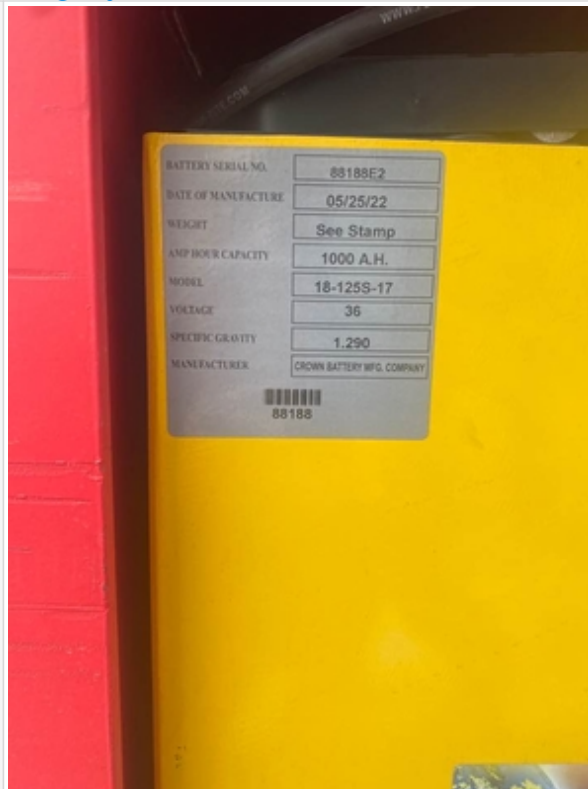
Engine Plate Photo

<p>The battery(engine) with the brake(for the left wheel) on top of it</p>			<p>The right brake and battery.</p>

<p>Water cord attachment for battery operation</p>			
Operating Voltage	36				
Battery Condition	3 - Normal Wear & Tear				
Comments	Battery was replaced in June of 2022				
Battery Charger	1 - Service Required				
Comments	Charger is NOT Included				
Cables & Connections	3 - Normal Wear & Tear				
Tight Connections?	Yes				
Solenoids	3 - Normal Wear & Tear				
Wire Harness	3 - Normal Wear & Tear				
Cooling System	3 - Normal Wear & Tear				
Fuse Panel(s)	3 - Normal Wear & Tear				
Computer Appearance	-1				
Electric Motor	3 - Normal Wear & Tear				
Screen Discoloration?	N/A				
Electric Operating System Overall Rating	3 - Normal Wear & Tear				
Overall Engine Appearance	Clean & Dry

Overall Electric Operating System Comments	Brakes have no rust. Engine compartment is dry with little dust. No visible wear and tear
--	---

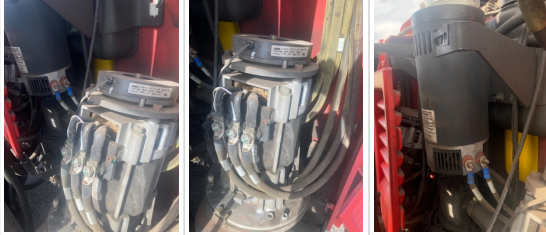
Drivetrain Photos

Hydrostatic Transmission?	No
Drive Type	Other (see comments)
Other Drive Type	unable to determine
Transmission Components	-1
Parking Brake	3 - Normal Wear & Tear
Parking Brake Function	Good brake function
Overall Drivetrain Rating	3 - Normal Wear & Tear
Overall Drivetrain Comments	Very light wear and tire, if any.
Front Axle	0
Rear Axle	0

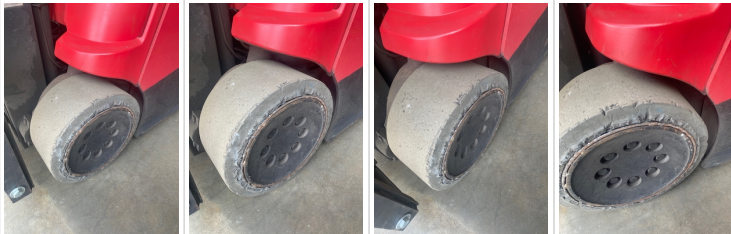
Wheel Type	Solid, Non-Marking
Wheel Seal Leaks	No
Tire Brand	Raymond OEM
Tire Size	6.25x7x11 In
Front Left Tire - Ratio Remaining	70%
Front Left Tire Photos

Front Right Tire Photos	 
Rear Right Tire - Ratio Remaining	90%
Rear Right Tire Photos	 
Rear Left Tire - Ratio Remaining	90%
Wheels & Hubs	4 - Very Light or Minimal Wear
Comments	The front tires are 80% remaining. Option not available to fill in.

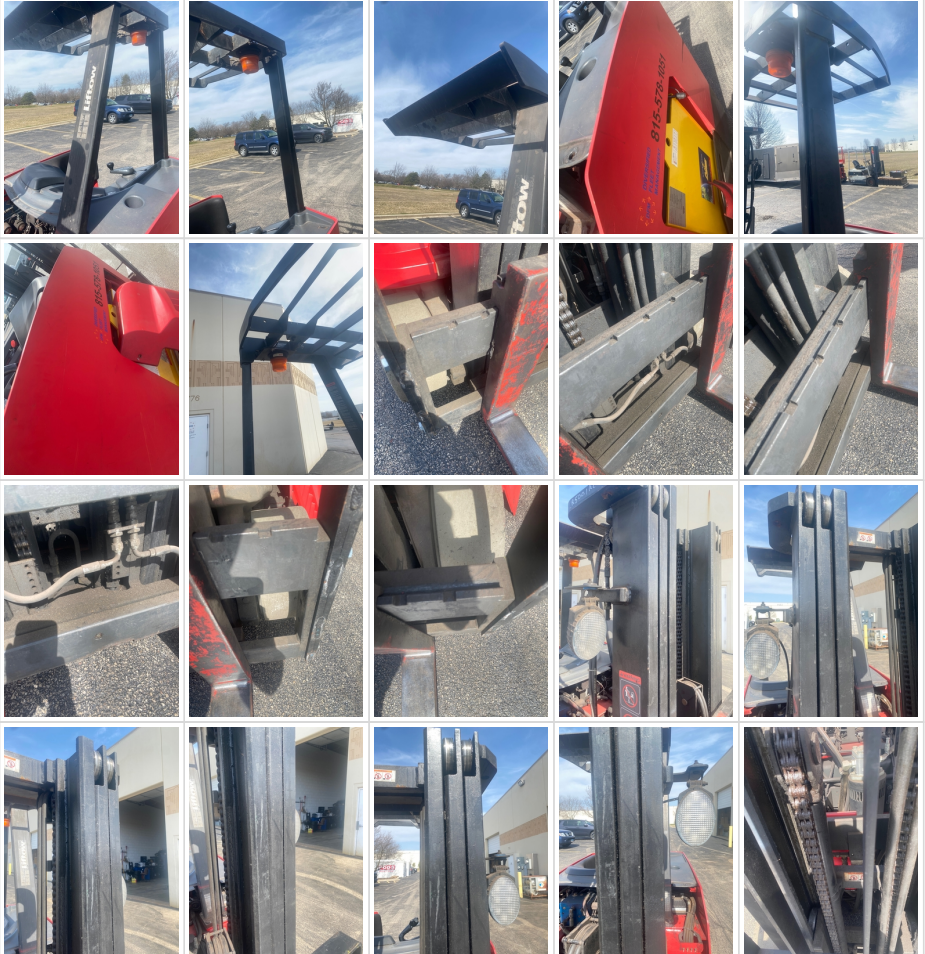
Chassis Photos

Frame	3 - Normal Wear & Tear
Stance	-1
Carriage Appearance	3 - Normal Wear & Tear
Mast Condition	3 - Normal Wear & Tear
Chain / Tensioners	4 - Very Light or Minimal Wear
Rollers & Guides	3 - Normal Wear & Tear
Overall Chassis	4 - Very Light or Minimal Wear
Overall Chassis Comments	Clear use of the chassis, but we've taken care of with no obvious drop off with care, no sounds evident in use or application
