Inspection Report (Forklift)

B&B Stock Number	A6866866
Year	2007
Make	Toyota
Model	7BRU18
Serial Number	7BRU18-34370
Serial Plate Photo

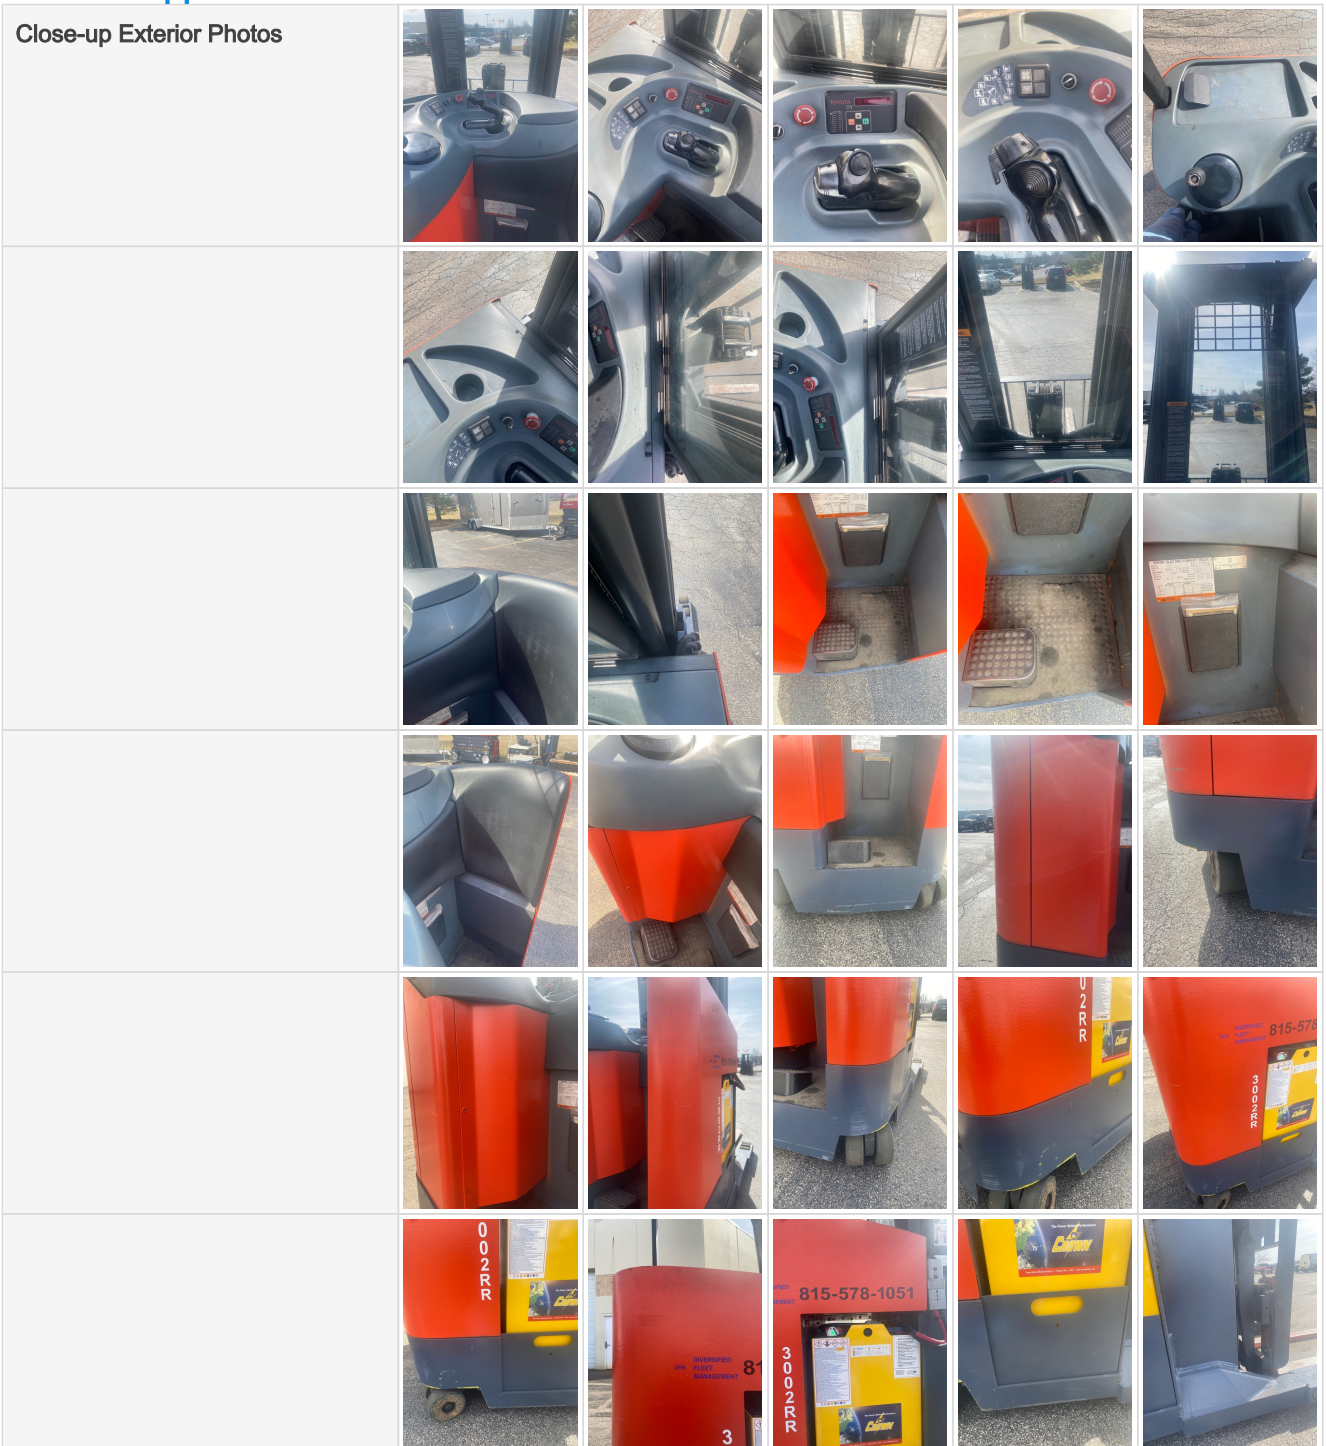
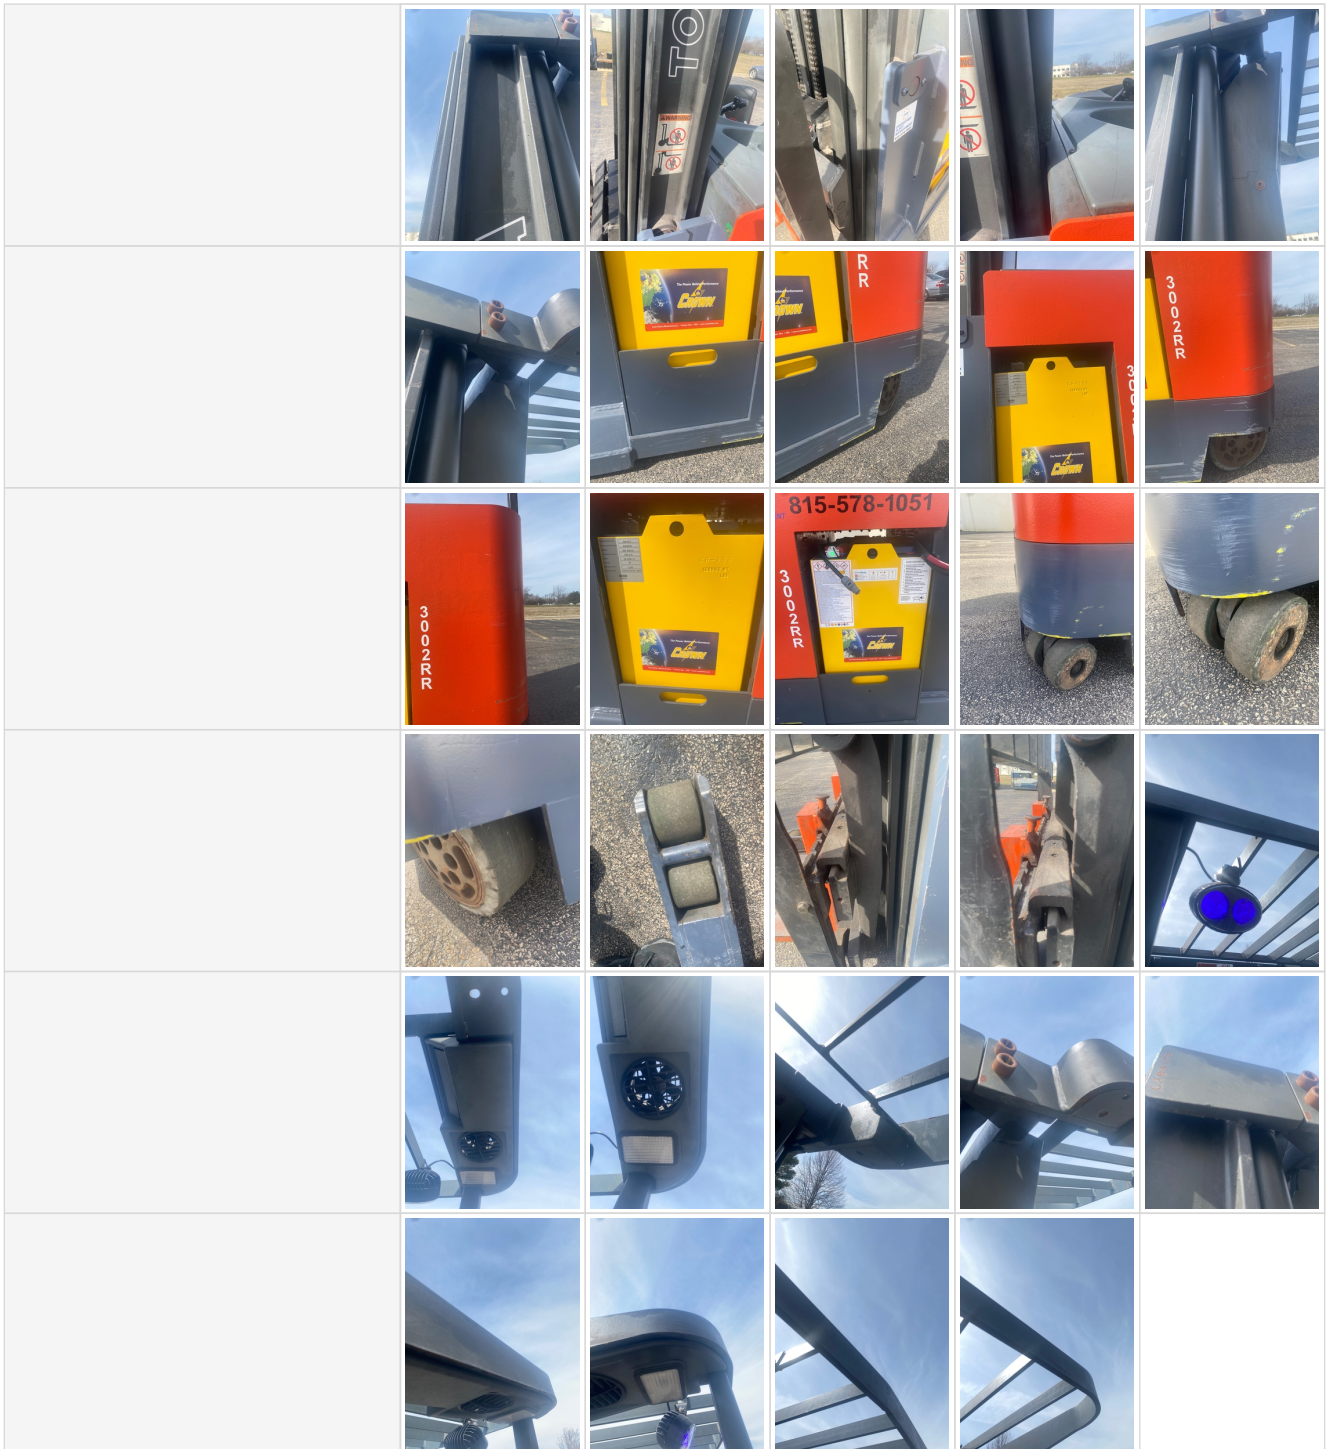
General Appearance Photos

Inspection Rating Criteria	Rating Scale	Explanation
	1 - Service Required	Requires immediate repairs to function as expected.
	2 - Above Average Wear & Tear	Exhibits greater wear than expected given age and usage. While operable, further diagnosis may be needed.
	3 - Normal Wear & Tear	Exhibits wear that is consistent with age and usage. Operation is normal, and as expected.
	4 - Very Light or Minimal Wear	Exhibits very minimal wear. Operation is better than expected given age and usage.
	5 - Like New, Recently Replaced	Excellent condition, free of visible wear or damage. Operation is within factory specifications.
Body Panels	3 - Normal Wear & Tear	
Body Panel Condition	Visible chipped paint or dents	
Doors / Canopy Latches	3 - Normal Wear & Tear	
Steps / Ladders	3 - Normal Wear & Tear	
Steps / Ladders Condition	Other (see comments)	
Comments	Partially torn step where foot lies	
Handrails	0	
Glass	3 - Normal Wear & Tear

Glass Condition	Other (see comments)	
Comments	No crack or chip observes. It needs a simple wash	
Mirrors	0	
Exterior Lights	3 - Normal Wear & Tear	
Overall Exterior	4 - Very Light or Minimal Wear	
Comments	Machine showing light wear from general use considering age. It is mostly clean with some minimal rust at the chassis and behind the forks(side shifter). The load back rest has some minor rust.

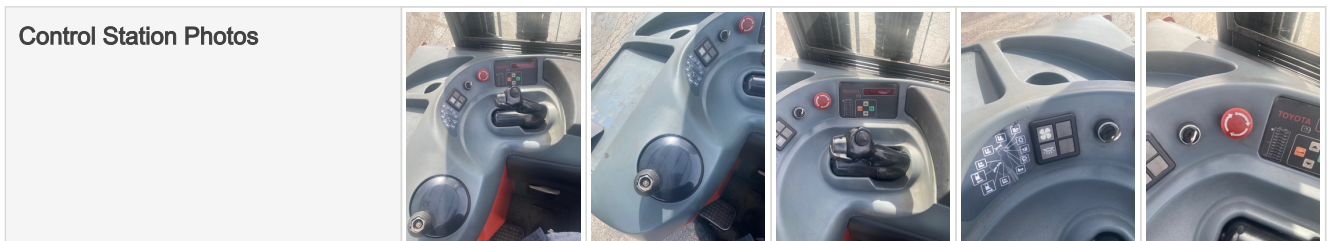
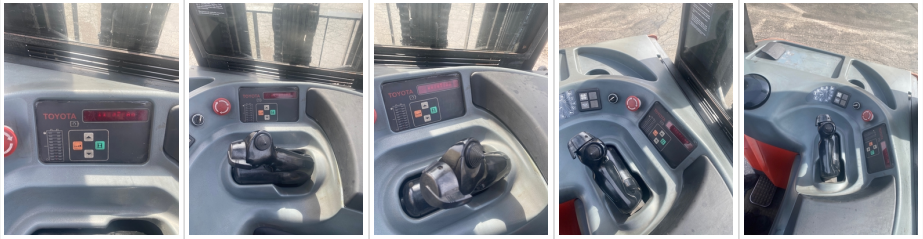
Control Station Photos

Control Station Type	Open Cab (OROPS)
Control Type	Pilot Controls
Control Configuration	N/A
Seat	-1
Cabin Lights	-1
Safety Lock Out / Stop	3 - Normal Wear & Tear
Safety Lock Out / Stop Condition	Safety lock out device is present, in good condition, and functional
Controls & Switches	3 - Normal Wear & Tear
Controls & Switches Condition	Switches have good functionality, minor cosmetic damage observed, All switches are installed and functional
Hour Meter Activity	3 - Normal Wear & Tear
Hour Meter Condition	Hour meter is functional, with some minor wear and/or cosmetic damage
Other Gauge Activity	-1
Heater & A/C	-1
Travel Alarm	-1
Horn	3 - Normal Wear & Tear
Horn Condition	Horn is installed and functioning as expected
Backup Camera	0
Control Station Overall Rating	3 - Normal Wear & Tear
Control Station Overall Condition	Minor cosmetic wear to cabin surfaces, floors, panels, and ceiling, Good cabin appearance, solid floors, panels, and ceiling

Comments	Overall control station clear of dirt, clutter. Minimal signs of wear

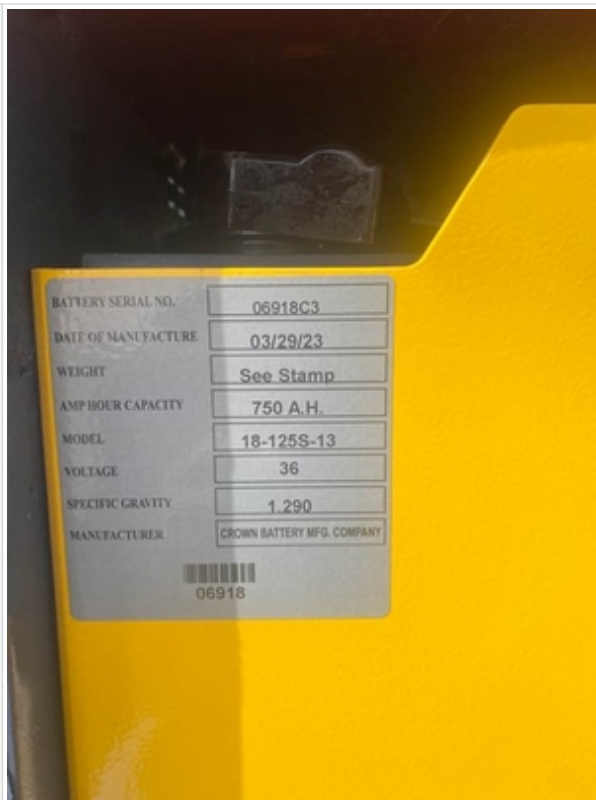
Engine Plate Photo

Operating Voltage	36
Battery Condition	4 - Very Light or Minimal Wear
Comments	Battery was replaced in March of 2023
Battery Charger	1 - Service Required
Comments	Charger is NOT included.
Cables & Connections	3 - Normal Wear & Tear
Tight Connections?	Yes
Solenoids	3 - Normal Wear & Tear
Wire Harness	3 - Normal Wear & Tear
Cooling System	-1
Fuse Panel(s)	5 - Like New, Recently Replaced
Computer Appearance	-1
Electric Motor	5 - Like New, Recently Replaced
Screen Discoloration?	N/A
Electric Operating System Overall Rating	3 - Normal Wear & Tear
Overall Engine Appearance	Clean & Dry

Overall Electric Operating System Comments	The fuse panel is located inside of the machine under the control panel. Also the electric engine system pictures are located in the drivetrain section. They are both in the same place Charger is NOT included in the sale.
---	--

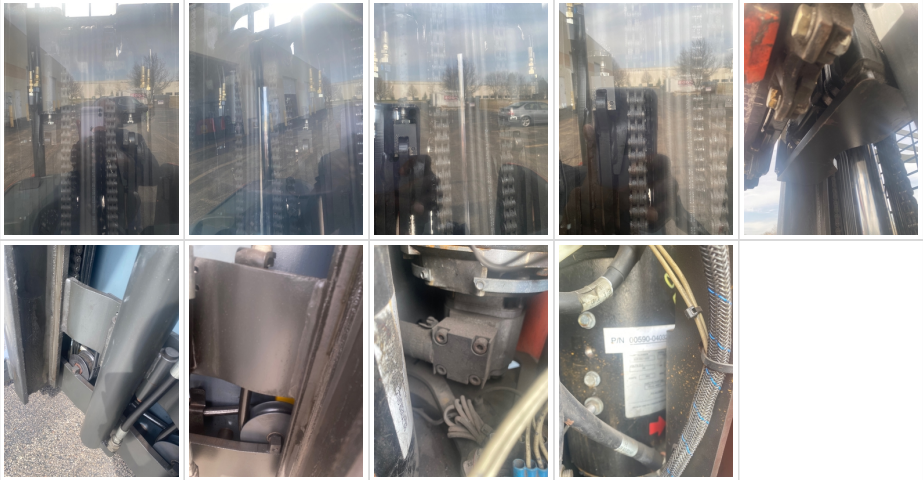
Hydraulic System Photos

Wet or Damp Hydraulic Lines / Fittings	No
Hydraulic Lines/Fittings	3 - Normal Wear & Tear
Hydraulic Lines / Fittings Condition	Hydraulic lines & fittings are clean and in good condition
Hydraulic Pump(s)	3 - Normal Wear & Tear
Unusual Noises	No
Hydraulic Pump Notes	No unusual noises heard during operation

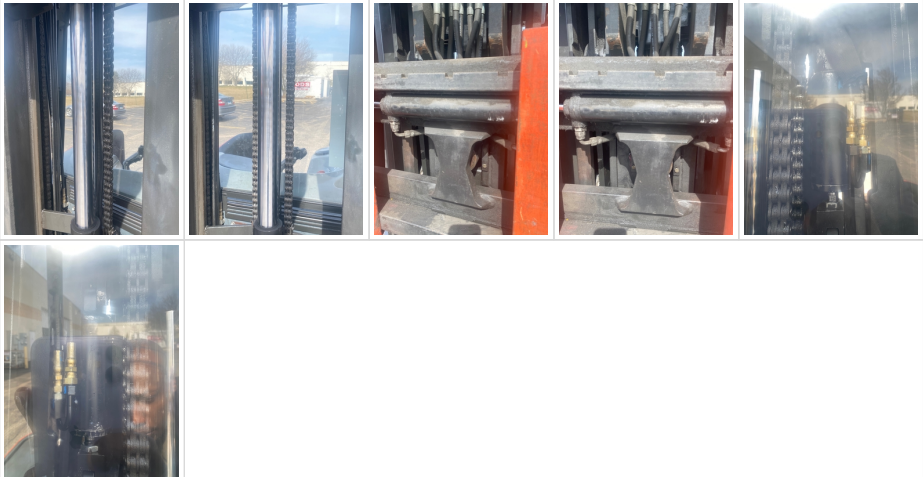
Hydraulic Cylinder Photos

Mounting Pins	3 - Normal Wear & Tear
Cylinder Oil Leaks	No
Hydraulic System Overall	3 - Normal Wear & Tear
Comments	Maintained well. No rust, wear or grime. Clean

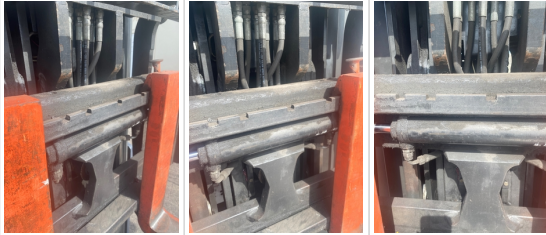
Attachment Type	Sideshifter
Attachment Make	Toyota
Attachment Size / Specs	N/A
Attachment Condition	4 - Very Light or Minimal Wear
Attachment Photos
