Inspection Report (On-Highway Truck Cab + Chassis)

B&B Stock Number	A5995225
Year	2016
Make	Freightliner
Model	Cascadia
Serial Number	3AKJGBDV0GSGX9584
Serial Plate

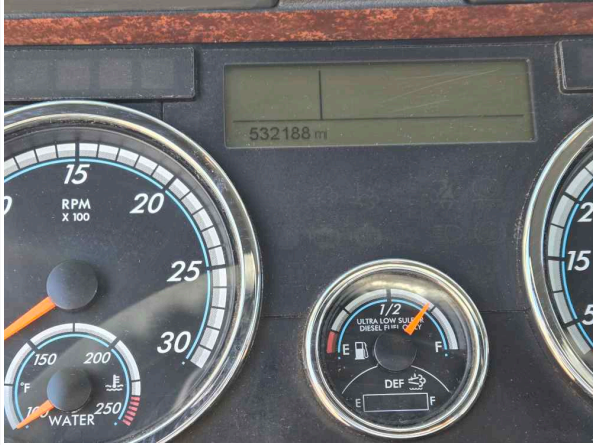
Odometer Reading	532188
Odometer

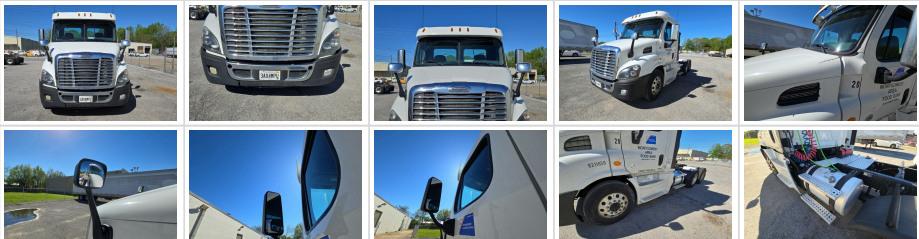
Close-up Exterior Photos

Handrails	3 - Normal Wear & Tear	
Handrails Condition	Handrails are fully intact and appear structurally sound	
Glass	4 - Very Light or Minimal Wear	
Glass Condition	Glass intact, no visible damage	
Mirrors	4 - Very Light or Minimal Wear	
Mirror Condition	Mirrors present and intact, no visible damage	
Exterior Lights	3 - Normal Wear & Tear	
Exterior Lights Condition	No visible damage, lighting system is operational	
Overall Exterior	3 - Normal Wear & Tear	
Comments	The exterior is in good shape with a normal amount of wear and tear.

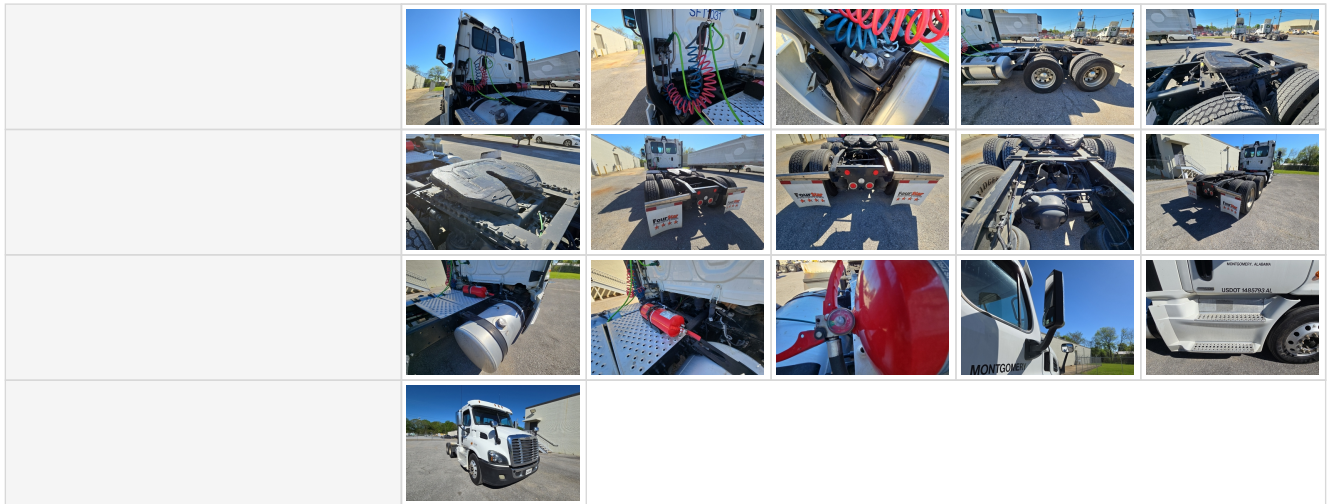
Inspection Rating Criteria	Rating Scale	Explanation
	1 - Service Required	Requires immediate repairs to function as expected.
	2 - Above Average Wear & Tear	Exhibits greater wear than expected given age and usage. While operable, further diagnosis may be needed.
	3 - Normal Wear & Tear	Exhibits wear that is consistent with age and usage. Operation is normal, and as expected.
	4 - Very Light or Minimal Wear	Exhibits very minimal wear. Operation is better than expected given age and usage.
	5 - Like New, Recently Replaced	Excellent condition, free of visible wear or damage. Operation is within factory specifications.
Body Panels	3 - Normal Wear & Tear	
Body Panel Condition	No visible damage, good paint condition and panel fitment	
Doors / Canopy Latches	3 - Normal Wear & Tear	
Doors / Canopy Latches Condition	No visible damage	
Steps / Ladders	3 - Normal Wear & Tear	
Steps / Ladders Condition	Steps/ladders are fully intact and appear structurally sound

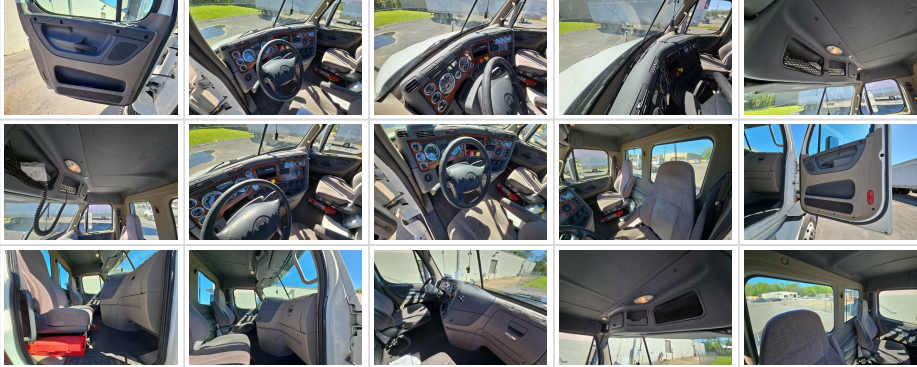
Cab Interior Photos

Odometer Activity	3 - Normal Wear & Tear
Odometer	Odometer is working and in good condition
Controls/Switches/Gauges	3 - Normal Wear & Tear
Controls/Switches/Gauges	All switches/gauges are in good condition and functioning
Brake System Type	Air Brakes
Air Brakes Build Correct Pressure	Yes
Clutch	0
Horn	3 - Normal Wear & Tear
Horn Function	Horn is functioning as expected
Reverse Alarm / Backup Camera	0
Heater & A/C	3 - Normal Wear & Tear
Heat & A/C	A/C blows cold - significantly colder than air temp
Interior Lights	3 - Normal Wear & Tear
Interior Lights	All interior lights are installed and functioning
Seats/Seat Belts	2 - Above Average Wear & Tear
Seats/Seat Belt	Seat belt secures properly, Seat(s) have minor surface staining or small tears, Other (see comments)
Comments	The driver side airbag to the drivers seat does not inflate.
Cab Interior Overall	3 - Normal Wear & Tear

What Needs Work	The airbag on the drivers seat does not inflate properly.	
Any Additional Info from the Seller?	This truck was used in a food bank to transport goods	
Date/Time	03-28-2024	
Inspector Name	Steven Mesa

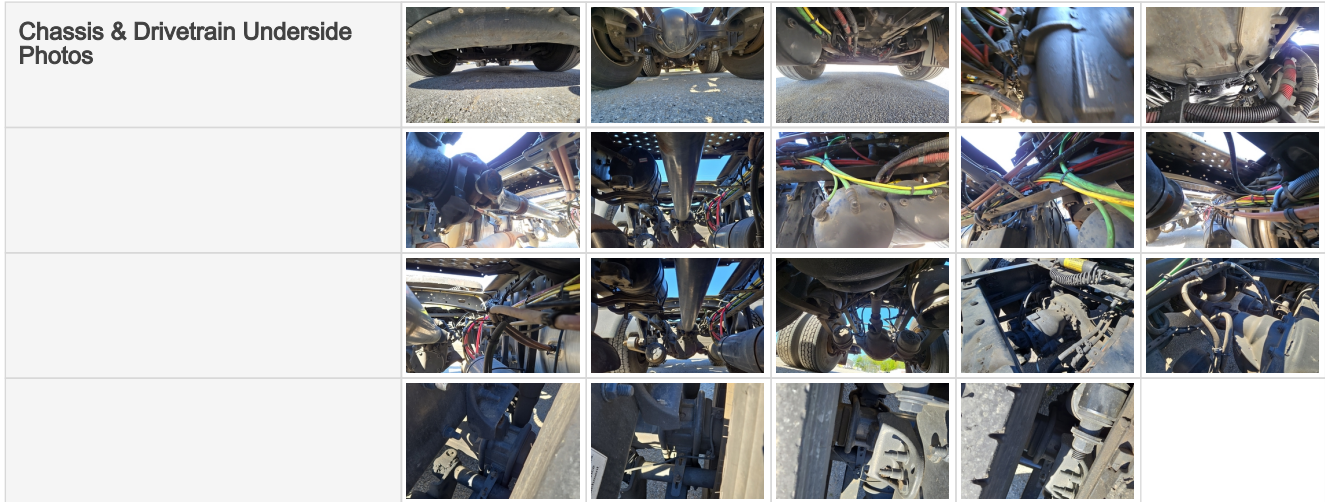
Chassis & Drivetrain Photos

Frame	3 - Normal Wear & Tear
Suspension	3 - Normal Wear & Tear
Steer Axle	3 - Normal Wear & Tear
Steering Components	3 - Normal Wear & Tear
Overall Chassis Condition	3 - Normal Wear & Tear
Overall Chassis Comments	The chassis is in good condition
