Inspection Report (Excavator)

B&B Stock Number	A8807528
Year	2012
Make	Volvo
Model	EC140
Serial Number	111010
Serial Plate Photo

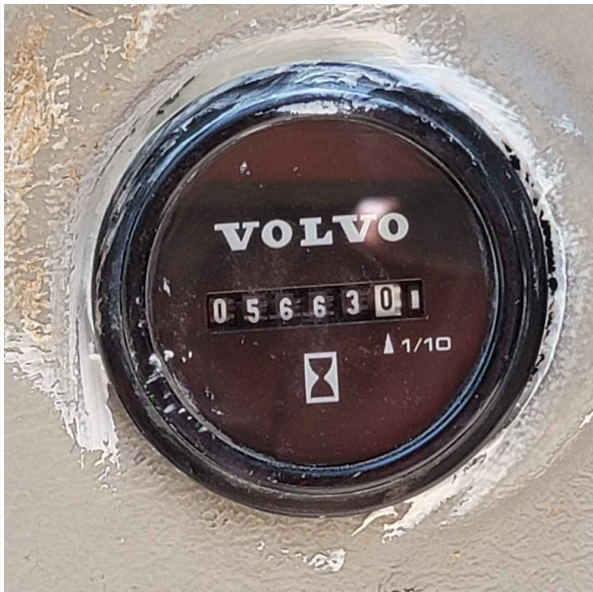
Hour Meter Reading	5663
Hour Meter Photo

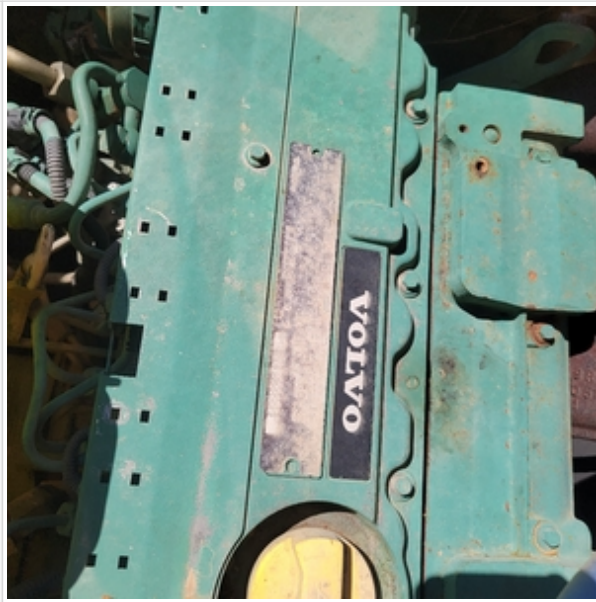
Engine Data Plate

Engine Type (Make, Model, Cylinders, Hp)	Cummins B3.5c 4 cyl 107 hp				
Emissions Tier	Tier 3				
Engine Fuel Type	Diesel

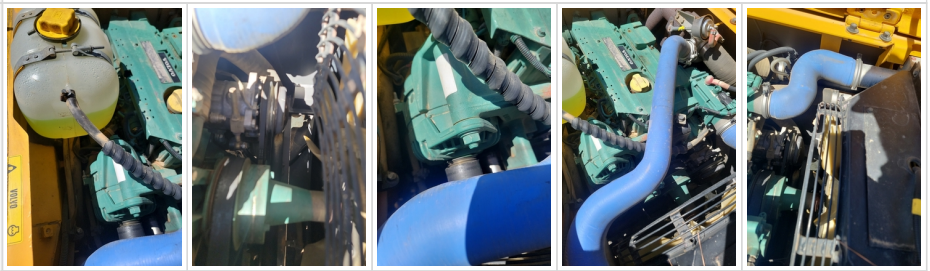
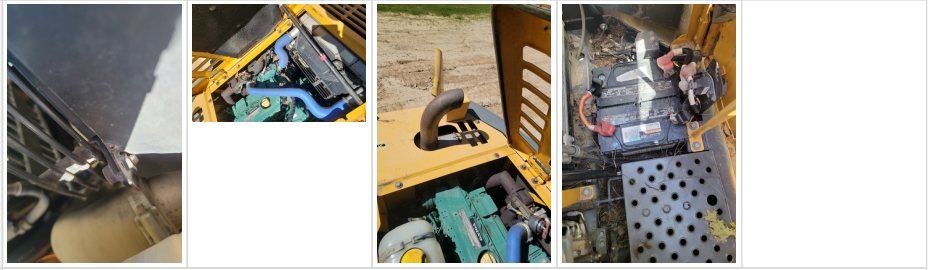
Engine Compartment Photos

Oil Leaks	No
Oil Appearance	3 - Normal Wear & Tear
Oil Appearance Notes	Clean oil appearance, no signs of cross contamination
Fuel Leaks	No
Equipped with DPF (Diesel Particulate Filter)	No
Requires DEF (Diesel Exhaust Fluid)	No
Overall Engine Rating	3 - Normal Wear & Tear
Overall Engine Appearance	Clean & dry, Areas of surface corrosion seen on some engine components
Overall Engine Comments	Rust on exhaust parts

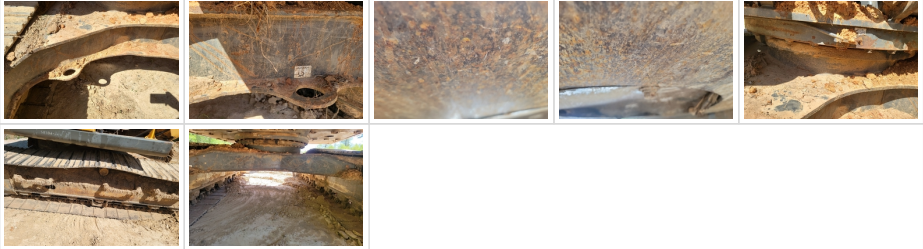
Chassis Photos

Boom Condition	3 - Normal Wear & Tear
Comments	boom has minor scratches
Stick Condition	3 - Normal Wear & Tear
Boom Base Pin & Bushings	3 - Normal Wear & Tear
Comments	well greased
Boom to Stick Pin & Bushings	3 - Normal Wear & Tear
Comments	well greased
Stick to Bucket Pin & Bushings	3 - Normal Wear & Tear
Comments	well greased
Turntable Bearing	3 - Normal Wear & Tear
Overall Chassis	3 - Normal Wear & Tear
Overall Chassis Comments	Chassis is in good condition

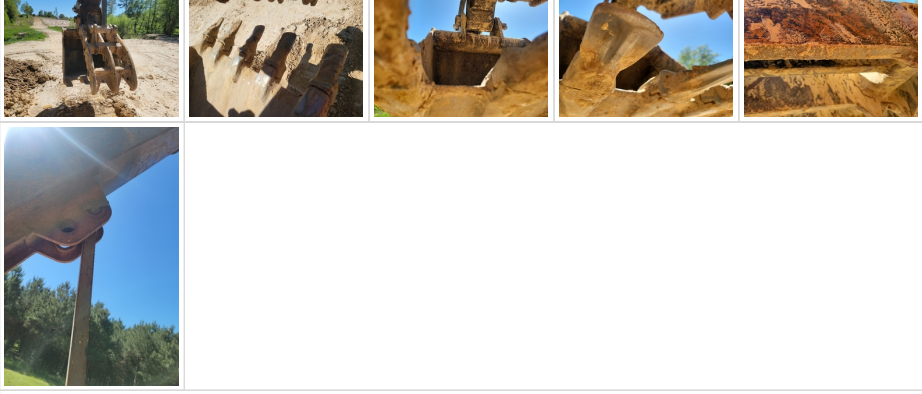
Attachment Photos

Bucket	3 - Normal Wear & Tear
Bucket Teeth	3 - Normal Wear & Tear
Blade	0
Blade Edge	0
