VIN: Z45250525069

2005 GENIE Z-45-25 / 0

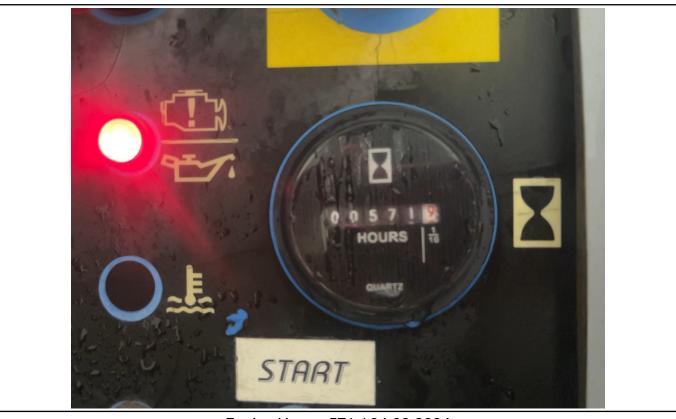
Engine Hours: 571 / 04-03-2024

The hours appear to be low for the age of the unit. The lower sheet metal on the basket is paint is worn off and metal is rusted and bent. The rails on the basket have paint missing and metal is rusty. The fire extinguisher is missing from the basket. The EMS panel is showing there is a red light warning and the unit either has a check engine warning or an engine oil pressure problem. The engine coolant is low in the reservoir. The engine oil filter is rusty. The exhaust pipe tip is rusty. The plastic fuel tank appears to have a hole rubber into it on the side. The engine oil appears to be above the full mark on the dipstick. The hydraulic hose fittings are rusty to going to the body lift cylinder. The hydraulic hose appears to have cracks in it by the front left steering cylinder. The rear right tire has gouges in the sidewall by the lip of the wheel and the front left tire has a small gouge in the rubber by the lip of the wheel. There is green fluid under the unit at the time of inspection it possibly appears to look like coolant. The travel alarms did not operate in the

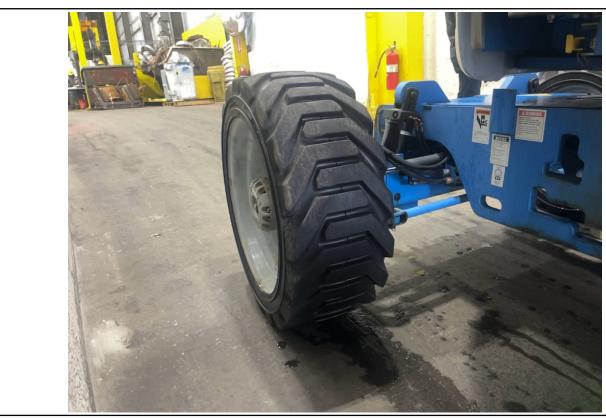
Front Left Tire Condition / 04-03-2024

Specifications	
Year	2005
Make	GENIE
Model	Z-45/25
Date of Inspection	04/03/2024
Location of Inspection	1800 Harrison Ave , Kearny, NJ, 07032, USA
Serial Number	Z45250525069
Engine Hours	571
EMS Warning Lights	Active Warnings
Travel Control	No Damages Observed
Operator's Seat	N/A
Mirrors	N/A
Radio	N/A
A/C	N/A
Steering Wheel	N/A
Pedals	No Damages Observed
Floorboard	No Damages Observed
Power Mirrors	N/A
Heated Mirrors	N/A
Switches and Controls	No Damages Observed
Steps	N/A
Handrails	N/A
Oil Dipstick	Low Level / Good Color
Engine Compartment	See Notes
Exhaust Pipe	See Notes
Axles	No Damages Observed
Backup Camera	N/A
ROPS	N/A
Front Lights	No Damages Observed
Rear Lights	No Damages Observed
Front Right Tire Condition	No Damages Observed
Front Right Tire Brand	Outrigger
Front Right Tire Size	355/55D625
Rear Right Tire Condition	See Notes
Rear Right Tire Brand	Outrigger
Rear Right Tire Size	355/55D625
Front Left Tire Condition	See Notes

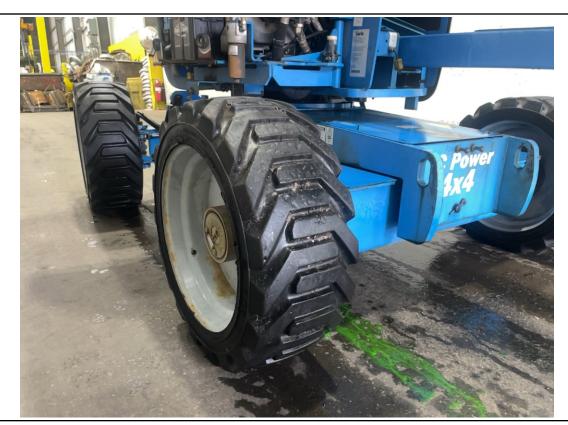
Rear Left Tire Condition / 04-03-2024

Front Left Tire Brand	Outrigger
Front Left Tire Size	355/55D625
Rear Left Tire Condition	No Damages Observed
Rear Left Tire Brand	Outrigger
Rear Left Tire Size	355/55D625
