## Inspection Report (Excavator)

B&B Stock Number	A6915826
Year	2019
Make	Caterpillar
Model	304E2 CR
Serial Number	CAT0304EJME404701
Serial Plate Photo

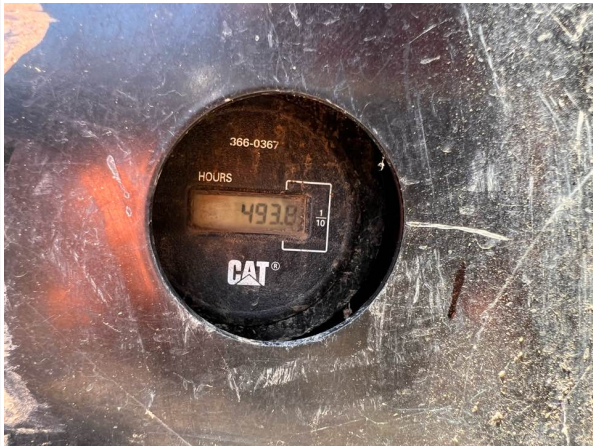
Hour Meter Reading	493.8
Hour Meter Photo

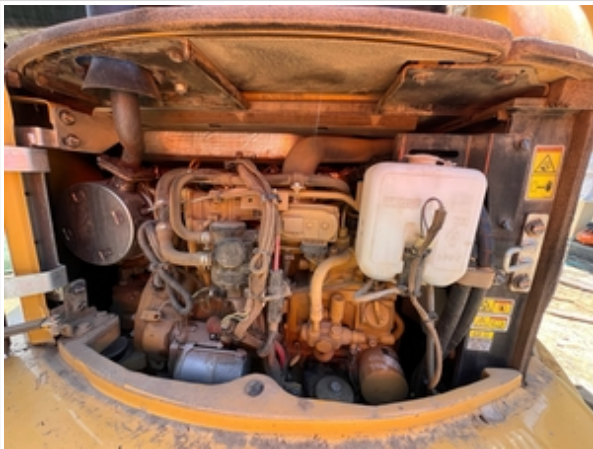
Engine Data Plate

Engine Type (Make, Model, Cylinders, Hp)	Unable to verify
Emissions Tier	Undetermined
Engine Serial Number	Unable to verify
Engine Fuel Type	Diesel
Blow-by (Visual Observation Check)	No
Unusual Noises (Upon Start-up, Idle, Shutdown)	No
Engine Smoke (Upon Start-up, Idle, Shutdown)	No
Engine Exhaust Color	Clear
Battery	3 - Normal Wear & Tear
Radiator	3 - Normal Wear & Tear
Belts	3 - Normal Wear & Tear
Hoses	3 - Normal Wear & Tear
Water Pump	3 - Normal Wear & Tear
Cooling System Leaks	No
Coolant Appearance	3 - Normal Wear & Tear
Oil Leaks	No
Oil Appearance	3 - Normal Wear & Tear
Fuel Leaks	No
Equipped with DPF (Diesel Particulate Filter)	Yes
DPF Condition	3 - Normal Wear & Tear
Requires DEF (Diesel Exhaust Fluid)	No
Overall Engine Rating	3 - Normal Wear & Tear
Overall Engine Appearance	Dusty & dry
Overall Engine Comments	Normal wear and tear no major issues to report
