Inspection Report (Excavator)

B&B Stock Number	A6164397
Year	2015
Make	John Deere
Model	35G
Serial Number	1FF035GXLFK274629
Serial Plate Photo

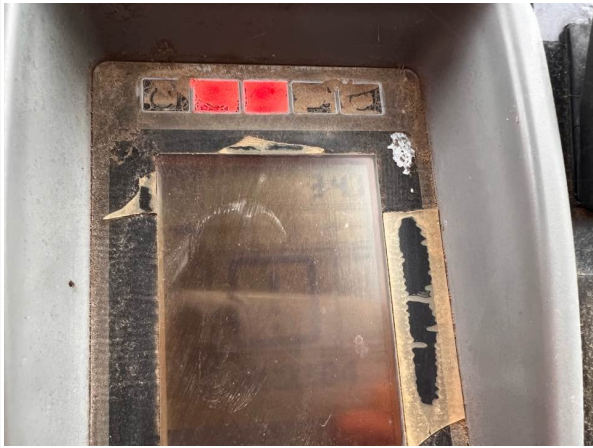
Hour Meter Reading	2304
Hour Meter Photo

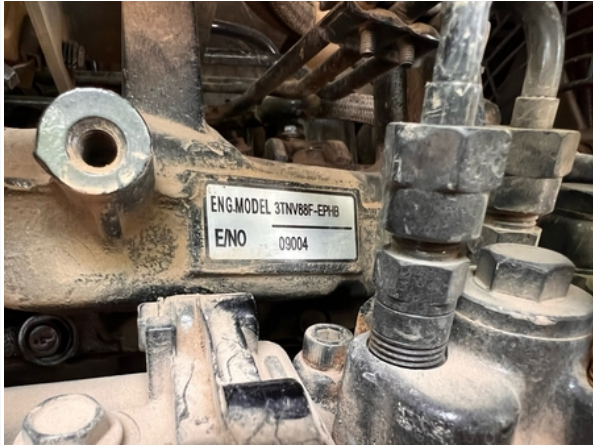
Engine Data Plate

Engine Type (Make, Model, Cylinders, Hp)	Yanmar	
Emissions Tier	Undetermined	
Engine Serial Number	09004	
Engine Fuel Type	Diesel	
Blow-by (Visual Observation Check)	No	
Unusual Noises (Upon Start-up, Idle, Shutdown)	No	
Engine Smoke (Upon Start-up, Idle, Shutdown)	No	
Engine Exhaust Color	Clear	
Battery	3 - Normal Wear & Tear	
Radiator	3 - Normal Wear & Tear	
Belts	3 - Normal Wear & Tear	
Hoses	3 - Normal Wear & Tear	
Water Pump	3 - Normal Wear & Tear	
Cooling System Leaks	No	
Coolant Appearance	3 - Normal Wear & Tear	
Oil Leaks	No	
Oil Appearance	3 - Normal Wear & Tear	
Fuel Leaks	No	
Equipped with DPF (Diesel Particulate Filter)	No	
Requires DEF (Diesel Exhaust Fluid)	No	
Overall Engine Rating	3 - Normal Wear & Tear	
Overall Engine Appearance	Dusty & dry	
Overall Engine Comments	Normal wear and tear
