Inspection Report (Wheel Loader)

B&B Stock Number	A7743104
Year	2013
Make	Caterpillar
Model	950K
Serial Number	CAT0950KCR4A01228
Serial Plate Photo

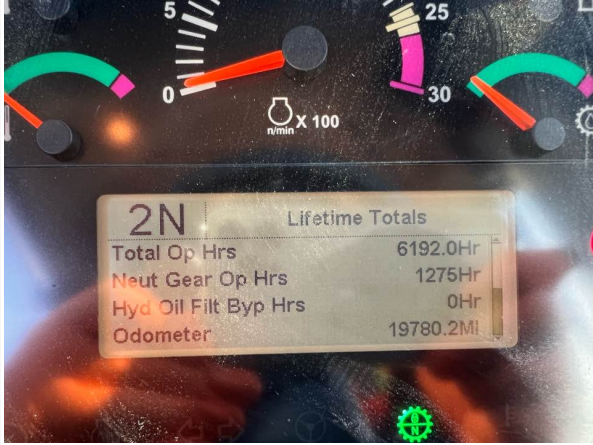
Hour Meter Reading	6192.0
Single Photo

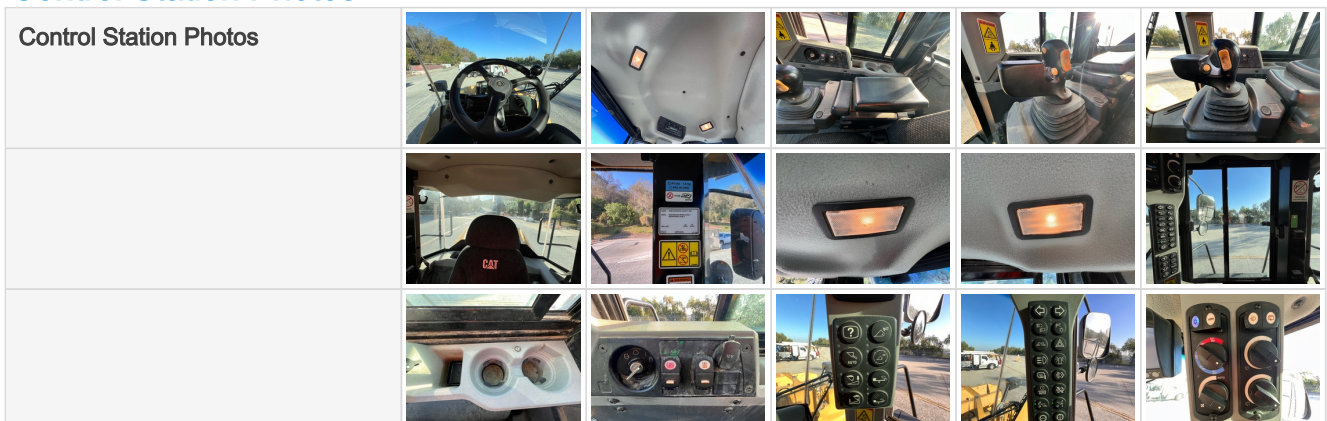
Control Station Photos

Control Station Type	Enclosed Cab (EROPS)
Control Type	Pilot Controls
Control Configuration	N/A
Seat	3 - Normal Wear & Tear
Cabin Lights	3 - Normal Wear & Tear
Safety Lock Out / Stop	3 - Normal Wear & Tear
Controls & Switches	3 - Normal Wear & Tear
Hour Meter Activity	3 - Normal Wear & Tear
Other Gauge Activity	3 - Normal Wear & Tear
Heater & A/C	3 - Normal Wear & Tear
Travel Alarm	0
Horn	3 - Normal Wear & Tear
Backup Camera	3 - Normal Wear & Tear
Control Station Overall Rating	3 - Normal Wear & Tear

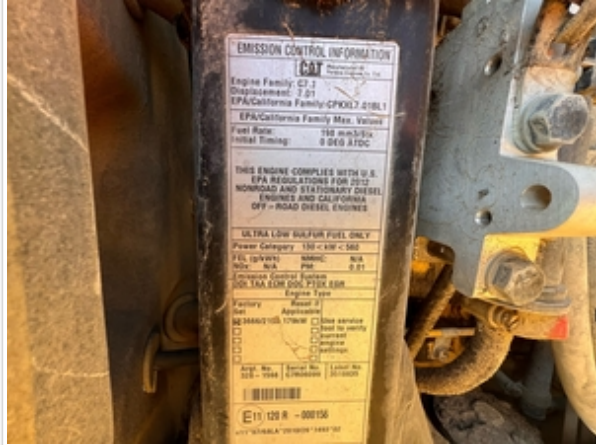
Engine Data Plate

Engine Type (Make, Model, Cylinders, Hp)	Cat, C7				
Emissions Tier	Undetermined				
Engine Serial Number	C7R06099				
Engine Fuel Type	Diesel				
Blow-by (Visual Observation Check)	No				
Unusual Noises (Upon Start-up, Idle, Shutdown)	No				
Engine Smoke (Upon Start-up, Idle, Shutdown)	No

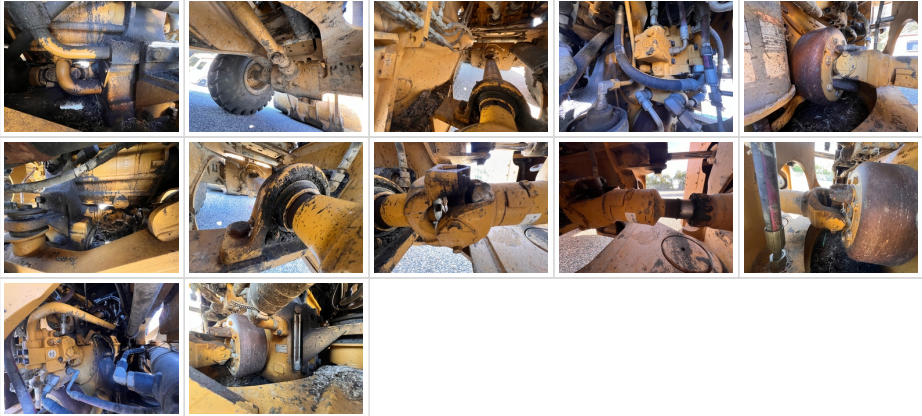
Drivetrain Photos

Transmission Components	2 - Above Average Wear & Tear
Transmission Condition	Jerking, shaking, or grinding felt
Comments	Jerking motion while in operation
Drive Motors	0
Parking Brake	3 - Normal Wear & Tear
Overall Drivetrain Rating	3 - Normal Wear & Tear
Overall Drivetrain Comments	Above average wear and tear due to jerking motion while machine is operating

What Needs Work	The things that need work on this machine are the jerking well in operation, the bent fenders on both sides and the areas of surface rust observed	
Date/Time	06-26-2024	
Inspector Name	Javier Bobcat

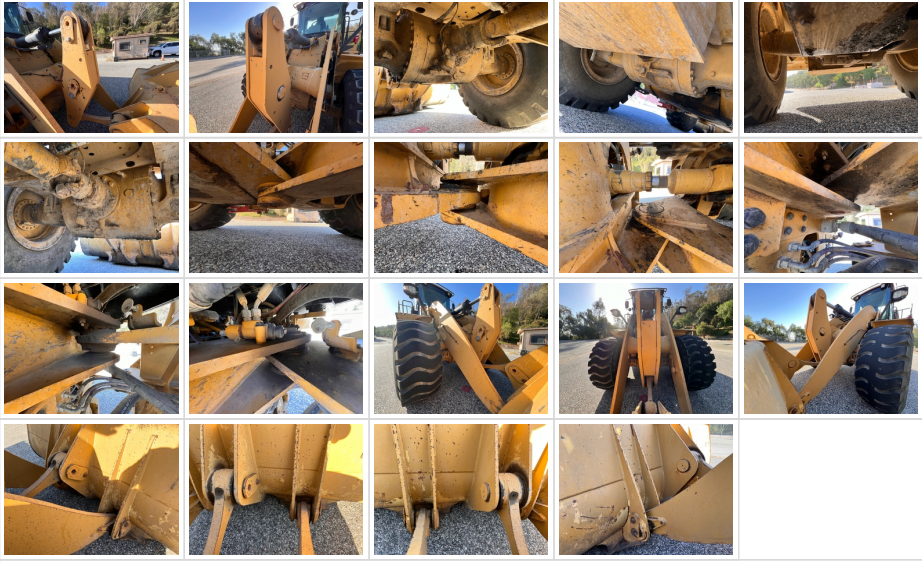
Chassis Photos

Frame	3 - Normal Wear & Tear
Stance	3 - Normal Wear & Tear
Front Axle Appearance	3 - Normal Wear & Tear
Rear Axle Appearance	3 - Normal Wear & Tear
Articulating Center Pin Appearance	3 - Normal Wear & Tear
Lift Arm	3 - Normal Wear & Tear
Chassis to Arm Pins	3 - Normal Wear & Tear
Tilt Linkage	3 - Normal Wear & Tear
Tilt Linkage Pins and Bushings	3 - Normal Wear & Tear
Quick Coupler	0
Quick Coupler to Arms Pins	0
Overall Chassis	3 - Normal Wear & Tear

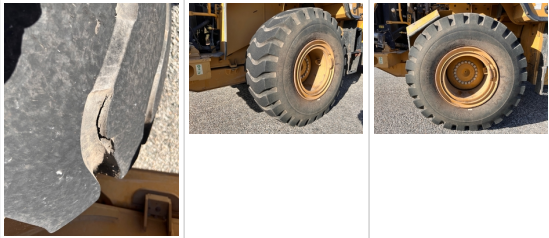
Rear Right Tire - Ratio Remaining	30%		
Rear Right Tire Photos
