Inspection Report (Bulldozer)

B&B Stock Number	A1756865
Year	2021
Make	John Deere
Model	450K
Serial Number	1T0450KXCMF403476
Serial Plate Photo

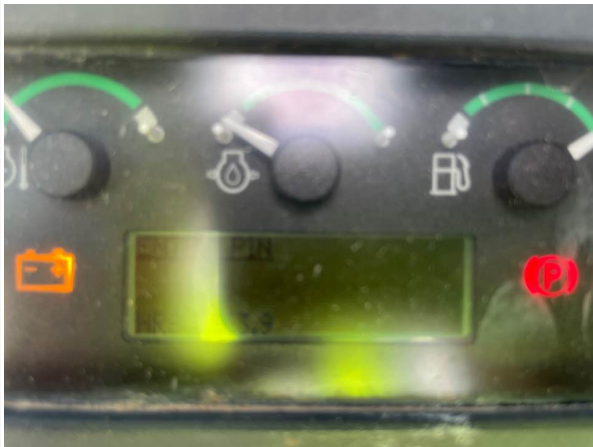
Hour Meter Reading	2254
Hour Meter Photo

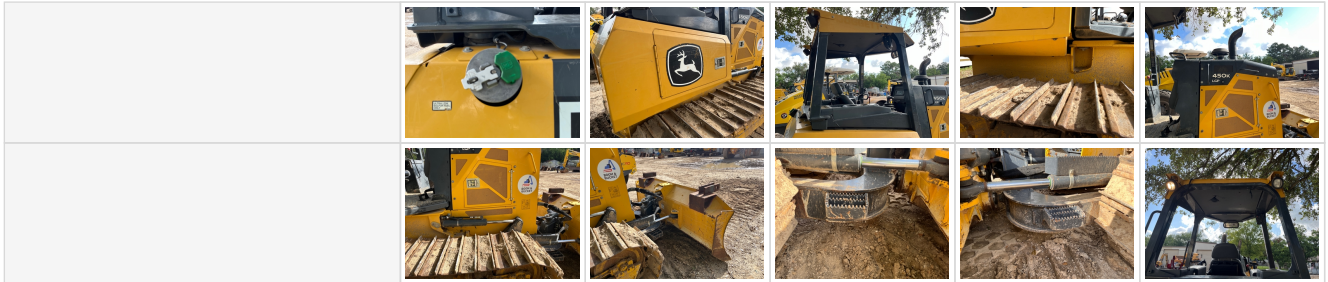
Close-up Exterior Photos	 
--------------------------	--

Handrails	4 - Very Light or Minimal Wear	
Handrails Condition	Handrails are fully intact and appear structurally sound	
Glass	0	
Mirrors	4 - Very Light or Minimal Wear	
Mirror Condition	Mirrors present and intact, no visible damage	
Exterior Lights	2 - Above Average Wear & Tear	
Exterior Lights Condition	No visible damage, lighting system is operational, One or more exterior lights are non-operational, Other (see comments)	
Comments	Rear right light not working	
Overall Exterior	4 - Very Light or Minimal Wear	
Comments	Machine is in good condition with no major cosmetic notes.

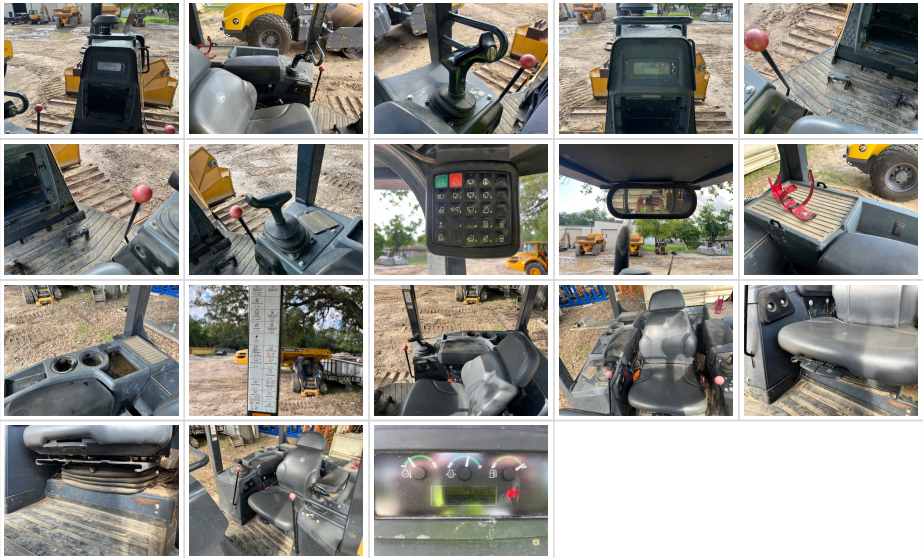
Control Station Photos

Control Station Type	Canopy
Control Type	Lever Controls
Control Configuration	Unable to confirm, N/A
Seat	3 - Normal Wear & Tear
Seat Condition	Seat belt secures properly, Seat belt is intact and in good condition, Seat(s) have minor surface staining or small tears, Seat adjustment controls move through full range of travel
Cabin Lights	0
Safety Lock Out / Stop	3 - Normal Wear & Tear
Controls & Switches	3 - Normal Wear & Tear
Controls & Switches Condition	All switches are installed and functional
Hour Meter Activity	3 - Normal Wear & Tear
Hour Meter Condition	Hour meter is functional and in good condition
Other Gauge Activity	3 - Normal Wear & Tear
Heater & A/C	0
Travel Alarm	3 - Normal Wear & Tear
Horn	3 - Normal Wear & Tear
Horn Condition	Horn is installed and functioning as expected
Backup Camera	0
Control Station Overall Rating	4 - Very Light or Minimal Wear
Control Station Overall Condition	Good cabin appearance, solid floors, panels, and ceiling

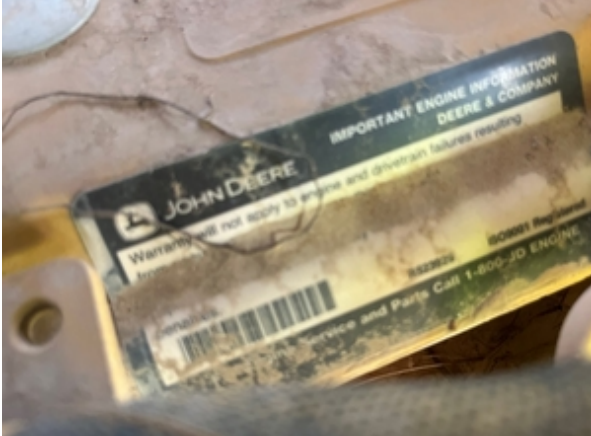
Engine Data Plate

Engine Type (Make, Model, Cylinders, Hp)	Verify
Emissions Tier	Undetermined
Engine Serial Number	Pe4045u132085
Engine Fuel Type	Diesel
Blow-by (Visual Observation Check)	No
Unusual Noises (Upon Start-up, Idle, Shutdown)	No
Engine Smoke (Upon Start-up, Idle, Shutdown)	No
Engine Exhaust Color	Clear
Battery	4 - Very Light or Minimal Wear
Battery Condition	Clean & dry appearance, tight connections
Radiator	3 - Normal Wear & Tear
Radiator Condition	Radiator fins & components appear to be in good working order, no signs of damage or leaks

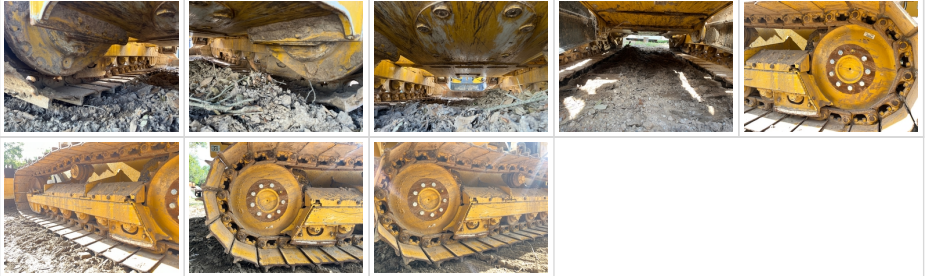
Drivetrain Photos

Hydrostatic Transmission?	Yes				
Speeds	Variable Speed				
Drive Type	N/A (Track Undercarriage)				
Transmission Components	3 - Normal Wear & Tear				
Drive Motors	3 - Normal Wear & Tear				
Parking Brake	3 - Normal Wear & Tear				
Overall Drivetrain Rating	3 - Normal Wear & Tear				
Overall Drivetrain Comments	Everything looks to be in good shape.

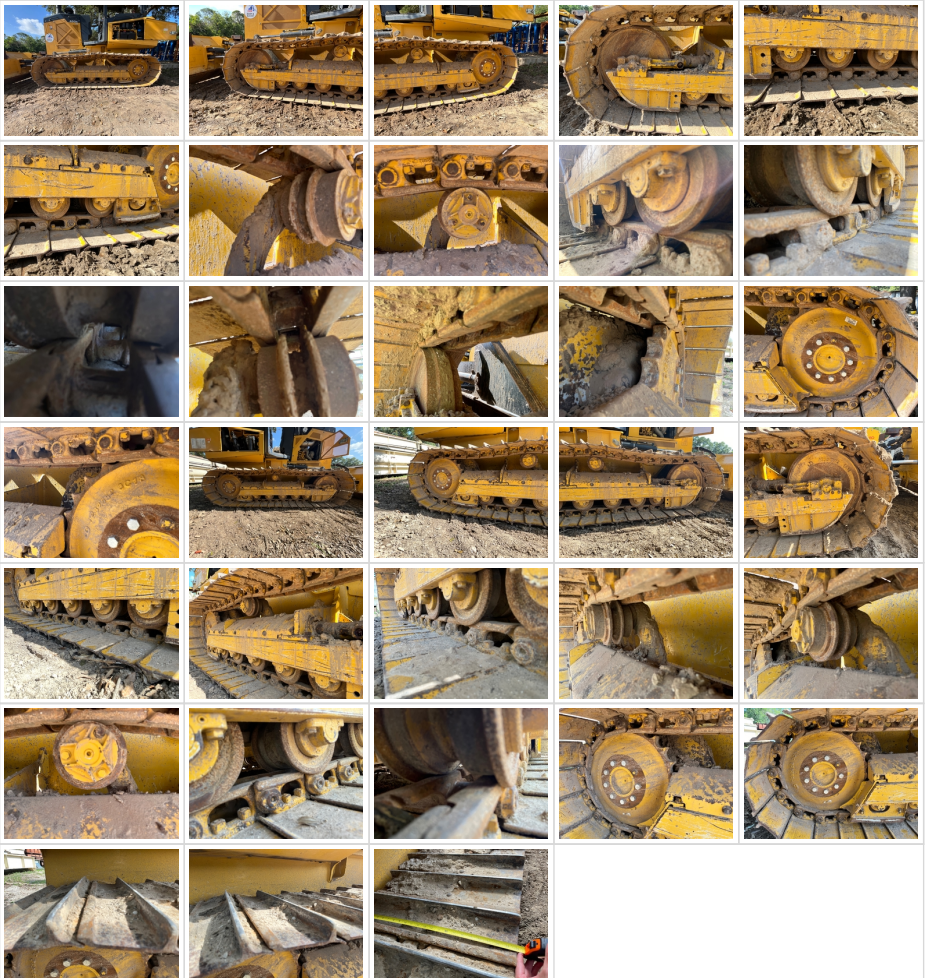
Undercarriage Photos

Sprocket Teeth	3 - Normal Wear & Tear
Track Bushings	3 - Normal Wear & Tear
Track Frames	3 - Normal Wear & Tear
Pivot Shafts	3 - Normal Wear & Tear

Equalizer Bar & Joints	3 - Normal Wear & Tear
Front Idler	3 - Normal Wear & Tear
Track Tensioner	3 - Normal Wear & Tear
Track links	3 - Normal Wear & Tear
Bottom Rollers	2 - Above Average Wear & Tear
Carrier Rollers	3 - Normal Wear & Tear
Overall Undercarriage	3 - Normal Wear & Tear
Overall Percent Estimate	50%
Overall Undercarriage Comments	Normal wear and tear.

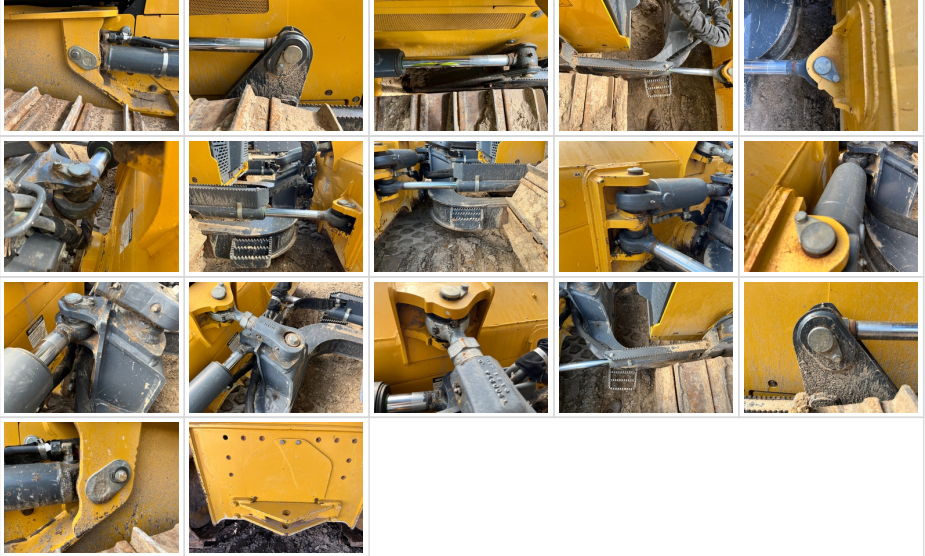
Chassis Photos

Push Arm / C-Frame Condition	3 - Normal Wear & Tear
Push Arm Pivot / C-Frame Trunnions Condition	3 - Normal Wear & Tear
Tilt Linkage Pin & Bushings	3 - Normal Wear & Tear
Angle Linkage Pin & Bushings	3 - Normal Wear & Tear
Blade Trunnions / Bushings	3 - Normal Wear & Tear
Frame Condition	3 - Normal Wear & Tear
Belly Pans	3 - Normal Wear & Tear
Overall Chassis	3 - Normal Wear & Tear
