## Inspection Report (Skid Steer/Track Loader)

B&B Stock Number	A0216480
Year	2021
Make	John Deere
Model	325G
Serial Number	1T0325GMLMJ394652
Serial Plate Photo

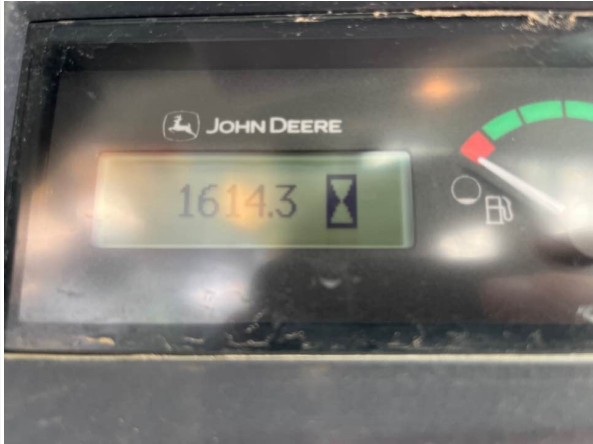
Hour Meter Reading	1614
Hour Meter Photo

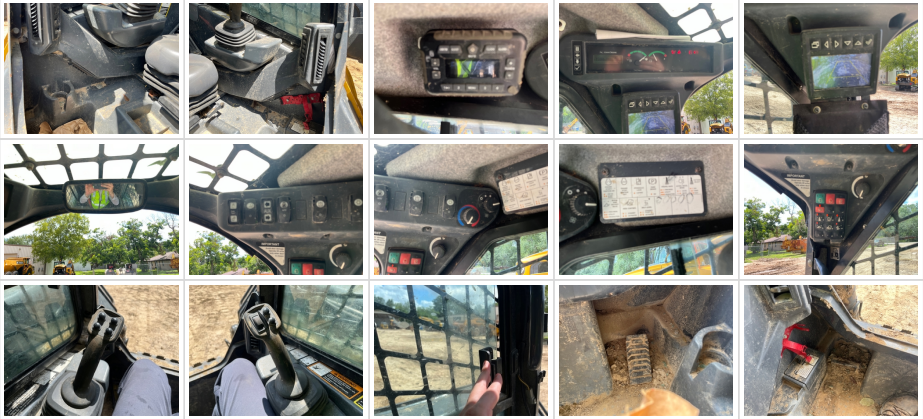
#### Control Station Photos

<b>Control Station Type</b>	Enclosed Cab (EROPS)
<b>Control Type</b>	Pilot Controls
<b>Control Configuration</b>	Unable to confirm
<b>Comments</b>	Enclosed cab, door will be included at sale
<b>Seat</b>	3 - Normal Wear & Tear
<b>Seat Condition</b>	Seat(s) in good condition, no stains or tears in upholstery
<b>Cabin Lights</b>	3 - Normal Wear & Tear
<b>Cabin Lights Condition</b>	Cabin lights are installed with all light covers in place, bulbs are installed and working properly
<b>Safety Lock Out / Stop</b>	3 - Normal Wear & Tear
<b>Controls &amp; Switches</b>	4 - Very Light or Minimal Wear
<b>Hour Meter Activity</b>	4 - Very Light or Minimal Wear
<b>Other Gauge Activity</b>	4 - Very Light or Minimal Wear
<b>Heater &amp; A/C</b>	3 - Normal Wear & Tear
<b>Heater &amp; A/C Condition</b>	Heater and A/C work as expected, A/C Blows cool - noticeably cooler than air temp
<b>Travel Alarm</b>	3 - Normal Wear & Tear

<b>Horn</b>	3 - Normal Wear & Tear
<b>Backup Camera</b>	3 - Normal Wear & Tear
<b>Control Station Overall Rating</b>	3 - Normal Wear & Tear
<b>Control Station Overall Condition</b>	Good cabin appearance, solid floors, panels, and ceiling

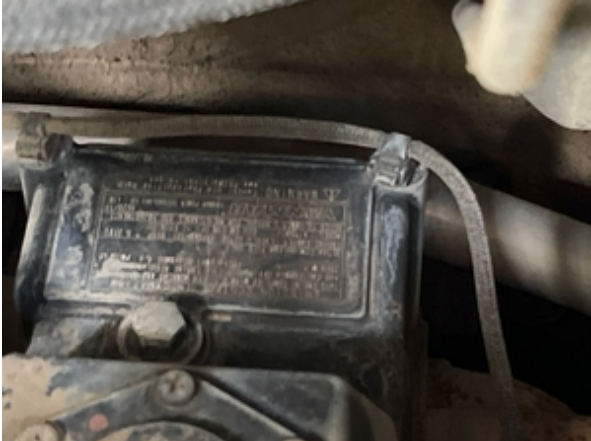
Engine Data Plate

Engine Type (Make, Model, Cylinders, Hp)	Unable to confirm
Emissions Tier	Undetermined
Engine Fuel Type	Diesel
Blow-by (Visual Observation Check)	N/A
Unusual Noises (Upon Start-up, Idle, Shutdown)	No
Engine Smoke (Upon Start-up, Idle, Shutdown)	No
Engine Exhaust Color	Clear
Battery	0
Radiator	3 - Normal Wear & Tear
Radiator Condition	Radiator fins & components appear to be in good working order, no signs of damage or leaks
Belts	3 - Normal Wear & Tear
Hoses	3 - Normal Wear & Tear
Water Pump	0
Cooling System Leaks	No

Coolant Appearance	3 - Normal Wear & Tear
Oil Leaks	No
Oil Appearance	3 - Normal Wear & Tear
Oil Appearance Notes	Clean oil appearance, no signs of cross contamination, Appropriate oil level
Fuel Leaks	No
Equipped with DPF (Diesel Particulate Filter)	N/A
Requires DEF (Diesel Exhaust Fluid)	No
Overall Engine Rating	3 - Normal Wear & Tear
Overall Engine Appearance	Clean & dry
Overall Engine Comments	Right engine compartment that's hard to see into. But, engine fired up and had no unusual noises. See videos.

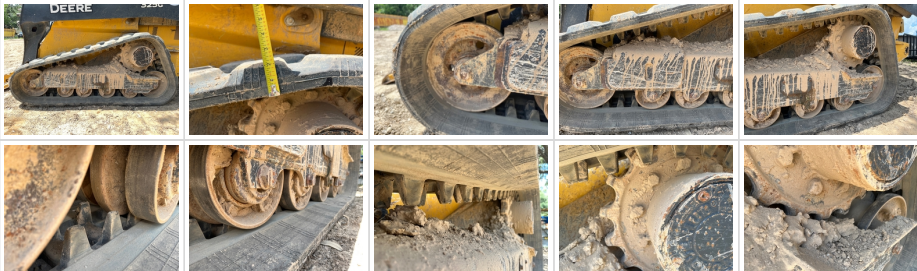
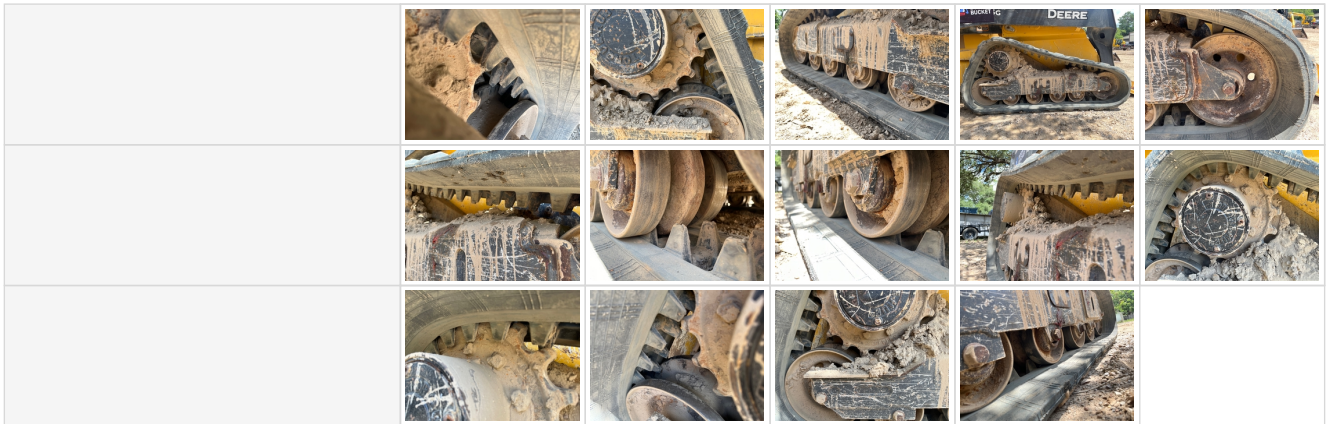
Undercarriage Photos

Track Width (inches)	16in
Track Length (inches)	70 on ground
Roller Frames	3 - Normal Wear & Tear
Track Belt	3 - Normal Wear & Tear
Rubber Belt Drive Lugs	3 - Normal Wear & Tear
Track Tensioners	3 - Normal Wear & Tear
Front Idlers	3 - Normal Wear & Tear
Rear Idlers	3 - Normal Wear & Tear
Track Rollers	3 - Normal Wear & Tear
Sprockets	3 - Normal Wear & Tear
Overall Undercarriage Rating	3 - Normal Wear & Tear
Left Track Belt - Percent Remaining Estimate	50%
Right Track Belt - Percent Remaining Estimate	50%
Overall Comments	Appears to be in good shape.

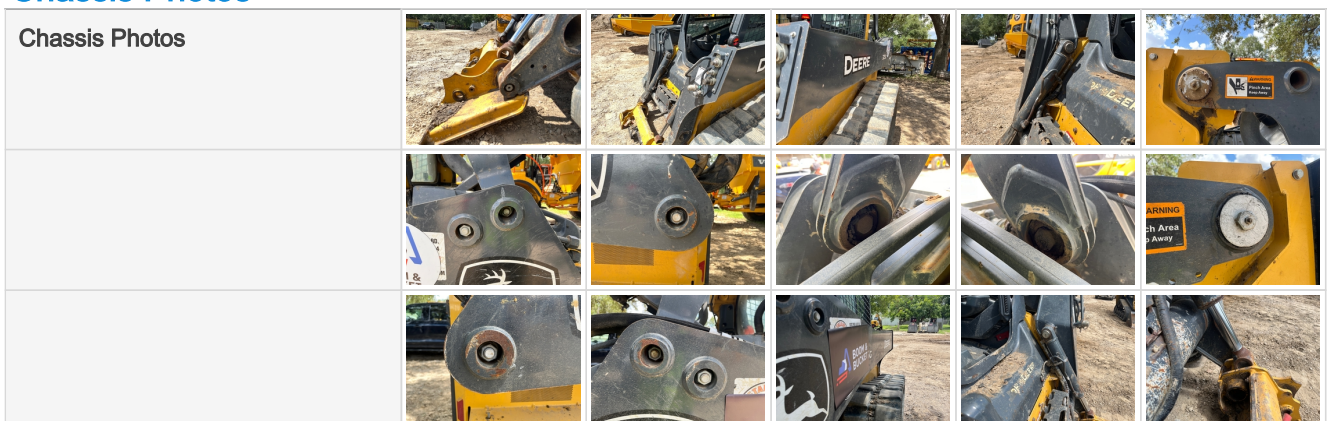
### Chassis Photos

Frame	3 - Normal Wear & Tear
Stance	3 - Normal Wear & Tear
Lift Arms	3 - Normal Wear & Tear
Chassis to Arm Pins	3 - Normal Wear & Tear
Quick Coupler	3 - Normal Wear & Tear
Quick Coupler to Arms Pins	3 - Normal Wear & Tear
Overall Chassis	3 - Normal Wear & Tear
Overall Chassis Comments	Everything appears to be in good working order.

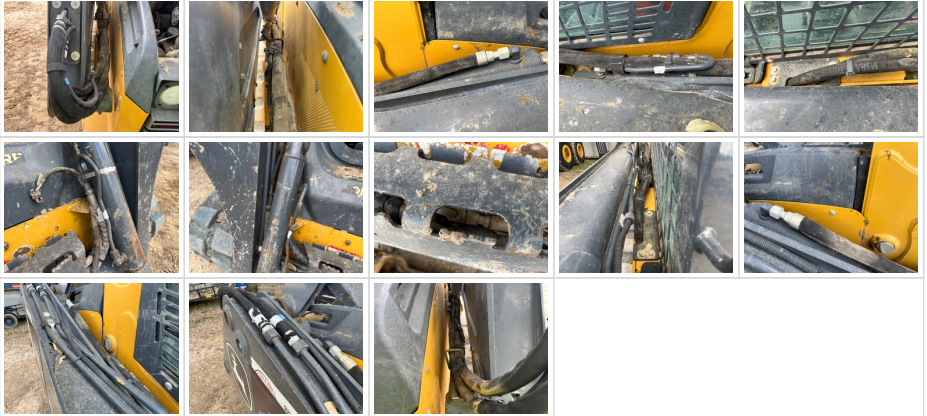
Hydraulic System Photos

Hydraulic Lines/Fittings	3 - Normal Wear & Tear				
Hydraulic Lines / Fittings Condition	Hydraulic lines & fittings are clean and in good condition				
Hydraulic Pump(s)	3 - Normal Wear & Tear				
Unusual Noises	No				
Hydraulic Pump Notes	No unusual noises heard during operation

Mounting Pins	3 - Normal Wear & Tear	
Cylinder Oil Leaks	No	
Hydraulic System Overall	3 - Normal Wear & Tear	
Comments	Unable to get a good look at the pump but no visible leaks or unusual noises
