Inspection Report (Skid Steer/Track Loader)

B&B Stock Number	A5195398
Year	2021
Make	John Deere
Model	325G
Serial Number	1T0325GKCMJ393942
Serial Plate Photo

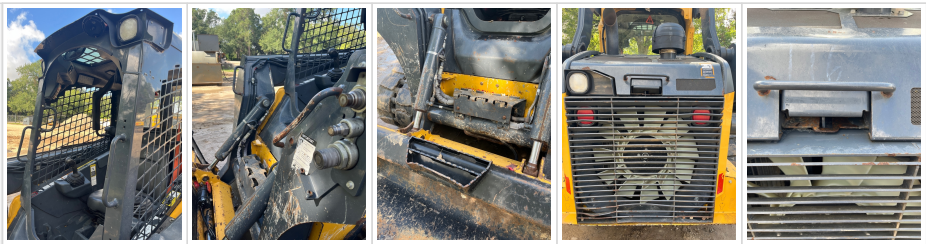
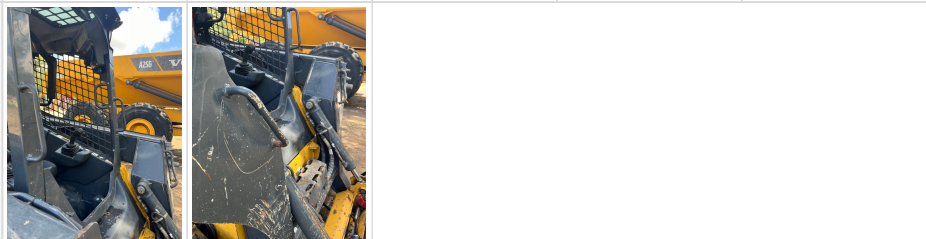
Close-up Exterior Photos

Inspection Rating Criteria	
Body Panels	3 - Normal Wear & Tear
Body Panel Condition	Areas of surface rust observed, Visible chipped paint or dents
Comments	Normal wear and tear
Doors / Canopy Latches	3 - Normal Wear & Tear
Doors / Canopy Latches Condition	No visible damage
Steps / Ladders	4 - Very Light or Minimal Wear
Steps / Ladders Condition	Steps/ladders are fully intact and appear structurally sound
Handrails	3 - Normal Wear & Tear
Handrails Condition	Handrails are fully intact and appear structurally sound, Bent or broken railings
Glass	4 - Very Light or Minimal Wear
Glass Condition	Glass intact, no visible damage
Mirrors	4 - Very Light or Minimal Wear
Mirror Condition	Mirrors present and intact, no visible damage

Exterior Lights	4 - Very Light or Minimal Wear
Exterior Lights Condition	No visible damage, lighting system is operational
Overall Exterior	3 - Normal Wear & Tear
Comments	Normal scratches and wear. Small bend and break on 1 hand rail but still structurally sound.

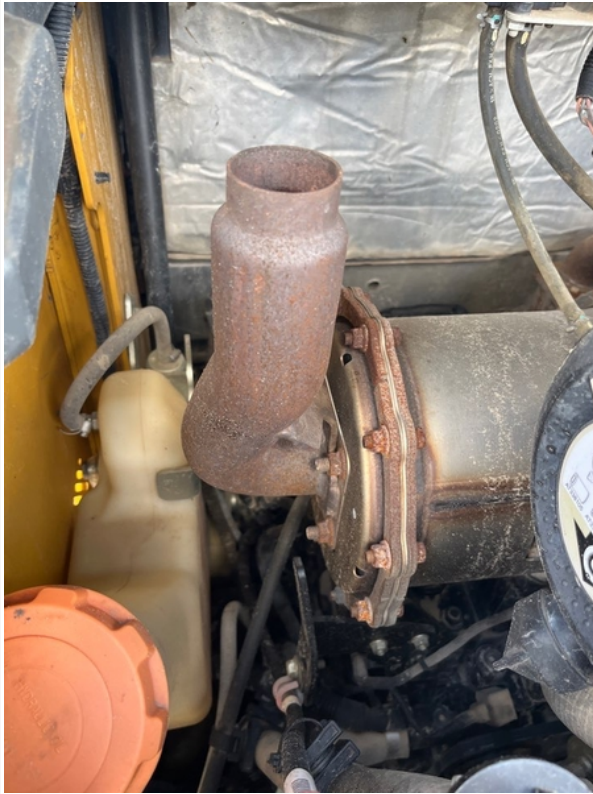
Engine Data Plate

Engine Type (Make, Model, Cylinders, Hp)	Deere				
Emissions Tier	Other (see comments)				
Comments	No DEF				
Engine Fuel Type	Diesel

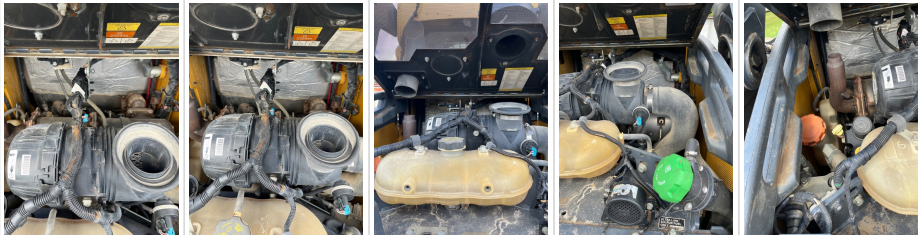
Engine Compartment Photos

Unusual Noises (Upon Start-up, Idle, Shutdown)	No
Engine Smoke (Upon Start-up, Idle, Shutdown)	No
Engine Exhaust Color	Clear
Cooling System Leaks	No
Oil Leaks	No
Fuel Leaks	No
Equipped with DPF (Diesel Particulate Filter)	No
Requires DEF (Diesel Exhaust Fluid)	No
Overall Engine Rating	4 - Very Light or Minimal Wear
Overall Engine Appearance	Clean & dry
Overall Engine Comments	Engine starts right up, no strange sounds or smoke.

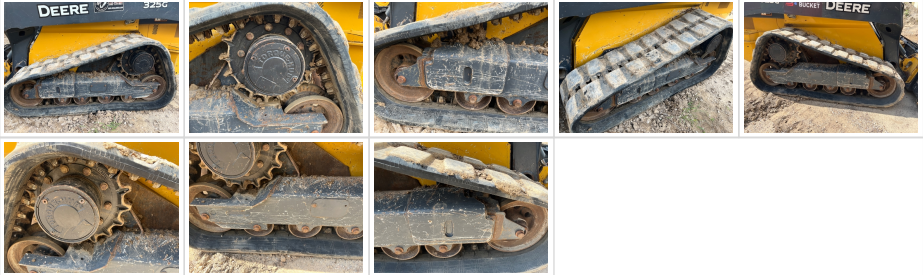
Drivetrain Photos

Hydrostatic Transmission?	Yes
Speeds	Variable Speed
Drive Type	N/A (Track Undercarriage)
Parking Brake	5 - Like New, Recently Replaced
Overall Drivetrain Rating	3 - Normal Wear & Tear
Overall Drivetrain Comments	Normal wear and tear

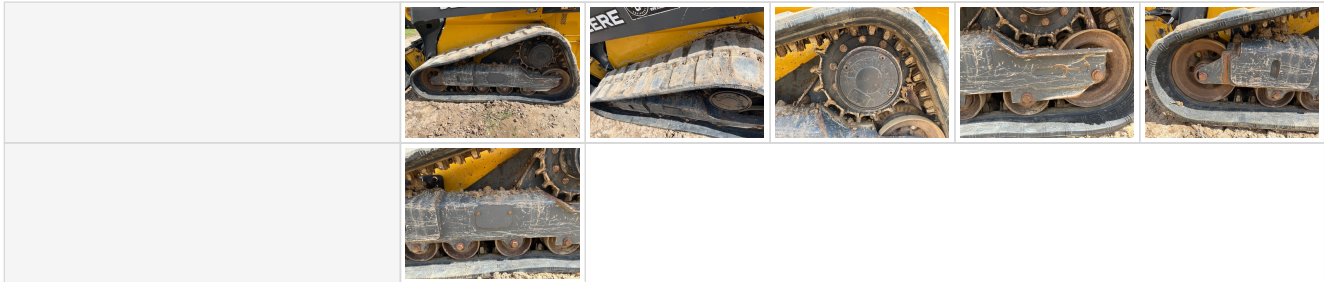
Undercarriage Photos

Track Width (inches)	16
Track Length (inches)	74
Roller Frames	3 - Normal Wear & Tear
Track Belt	3 - Normal Wear & Tear
Rubber Belt Drive Lugs	3 - Normal Wear & Tear
Track Tensioners	3 - Normal Wear & Tear
Front Idlers	3 - Normal Wear & Tear
Rear Idlers	3 - Normal Wear & Tear
Track Rollers	3 - Normal Wear & Tear
Sprockets	3 - Normal Wear & Tear
Overall Undercarriage Rating	3 - Normal Wear & Tear
Left Track Belt - Percent Remaining Estimate	N/A
Right Track Belt - Percent Remaining Estimate	N/A
Overall Comments	Standard wear and tear

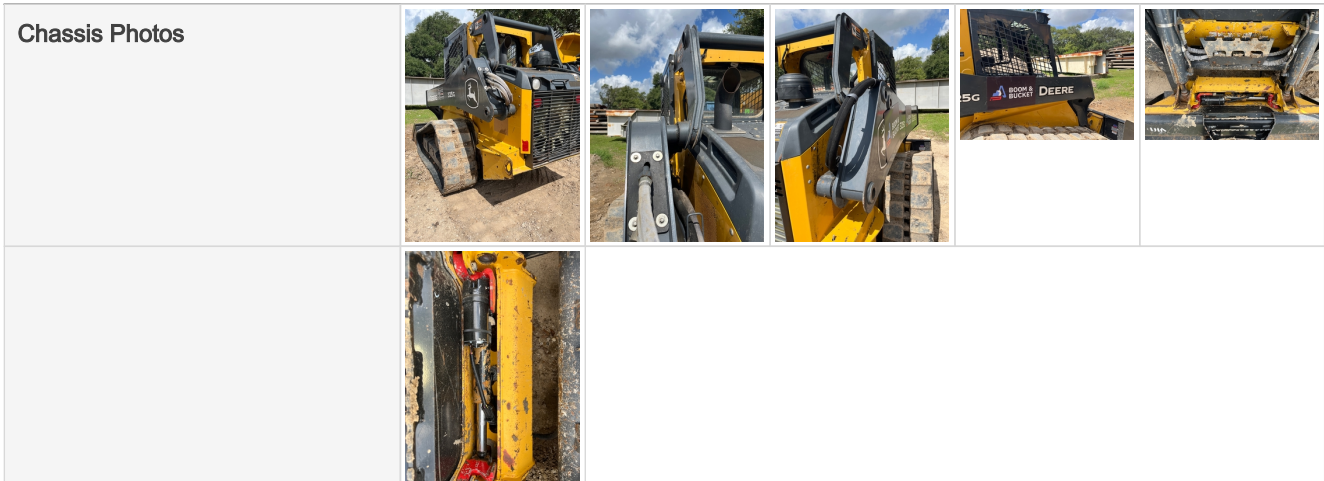
Chassis Photos

Frame	4 - Very Light or Minimal Wear
-------	--------------------------------

Stance	4 - Very Light or Minimal Wear
Lift Arms	4 - Very Light or Minimal Wear
Chassis to Arm Pins	4 - Very Light or Minimal Wear
Quick Coupler	4 - Very Light or Minimal Wear
Quick Coupler to Arms Pins	4 - Very Light or Minimal Wear
Overall Chassis	4 - Very Light or Minimal Wear
Overall Chassis Comments	Normal cosmetic wear and tear

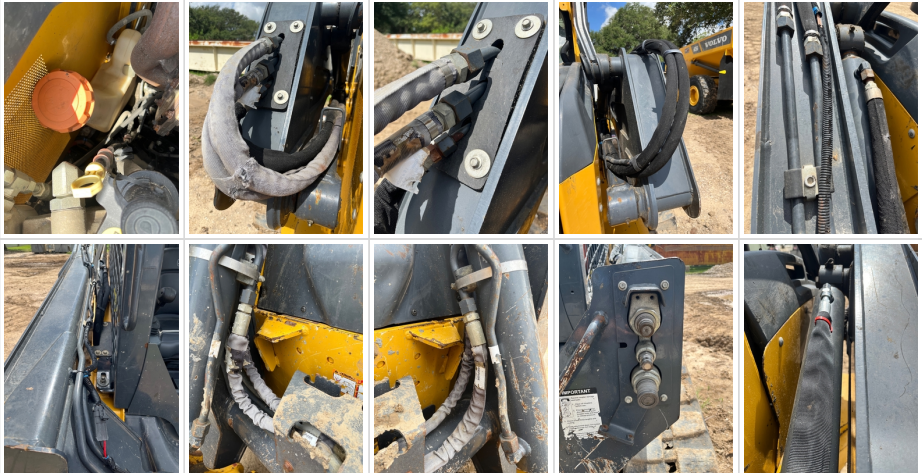
Hydraulic System Photos

Wet or Damp Hydraulic Lines / Fittings	No				
Hydraulic Lines/Fittings	3 - Normal Wear & Tear				
Hydraulic Lines / Fittings Condition	Worn, cut, or damaged hose covering, Hydraulic lines & fittings are clean and in good condition				
Hydraulic Pump(s)	0				
Unusual Noises	No
