## Inspection Report (Bulldozer)

B&B Stock Number	A1104116
Year	1984
Make	Caterpillar
Model	834B
Serial Number	92Z0194
Serial Plate Photo

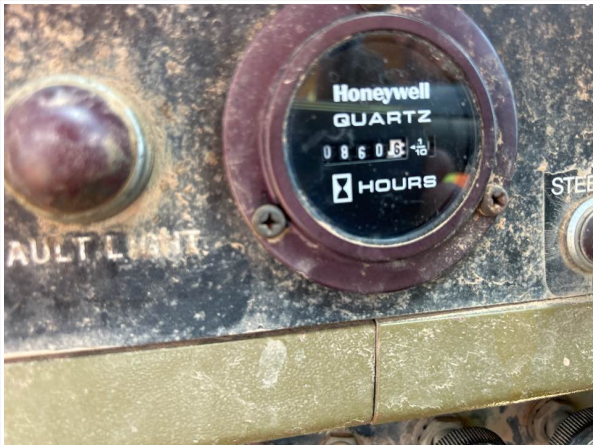
Hour Meter Reading	860 - meter replaced in April 2019, hours before unknown.
Hour Meter Photo

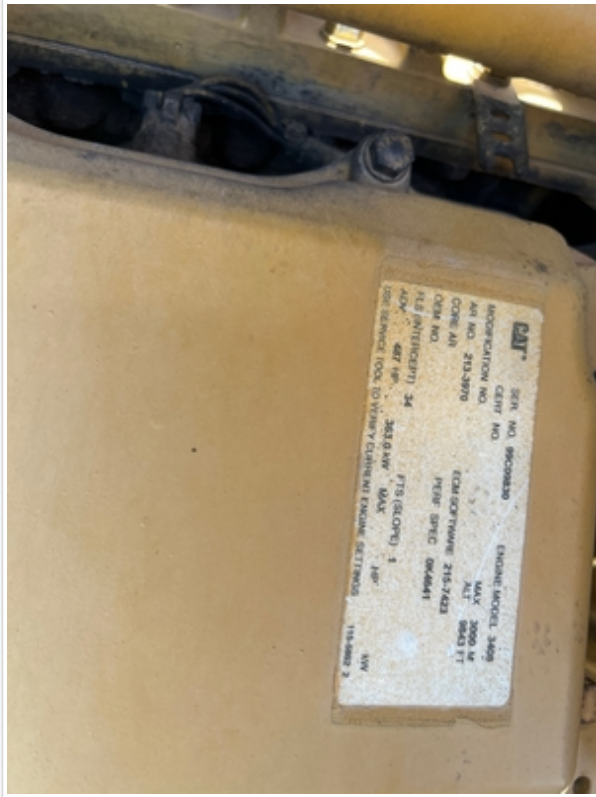
<p>Engine Data Plate</p>

Engine Type (Make, Model, Cylinders, Hp)	3408
Emissions Tier	Tier 0
Engine Fuel Type	Diesel
Blow-by (Visual Observation Check)	No
Unusual Noises (Upon Start-up, Idle, Shutdown)	No
Engine Smoke (Upon Start-up, Idle, Shutdown)	No
Engine Exhaust Color	Clear at operating temperature
Battery	3 - Normal Wear & Tear
Radiator	3 - Normal Wear & Tear
Hoses	3 - Normal Wear & Tear
Water Pump	3 - Normal Wear & Tear
Cooling System Leaks	No
Coolant Appearance	3 - Normal Wear & Tear
Oil Leaks	Yes
Oil Appearance	3 - Normal Wear & Tear
Fuel Leaks	No
Equipped with DPF (Diesel Particulate Filter)	No
Requires DEF (Diesel Exhaust Fluid)	No
Overall Engine Rating	3 - Normal Wear & Tear
Overall Engine Appearance	Areas of dried seepage seen on engine hoses & components, Dusty & dry
Overall Engine Comments	Good
