## Inspection Report (Skid Steer/Track Loader)

| Year | 2021 |
| Make | Bobcat |
| Model | T770 |

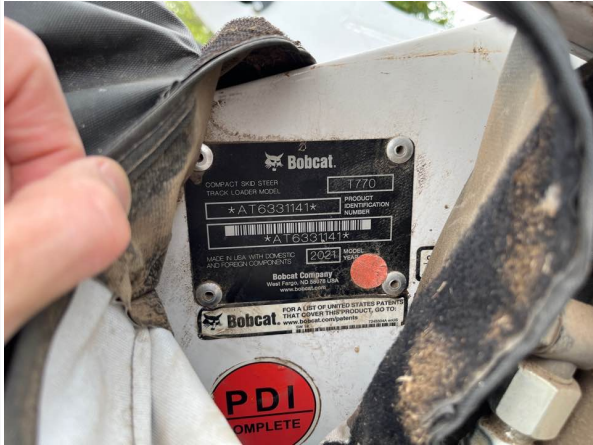
| Serial Plate Photo | |

| Serial Number | AT6331141 |

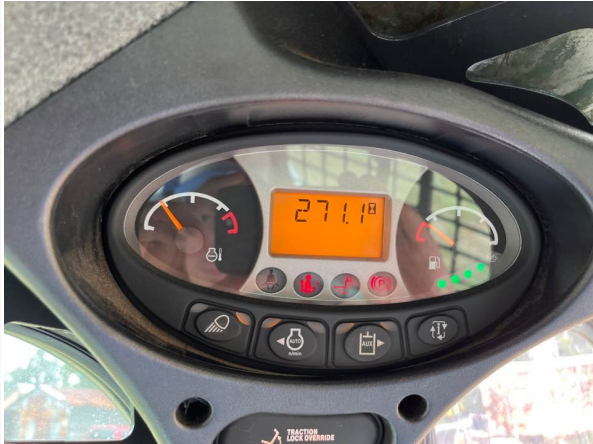
| Hour Meter Photo | |

| Hour Meter Reading | 271 |

| Hour Meter Condition | Hour meter is functional and in good condition |

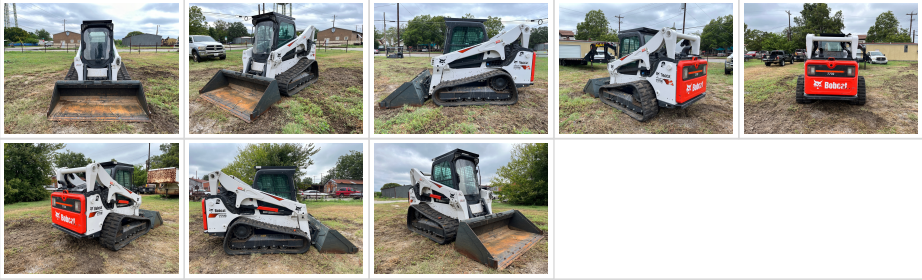
| Exterior Walkaround Photos | |

| Inspection Rating Criteria | Rating | Explanation |
|---|---|---|
| <b>Body Panels</b> | 4 - Expected Wear - Fully Operable | |
| <b>Body Panel Condition</b> | Good paint condition and panel fitment, Expected chipped paint or dents for its age. | |
| <b>Overall Exterior</b> | 5 - Very Light or Minimal Wear | |

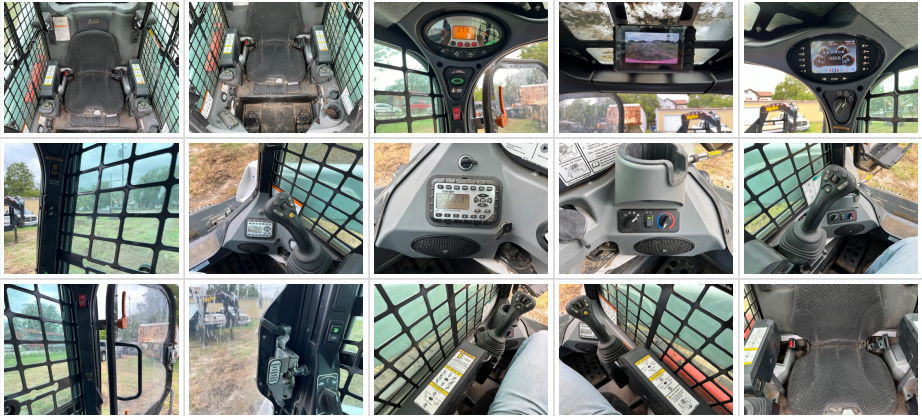
| <b>Control Station Photos</b> | | | | | |

| <b>Control Station Type</b> | Enclosed Cab (EROPS) | | | | |
| <b>Control Type</b> | Pilot Controls | | | | |

| Control Station Overall Rating | 5 - Very Light or Minimal Wear |

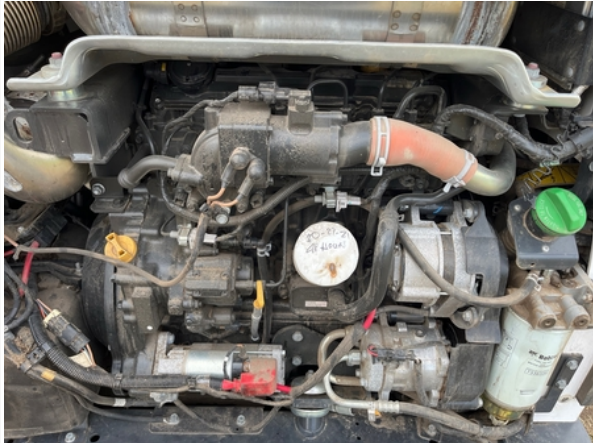
| Engine Data Plate | | | | | |

| Overall Engine Rating | 4 - Expected Wear - Fully Operable |

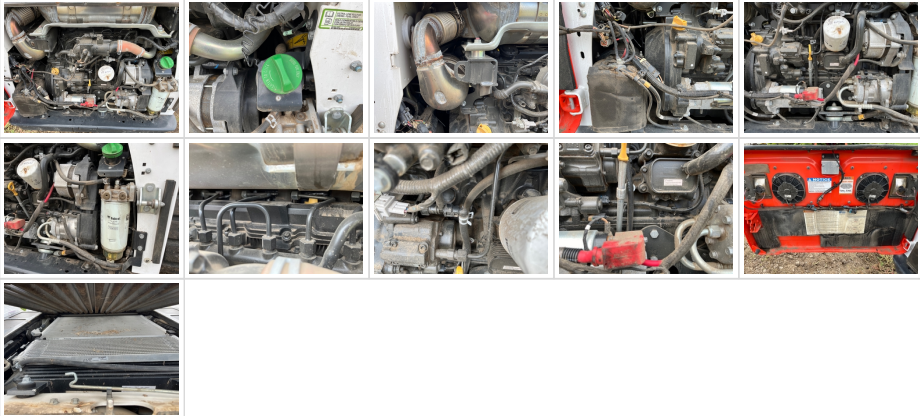
| Engine Compartment Photos | | | | | |

| Overall Engine Appearance | Clean & dry |
| Overall Engine Comments | Low hour machine and the engine reflects that. Seems to be in great shape with no apparent audible or visual issues. |

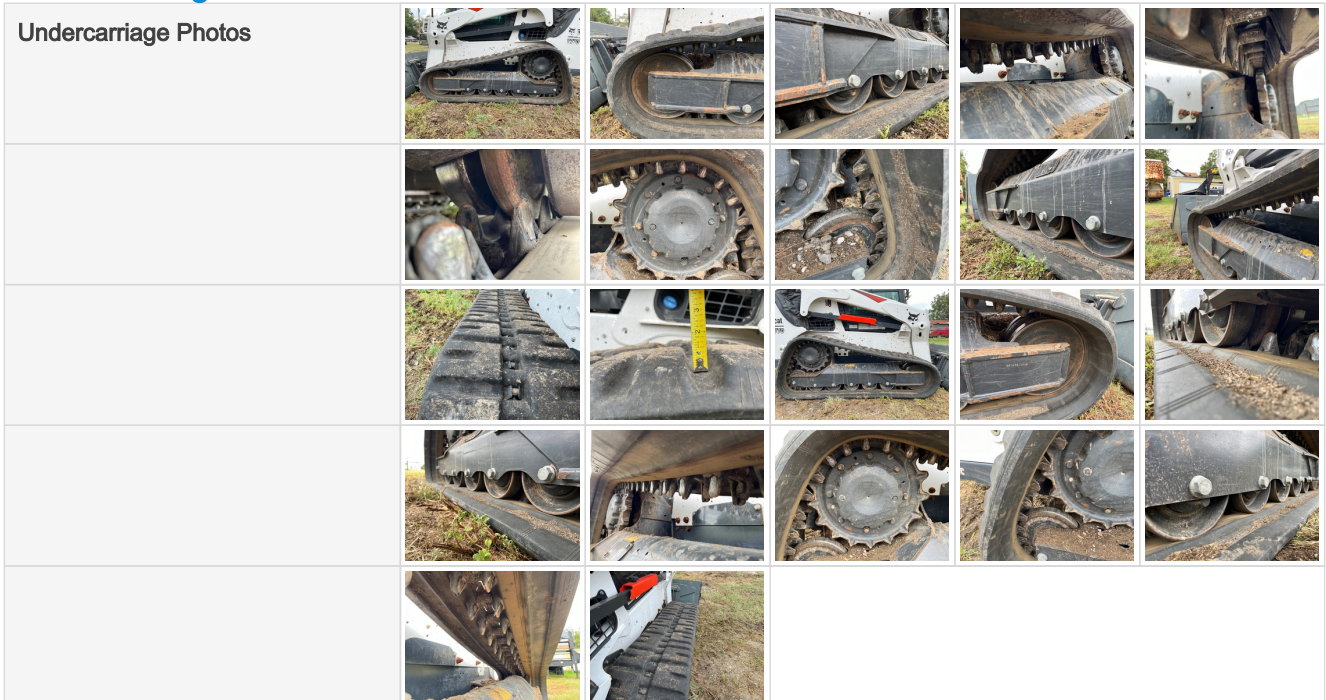
#### Undercarriage Photos

| Overall Undercarriage Rating | 4 - Expected Wear - Fully Operable |
| Left Track Belt - Percent Remaining Estimate | 70% |

| Right Track Belt - Percent Remaining Estimate | 70% |
| Overall Comments | Tracks appear lightly used and system is in good shape. |

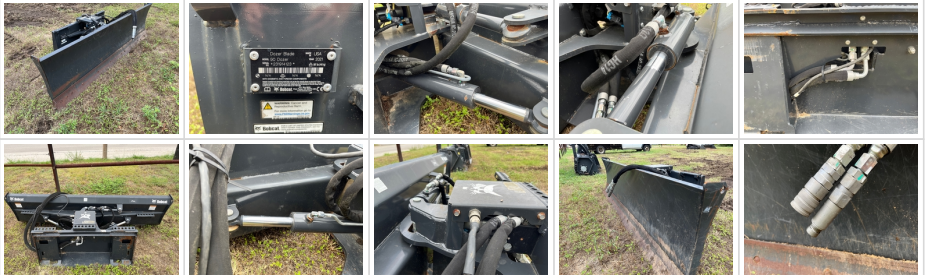
| Attachment Photos | |

| Attachment Type | Dozer blade |
| Attachment Size / Specs | 90" wide m, 24in tall |
| Attachment Condition | 5 - Very Light or Minimal Wear |

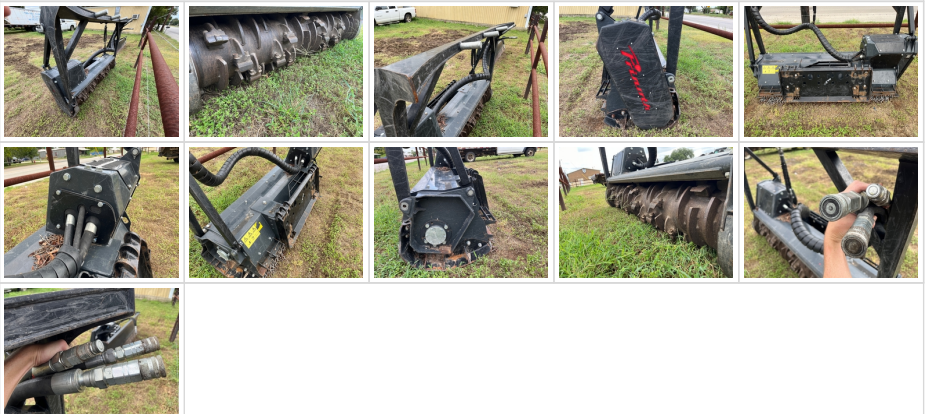
| Attachment Photos | |

| Attachment Type | Mulcher |
| Attachment Condition | 4 - Expected Wear - Fully Operable |
| Comments | One of the quick attach couplers is dented. Fully functions but doesn't connect smoothly. Easy replacement Sold separately and not included in the advertised price. Contact Boom & Bucketsales for pricing |
