Seller Onboarded Machine v2.0

| B&B Stock Number | A1289679 |
| Category | Forklift |
| Model | AH40 |

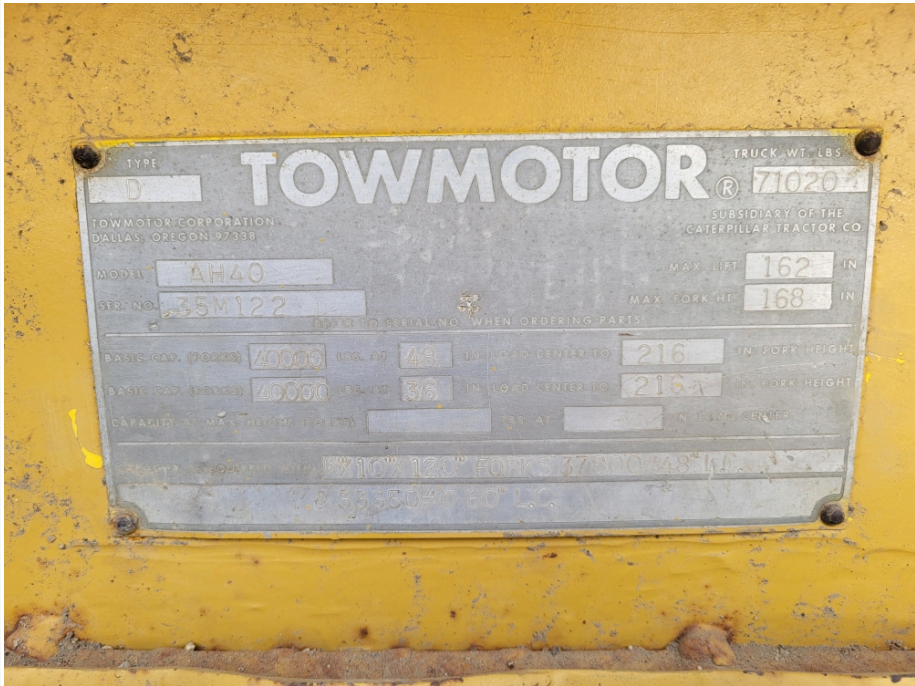
| Serial Number Plate / VIN Sticker | |

| Serial Number / VIN | 35M122 |

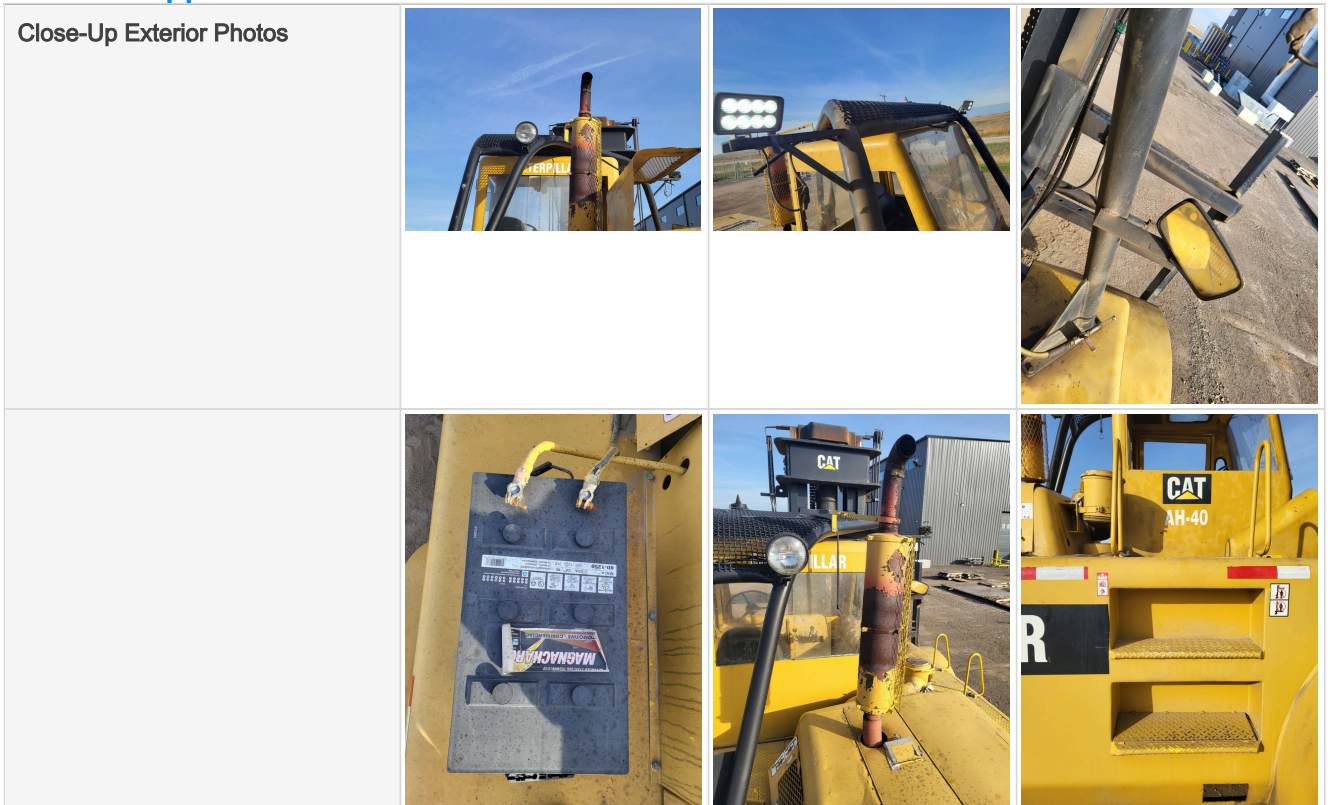
Close-Up Exterior Photos

| Exterior Comments | Exterior is in good overall condition with wear and tear as expected for the age of the unit. All the doors and panels work as required. Driver side window is missing the glass/plexiglass. | | |

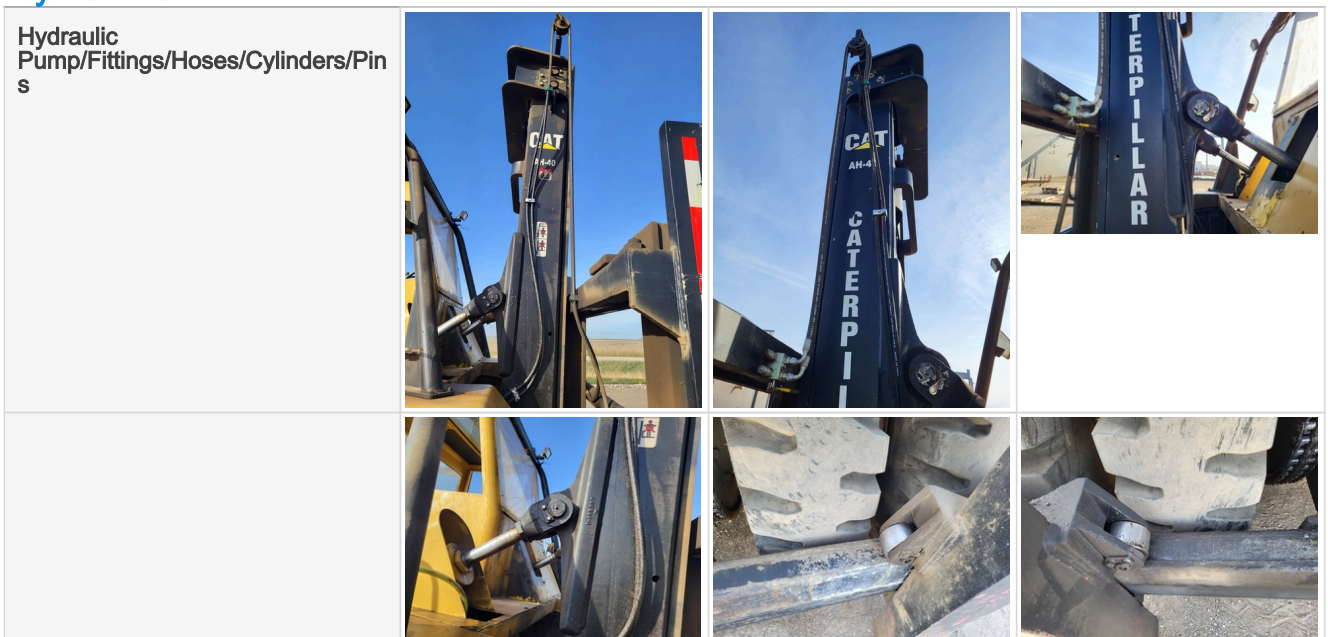
Hydraulic
Pump/Fittings/Hoses/Cylinders/Pin
s

| Hydraulic System Comments | Hoses on mast leak for side shift, due to cold temperature caused them to Crack. Main lift cylinder rebuilt. | |

| What needs work | Side shift hoses on the mast leak, hard to start in extreme cold temperatures, block heater has a short in it, windows in the cab needs some work, small fuel tank and hard on gas. |

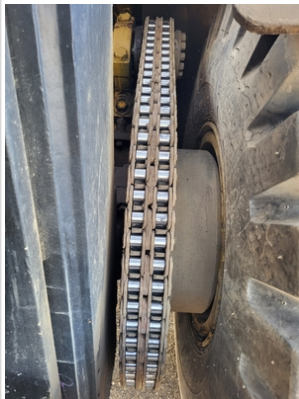
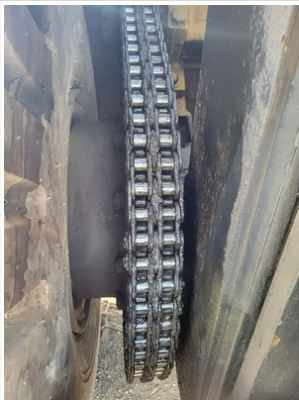
| Chassis Photos | | | |

| Comments | No apparent issues, the entire front frame is free of any cracks. | | |
