Inspection Report (Excavator)

B&B Stock Number	A1442432
Year	2021
Make	Sany
Model	SY365C LC
Serial Number	SY036MCA00388
Serial Plate Photo

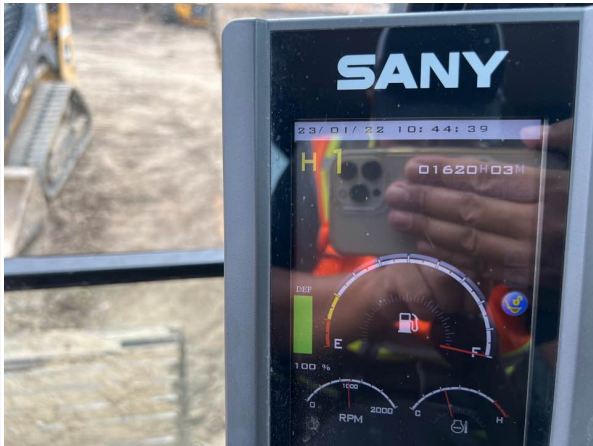
Hour Meter Reading	2337 (April 2025)
Hour Meter Photo

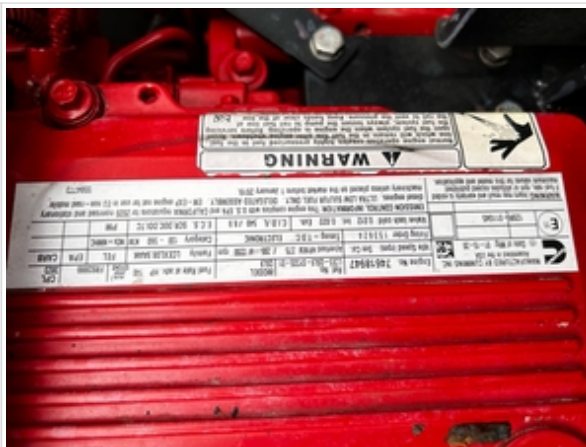
Engine Data Plate

Engine Type (Make, Model, Cylinders, Hp)	Cummins, QSL9
Emissions Tier	Tier 4F
Engine Serial Number	74618947
Engine Fuel Type	Diesel
Blow-by (Visual Observation Check)	No
Unusual Noises (Upon Start-up, Idle, Shutdown)	No
Engine Smoke (Upon Start-up, Idle, Shutdown)	No
Engine Exhaust Color	Clear
Battery	5 - Very Light or Minimal Wear
Radiator	5 - Very Light or Minimal Wear
Belts	4 - Expected Wear - Fully Operable
Hoses	5 - Very Light or Minimal Wear
Water Pump	5 - Very Light or Minimal Wear
Cooling System Leaks	No
Coolant Appearance	4 - Expected Wear - Fully Operable
Oil Leaks	No
Oil Appearance	4 - Expected Wear - Fully Operable
Fuel Leaks	No
Equipped with DPF (Diesel Particulate Filter)	Yes
DPF Condition	5 - Very Light or Minimal Wear
DPF Condition Notes	Filter housing is intact with no signs of damage or malfunction, DPF indicator is not illuminated
Requires DEF (Diesel Exhaust Fluid)	Yes

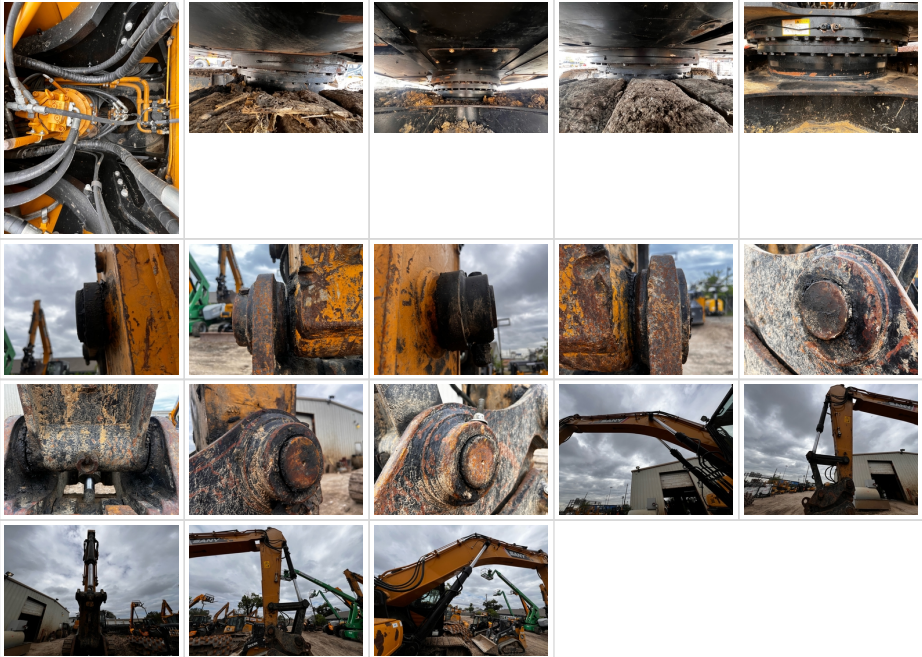
Chassis Photos

Boom Condition	5 - Very Light or Minimal Wear	
Stick Condition	5 - Very Light or Minimal Wear	
Boom Base Pin & Bushings	4 - Expected Wear - Fully Operable	
Boom to Stick Pin & Bushings	4 - Expected Wear - Fully Operable

Stick to Bucket Pin & Bushings	4 - Expected Wear - Fully Operable
Turntable Bearing	5 - Very Light or Minimal Wear
Bottom Covers	5 - Very Light or Minimal Wear
Overall Chassis	5 - Very Light or Minimal Wear
Overall Chassis Comments	Expected wear and tear for machines age no major issues to report

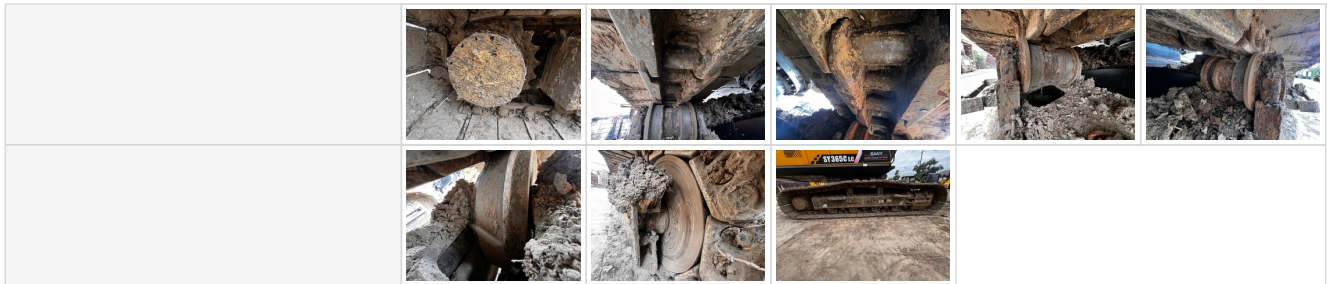
Undercarriage Photos

Sprocket Teeth	4 - Expected Wear - Fully Operable
Track Bushings	4 - Expected Wear - Fully Operable
Track Frames	4 - Expected Wear - Fully Operable
Pivot Shafts	N/A
Equalizer Bar & Joints	N/A
Front Idler	4 - Expected Wear - Fully Operable
Track Tensioner	4 - Expected Wear - Fully Operable
Track links	4 - Expected Wear - Fully Operable
Bottom Rollers	4 - Expected Wear - Fully Operable
Carrier Rollers	4 - Expected Wear - Fully Operable
Overall Undercarriage	4 - Expected Wear - Fully Operable
Overall Percent Estimate	70%
Overall Undercarriage Comments	Expected wear and tear due to age of machine no major issues to report
