# Inspection Report

**Property Address:**  
123 Pine Street  
Vancouver BC V3M6C5

**Fairbairn Inspection Services**

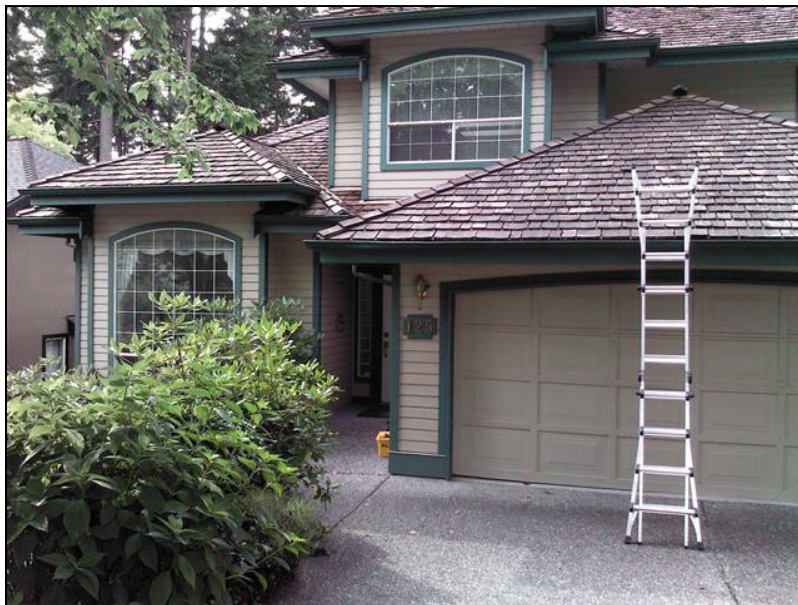
Exterior Front of Home

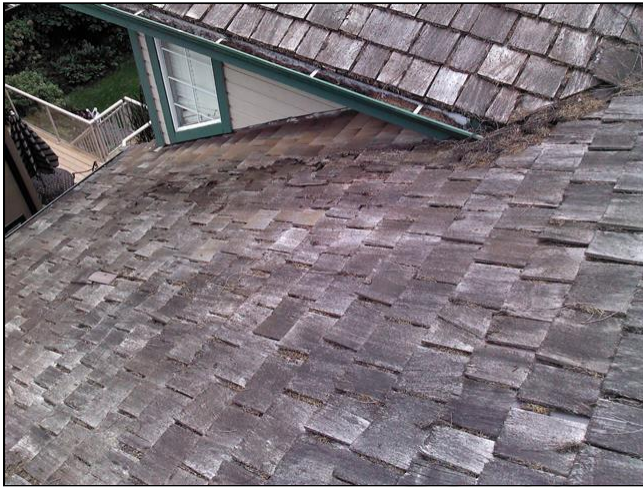
1.0 The cedar roof covering was deteriorated in multiple areas, with signs of prior repair. Many shingles were loose / split / cupping, and replacement of the entire roof covering may be required in the near future. Recommend further evaluation by a qualified roofing contractor.

Roof Covering

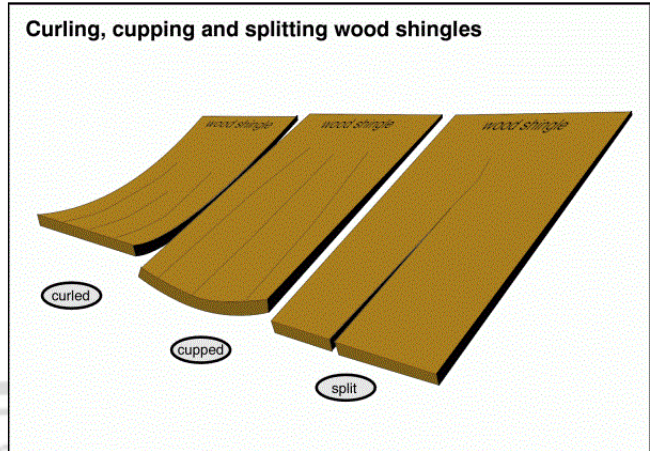
Cedar Diagram

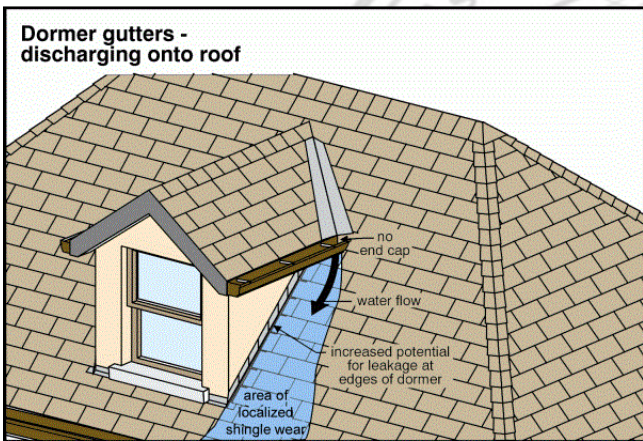
Drainage

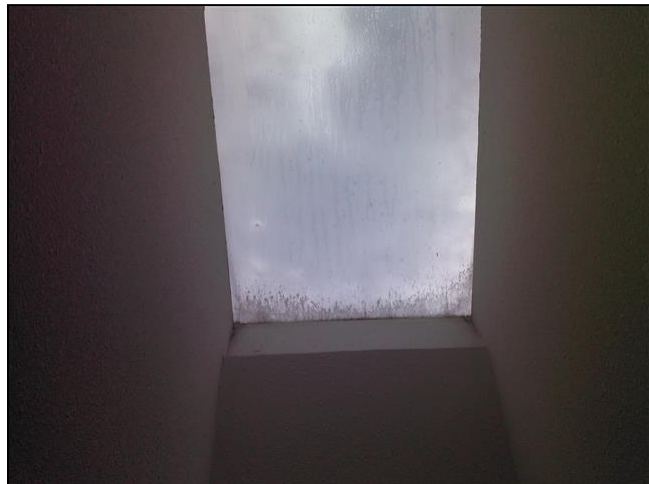
**1.2** Two skylight seals were broken, with visible moisture between the panes. Recommend replacement of the skylights.

Broken skylight seals

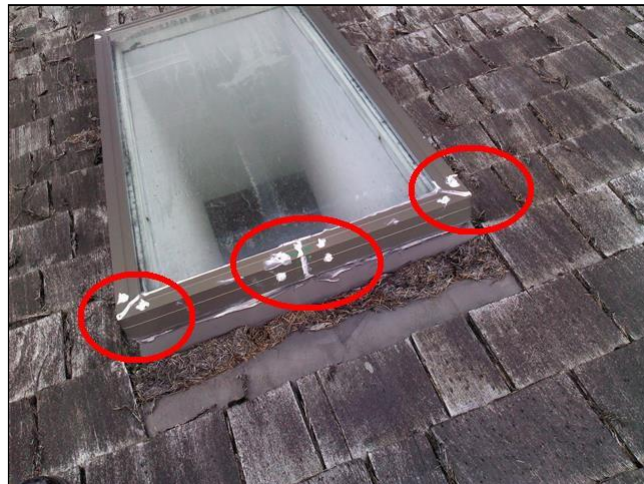
Caulking on roof

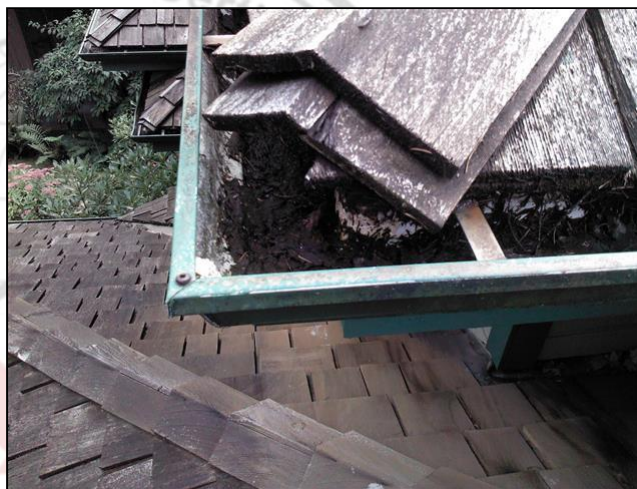
**1.3** The gutters are full of debris in areas and needs to be cleaned. The debris in gutters can also conceal rust, deterioration or leaks that are not visible until cleaned, and I am unable to determine if such conditions exist.

Gutters

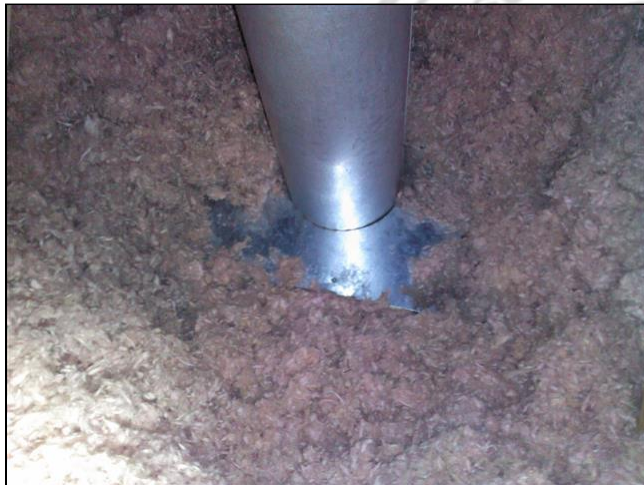
**2.2** The blown insulation should be moved away from the furnace flue to provide sufficient clearance.

Flue clearance

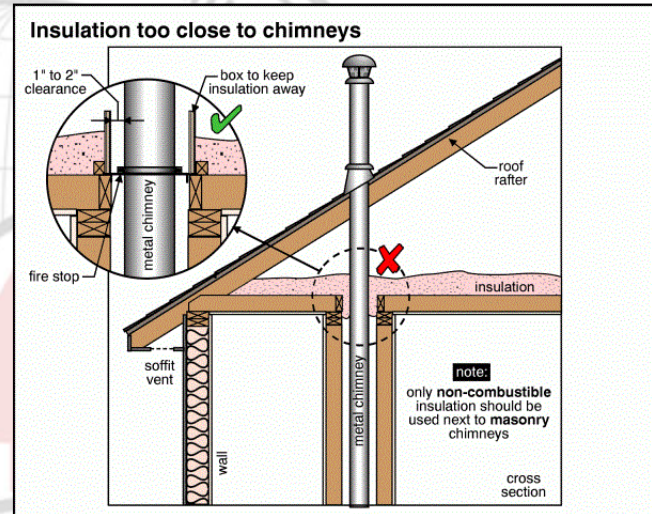
Diagram

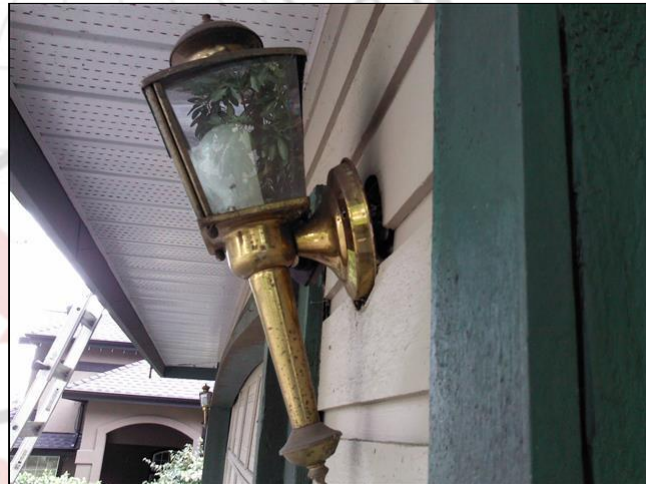
**3.0 (1)** Loose sconce lights at the front of the home - repair as needed.

Loose sconce

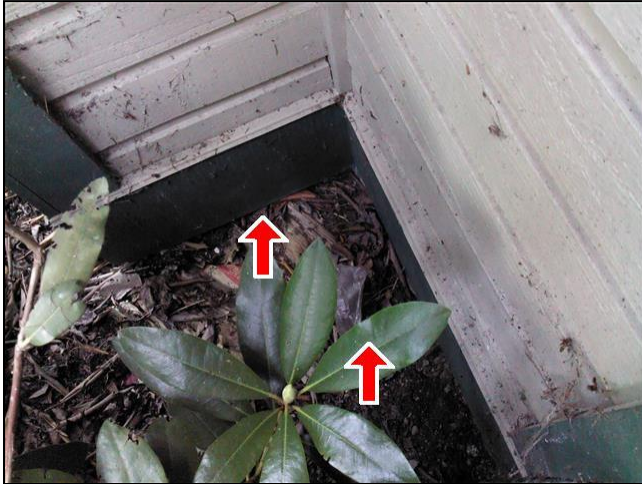
**3.0 (2)** Siding in contact with ground at front of home. Soil contact can cause deterioration of the wood trim. Recommend a ground clearance of six to eight inches where possible.

Soil clearance

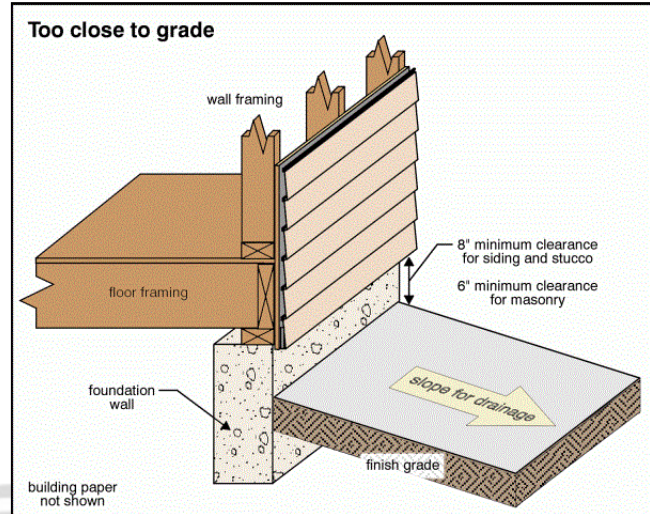
Grading diagram

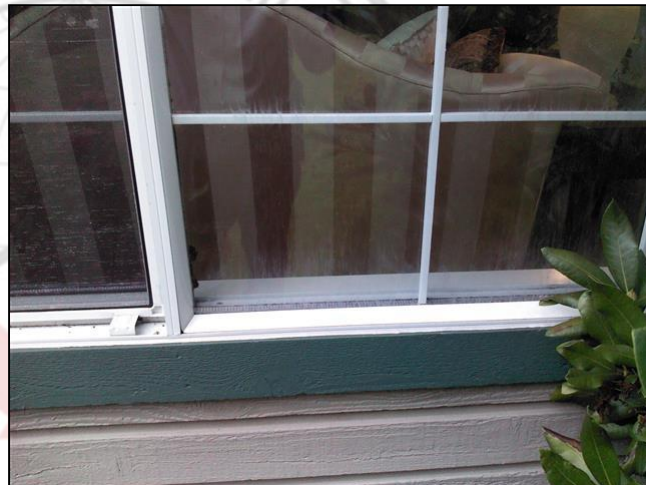
**3.2** The front living room window had a failed seal and should be replaced. The other windows in the home should also be tested by a qualified window contractor.

Front window

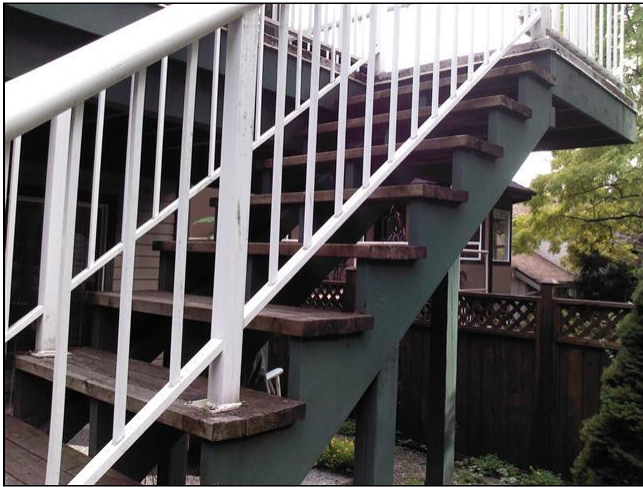
**3.3** Several framing members at the rear stairs were deteriorated / rotted, and should be replaced. The handrail at the top of the stairs was loose and should be re-secured. All work should be performed by a qualified general contractor.

Rear stairs

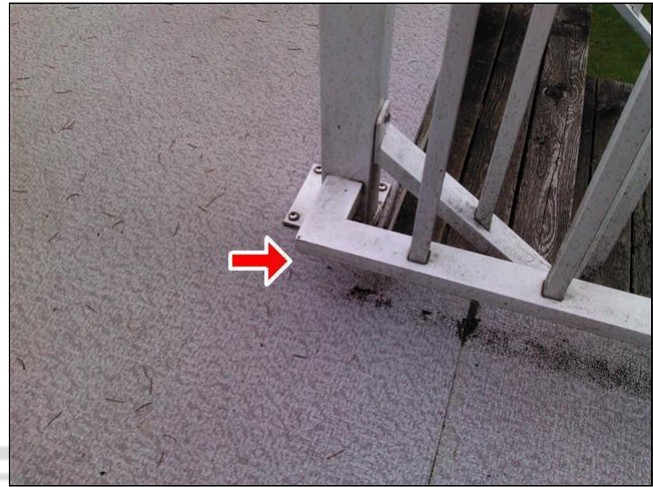
Handrails loose

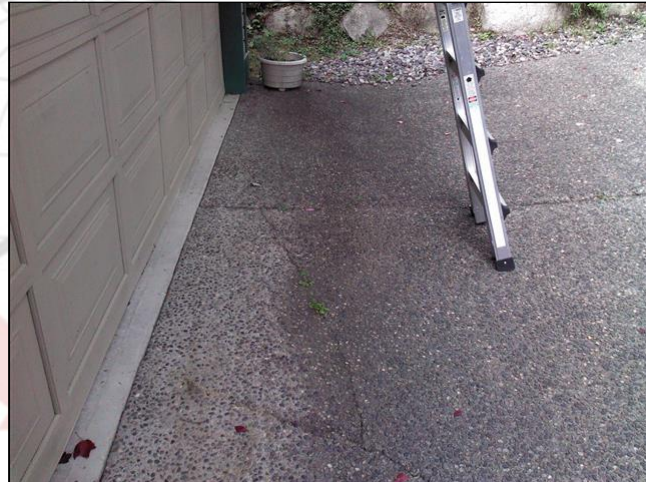
**3.4** The driveway sloped slightly toward the garage. Water may enter under the garage door during periods of heavy rain.

Garage door

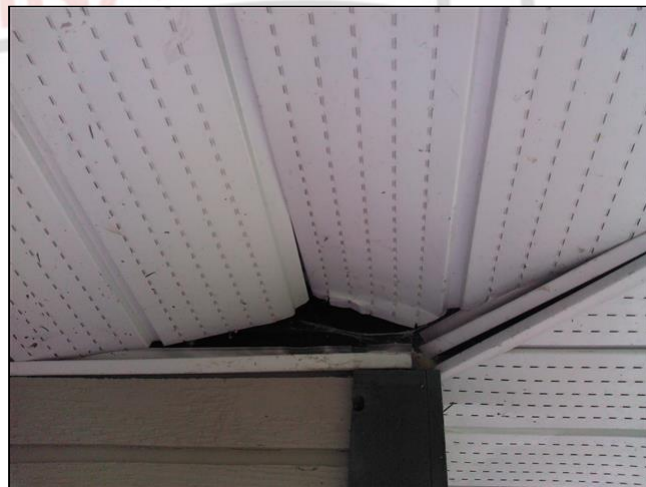
**3.5** Damage soffit at the front of the home - repair required

Soffit

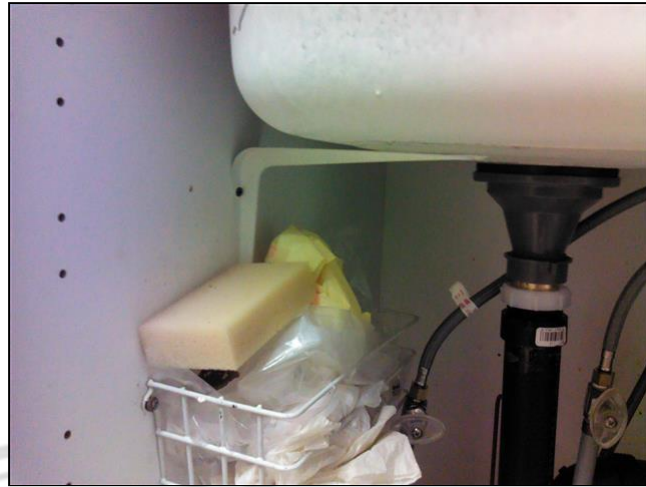
**4.6 (1)** The kitchen sink supports were improper and a steel strapping should be installed for safety.

Sink supports

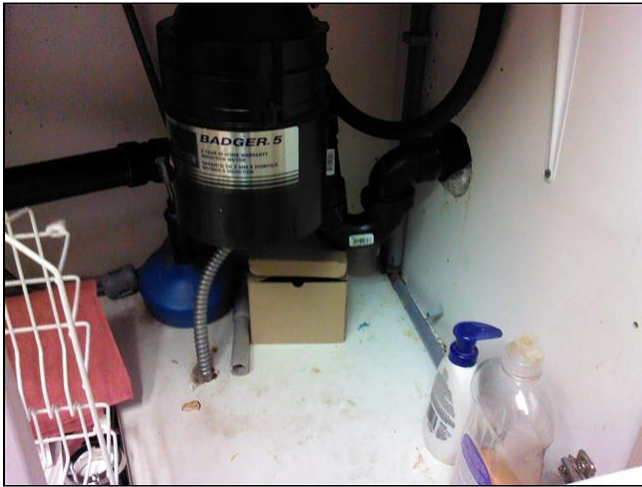
4.6 (2) One or more sink waste lines were double-trapped. Installing a second trap is a poor practice and can lead to drainage / siphoning problems. In addition the slope of the drain was poor and may lead to drainage issues. A plumber should evaluate and repair.

Double Trap

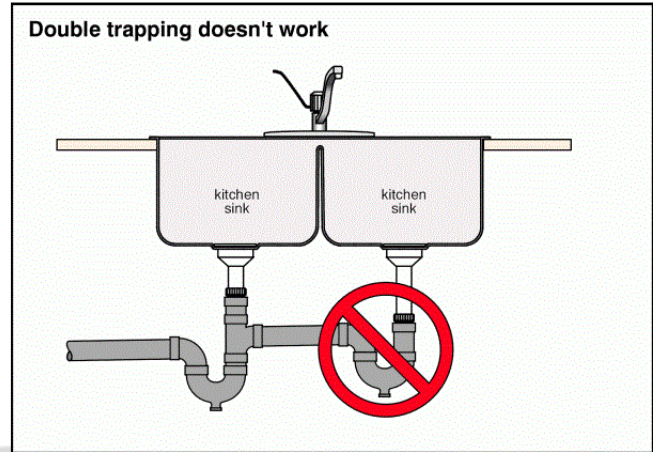
Double trap diagram

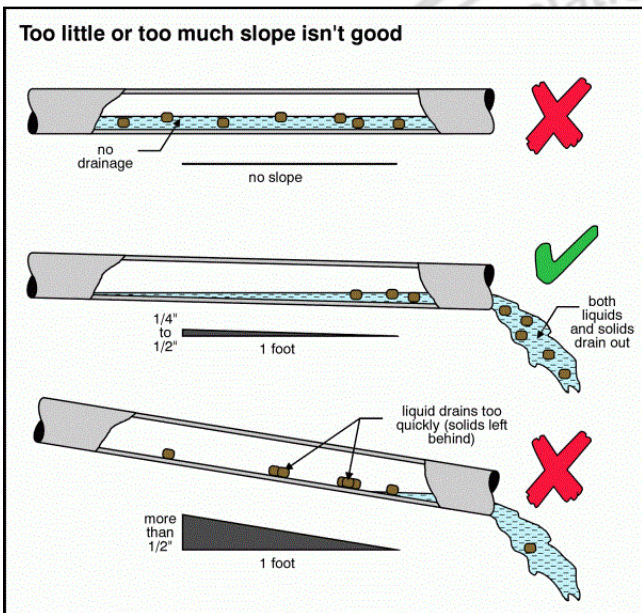
Slope diagram

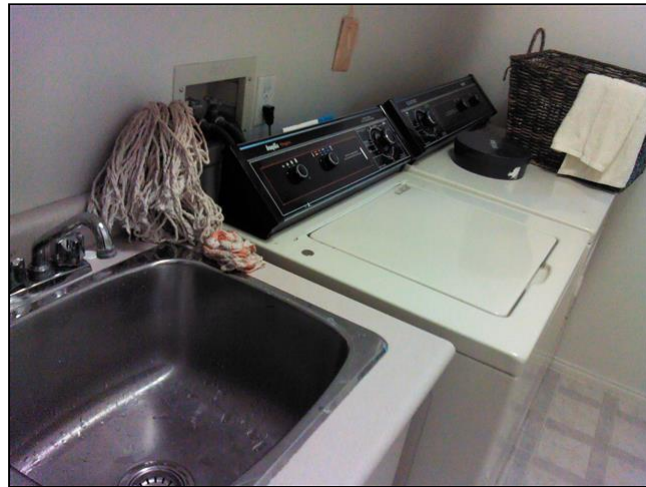
**4.15** The dryer vent was not connected in the laundry room - moisture damage will occur if dryer is run. It should be re-attached, and the vent cleaned out.

Dryer vent disconnected

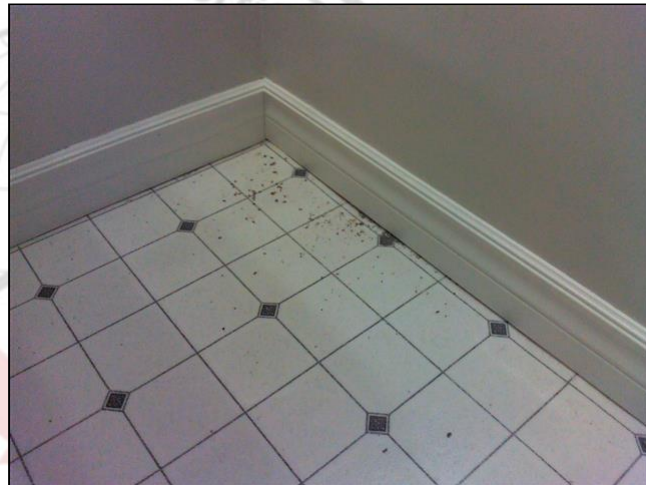
**5.1 (1)** Ant activity was noted in the basement. A pest control company should be called for further evaluation.

Ants

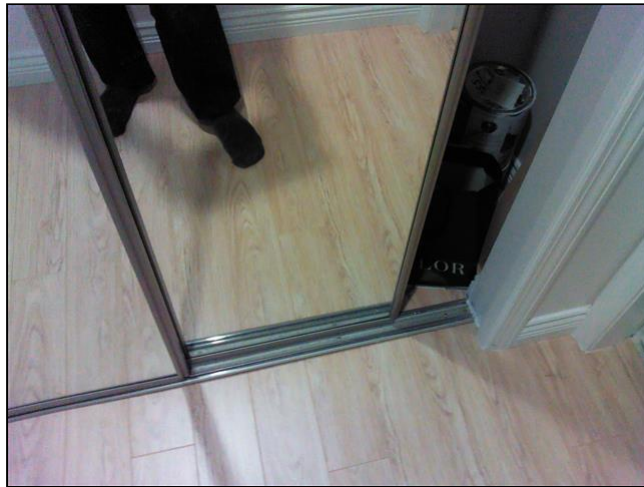
**5.4** The closet sliding door on the main floor was broken. Repair/replace as needed.

Closet Door

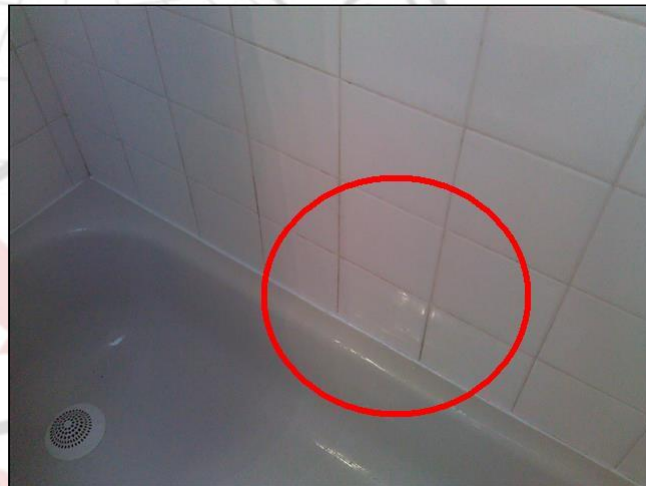
**6.3** Possible moisture was detected at the centre of the upstairs main shower. Grout cracking/pitting was noted in this area and it should be repaired.

Upstairs main shower

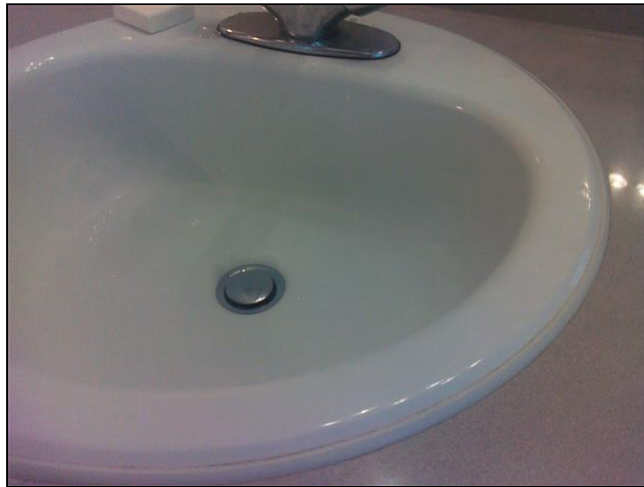
**6.5** The left ensuite sink drained very slowly and was likely plugged. A plumber should be called to clean/repair.

Ensuite sink plugged

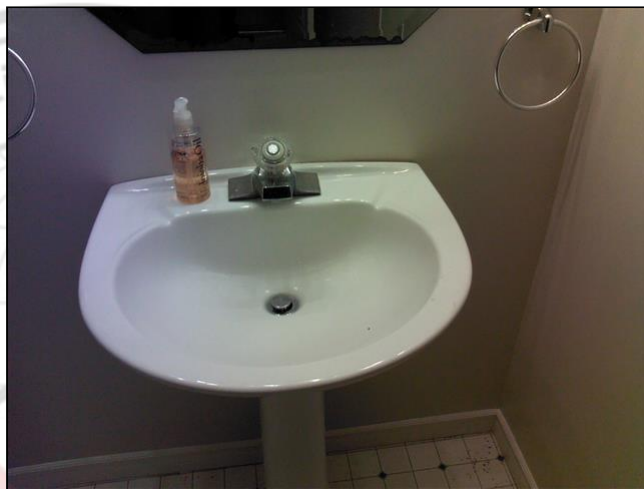
**6.6** The basement sink was loose and the stopper did not operate when tested. A plumber/contractor should be called for repair.

Loose sink

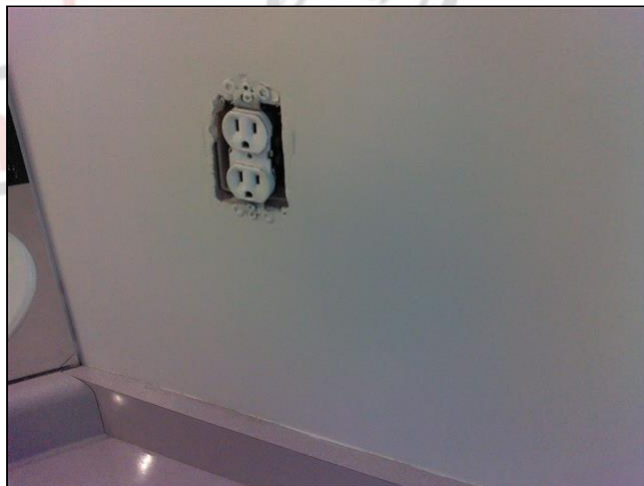
**6.7** One outlet at the ensuite was uncovered and poses a safety hazard. It should be replaced.

Missing outlet cover

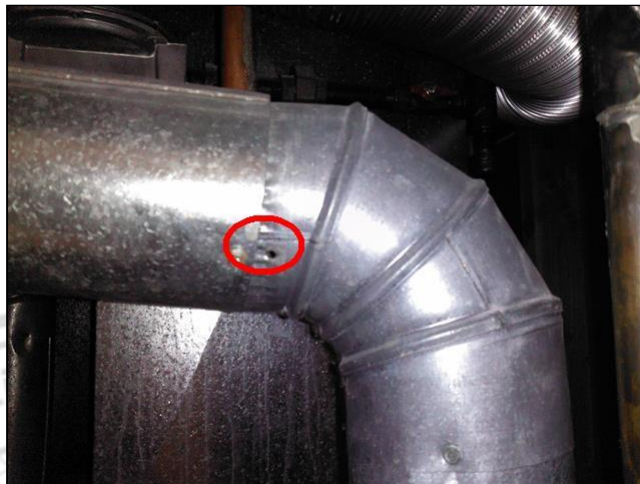
**7.1 (1)** The hot water tank flue had gaps which may allow combustion gasses to enter the home. The duct should be professionally repaired.

Flue holes

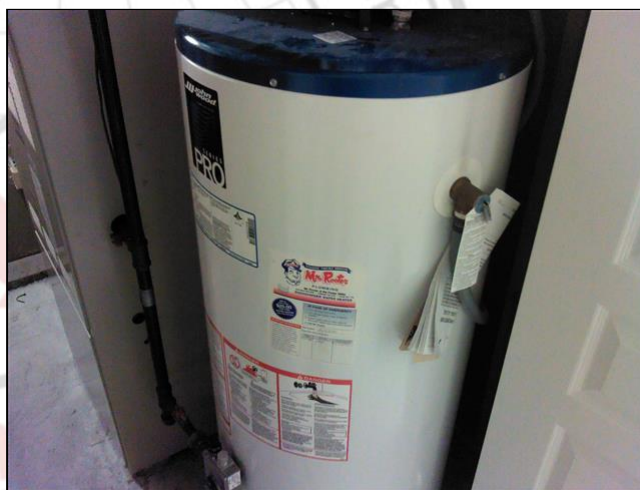
**7.1 (2)** The hot water tank had reached its expected life and should be replaced soon. A plumber should be called for a quotation on installation.

Hot water tank age

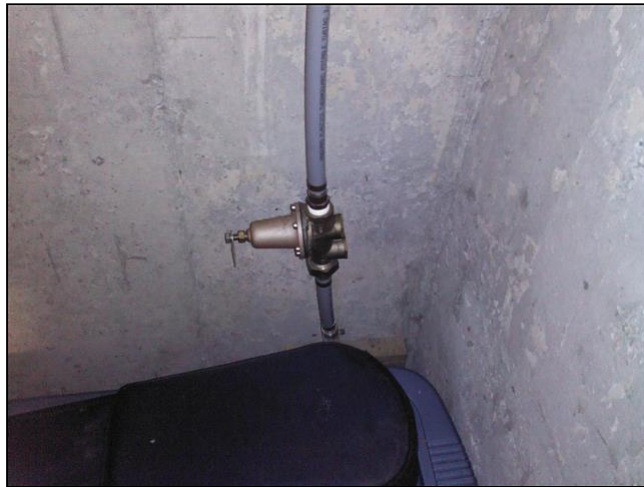
7.2 The main water shut-off valve was located in the basement..

Water shut-off

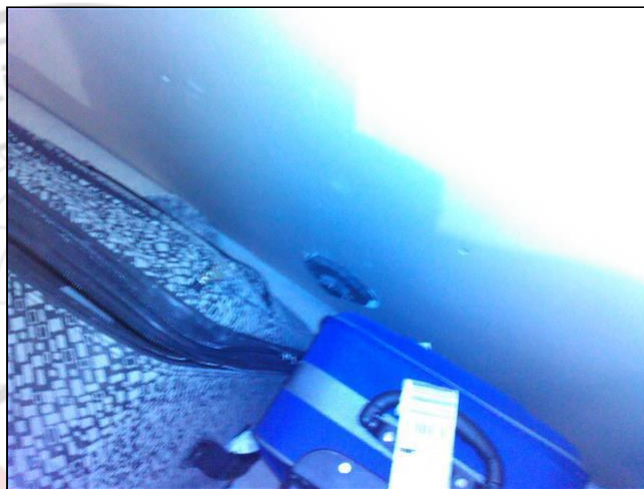
7.4 The main drain clean-out was located in the basement.

Drain clean-out

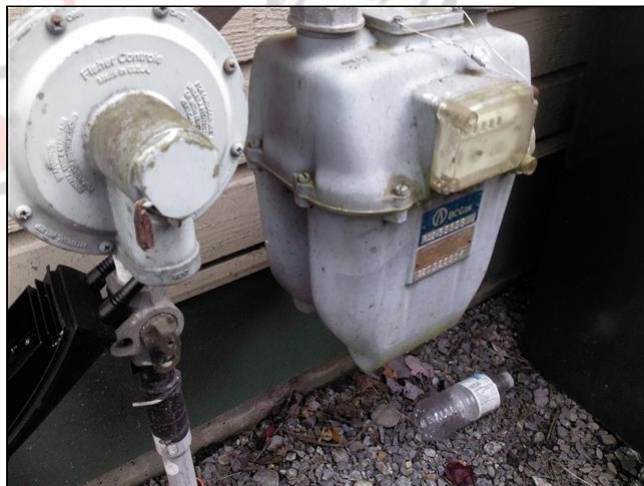
7.5 The main gas shut-off was located at the gas meter at the side of the home.

Gas meter

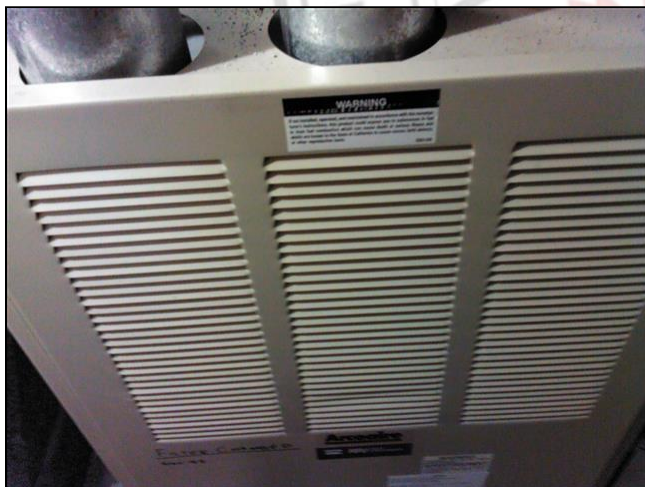
**8.0** The heating unit does not appear to have been serviced within the last 12 months. A heating system requires ongoing maintenance to ensure top performance and safety. In this case, the furnace burners did not appear to be burning "clean" and combustion was poor. The heating system should be serviced by a qualified heating contractor soon, and then every three months following.

Service furnace

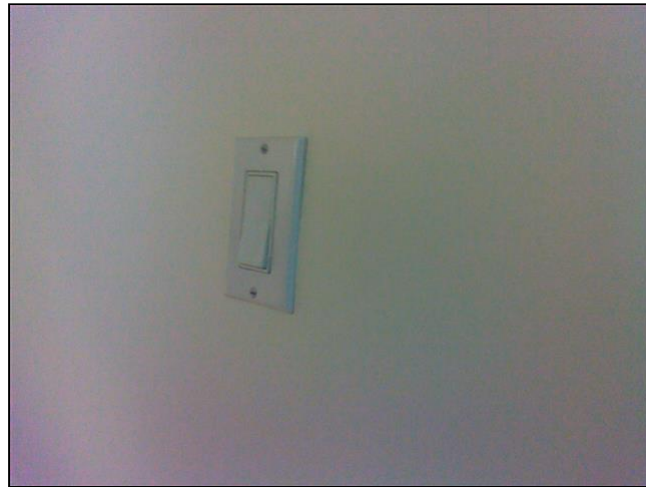
**8.6** The living room fireplace did not properly operate with the wall switch. Suspect faulty wall switch or bad thermocouple. A fireplace contractor should evaluate and repair.

Fireplace switch
