MARYLAND TRANSIT ADMINISTRATION

Light Rail Facilities Maintenance

# CONCRETE REPAIRS

## BEFORE DOCUMENTATION

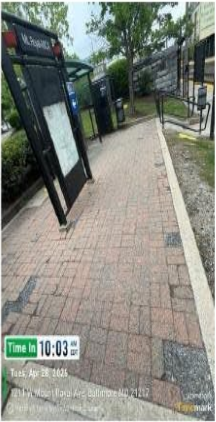
BEFORE — FIELD PHOTOS (Timemark Verified, April 28, 2026)

- Brick paver cracking & settlement
- Concrete platform surface cracks
- Platform edge deterioration
- Vegetation infiltration at joints

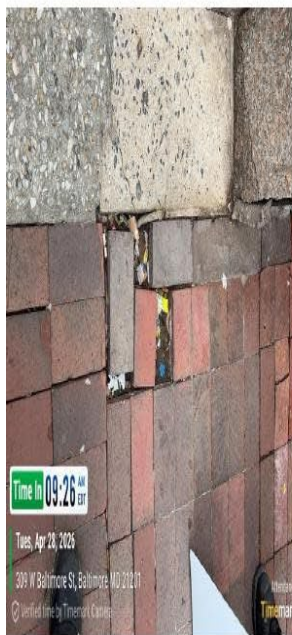
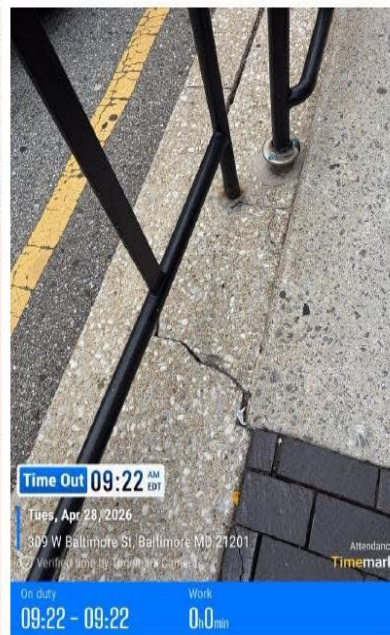
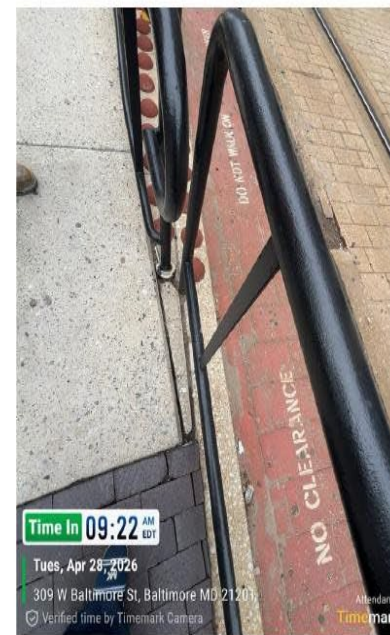
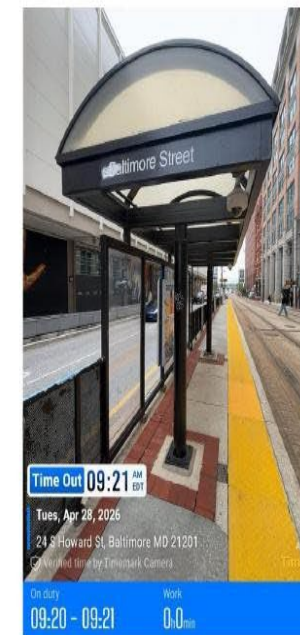
BEFORE — FIELD PHOTOS (Timemark Verified, April 28, 2026)

- Concrete platform cracking
- "No Clearance" zone surface damage
- Brick paver displacement
- Platform edge joint failure

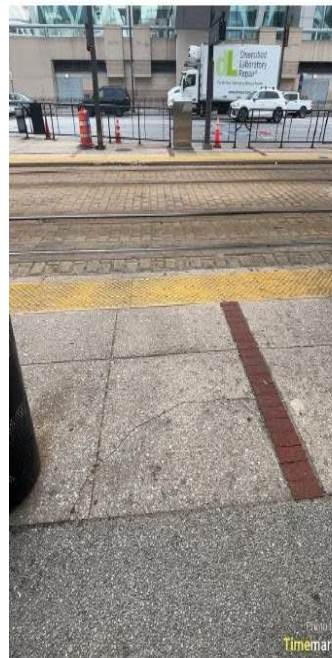
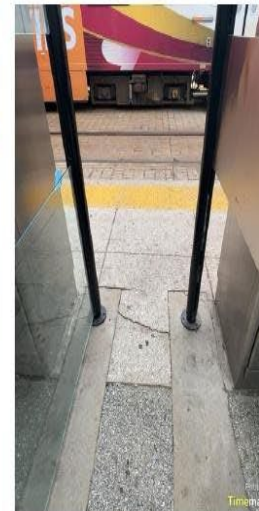
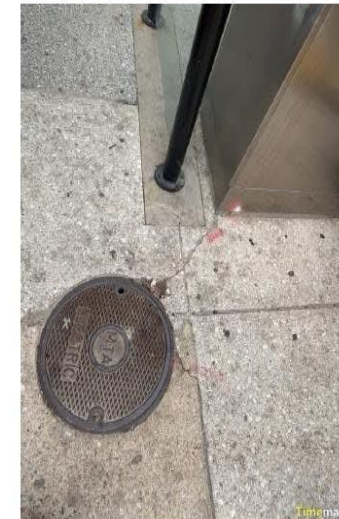
BEFORE — FIELD PHOTOS (Timemark Verified, April 28, 2026)

- Platform concrete surface cracking
- ADA detectable warning panel gaps
- Brick paver deterioration
- Concrete joint separation

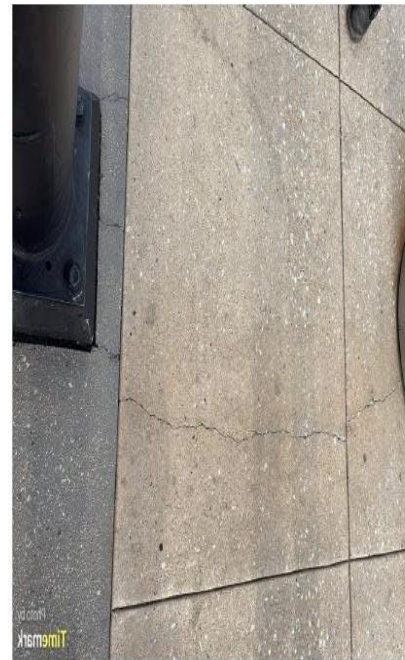
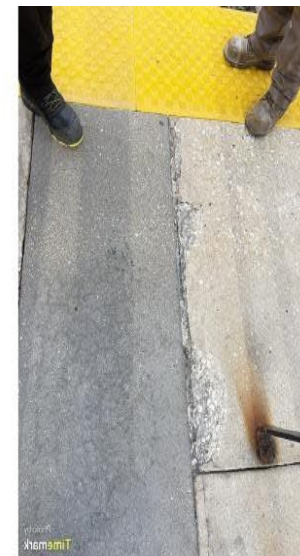
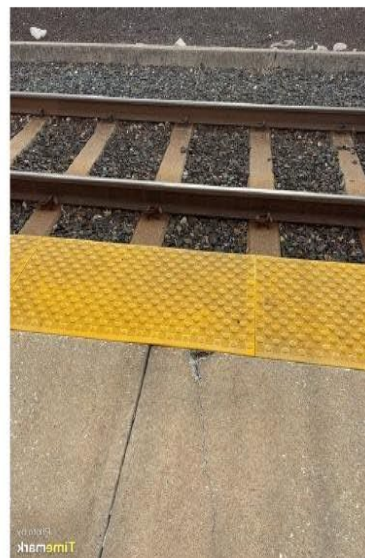
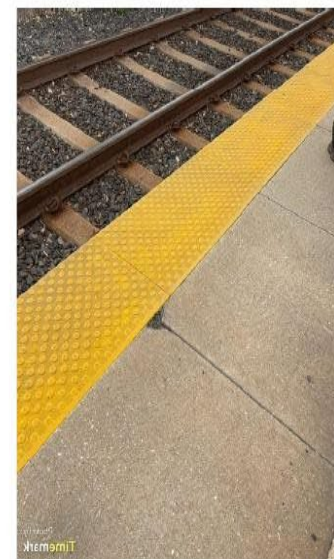
BEFORE — FIELD PHOTOS (Timemark Verified, April 28, 2026)

- Platform slab cracking
- ADA pad edge separation
- Concrete spalling at platform edge
- Surface joint failure throughout

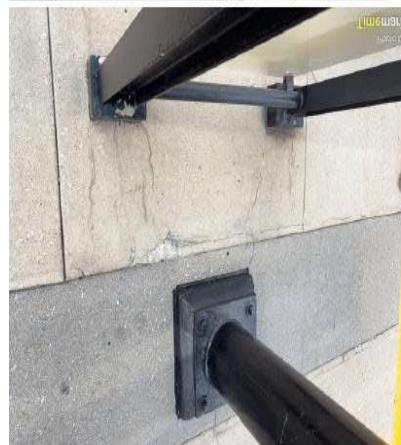
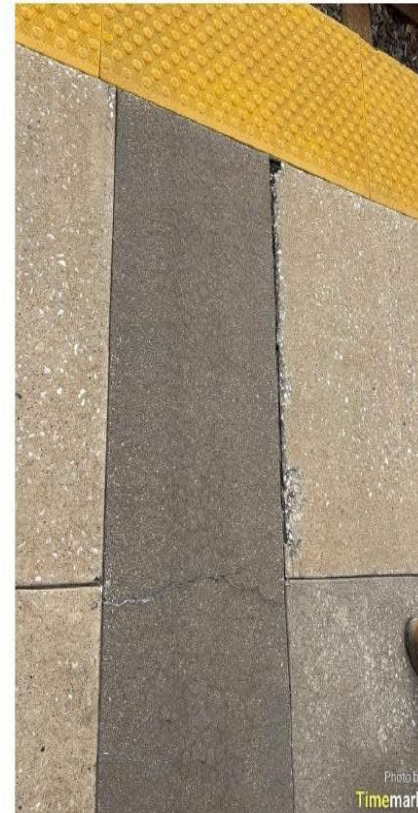
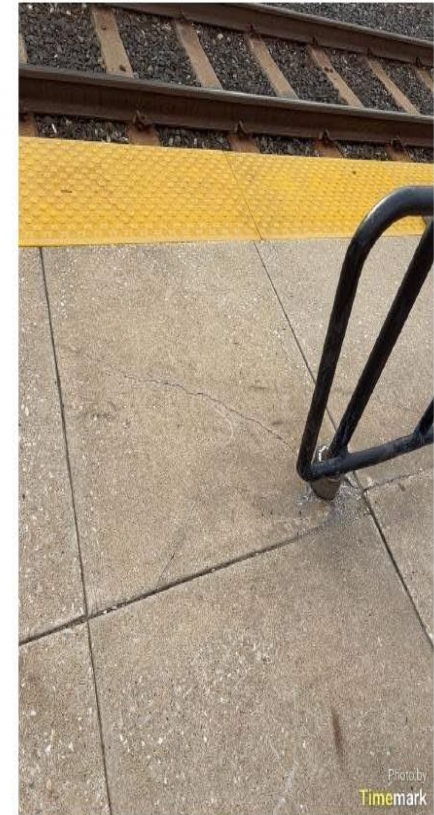
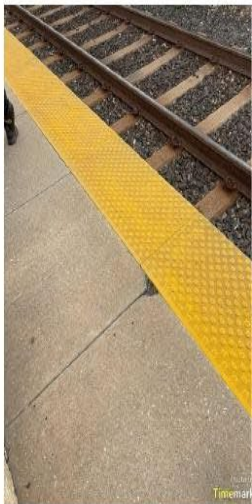
BEFORE — FIELD PHOTOS (Timemark Verified, April 28, 2026)

- Concrete slab cracking
- Platform edge deterioration
- Surface rust staining — structural concern
- ADA panel gaps & edge separation

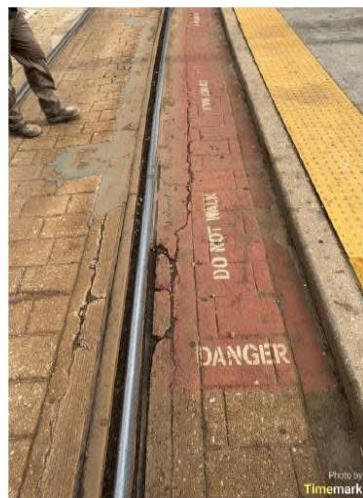
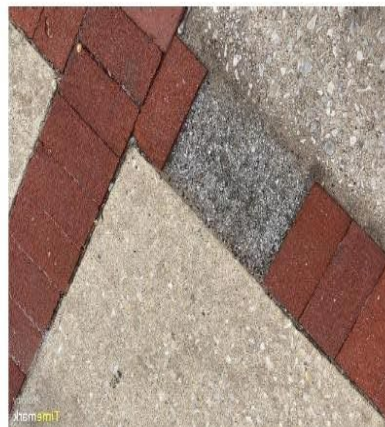
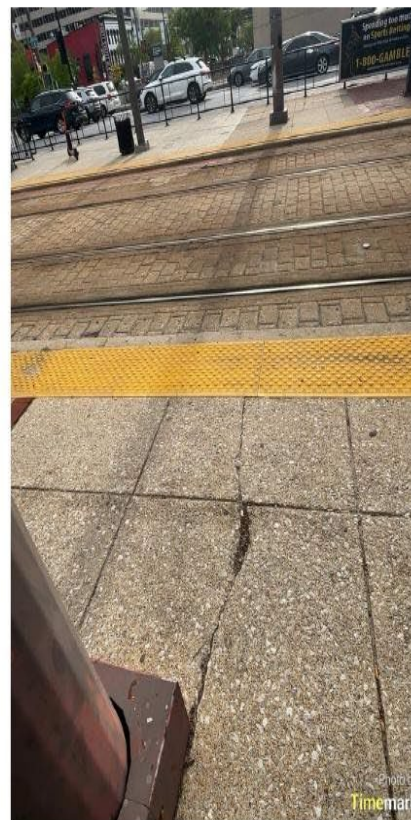
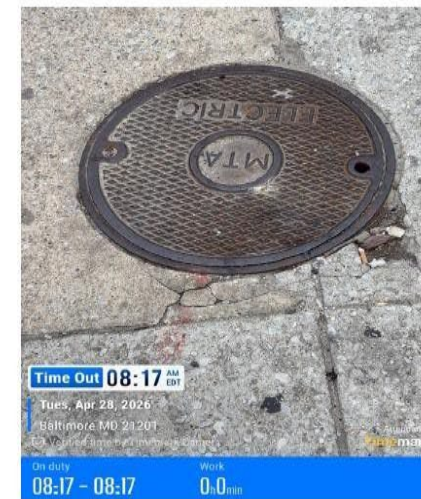
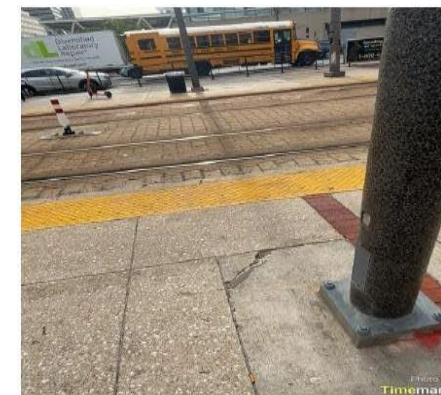
BEFORE — FIELD PHOTOS (Timemark Verified, April 28, 2026)

- Brick paver cracking & displacement
- MTA utility cover surround damage
- Platform concrete surface cracking
- Joint sealant failure throughout
