# HAWKEYE HOME INSPECTIONS

## HOME INSPECTION REPORT

2423 Edmondson Ave  
Baltimore, MD 21223

03/31/2026

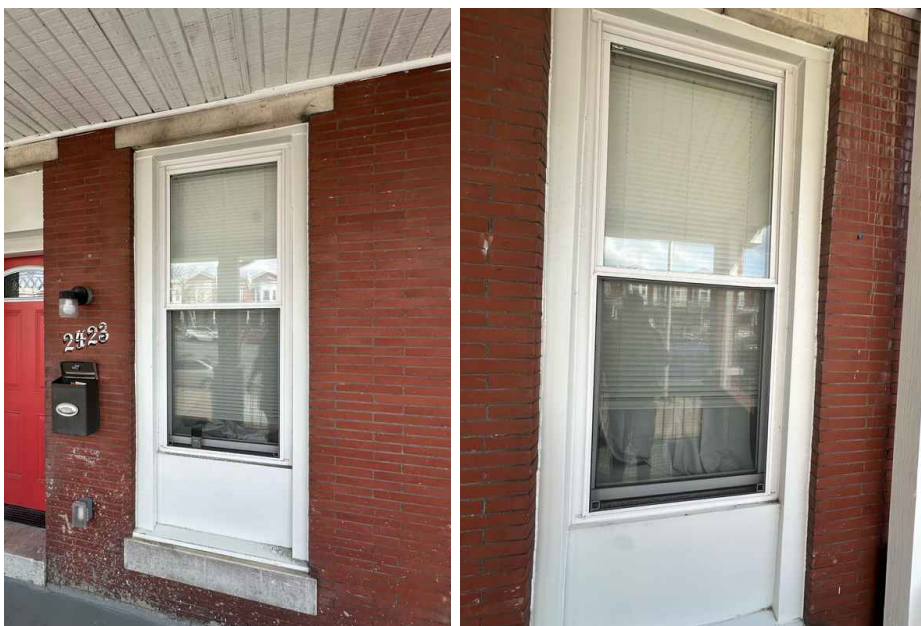
## Windows: Windows Inspected

A representative number of windows from the ground surface was inspected.

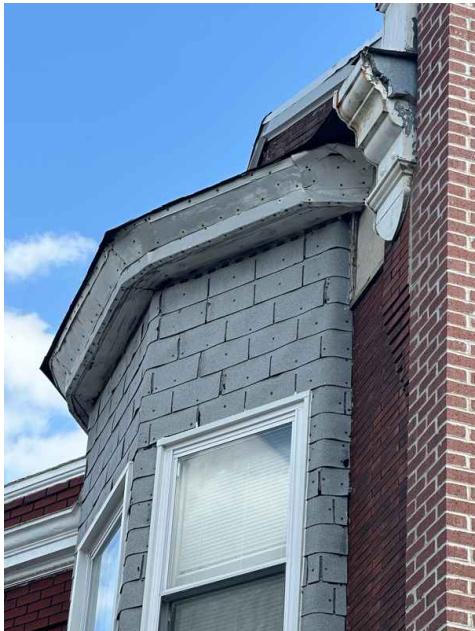
#### **MISSING FLASHING**

I observed areas where flashing was missing. Not installed. Improper installation of flashing. These areas of missing flashing are prone to water penetration. Flashing is installed to provide protection against roof leaks and to divert water away from certain areas. Correction and further evaluation is recommended.

Contact a qualified roofing professional.

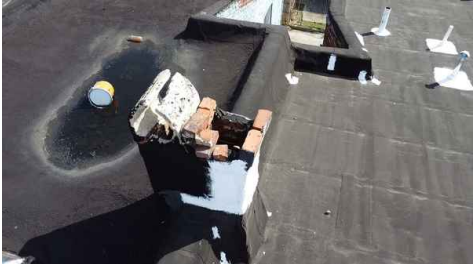
**CROWNED CAP WAS DAMAGED**

I observed indications of damage at the chimney wash or crowned cap. This is the top of the chimney that is shaped or "crowned" to divert water away from the top of the chimney stack.

If a wash or crown on top of the chimney is not properly sloped or is extensively cracked, defective, spalled, or displays rust stains, it should be replaced. Sheet metal caps/crowns with minor rust or corrosion should be repaired, but if rust or corrosion is extensive, replacement is recommended.

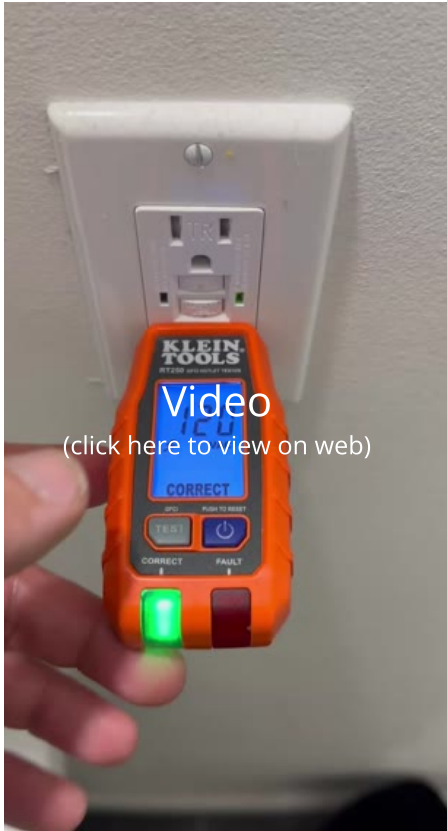
I inspected the GFCI-protection at the receptacle near the bathroom sink by pushing the test button at the GFCI device or using a GFCI testing instrument.

All receptacles in the bathroom must be GFCI protected.

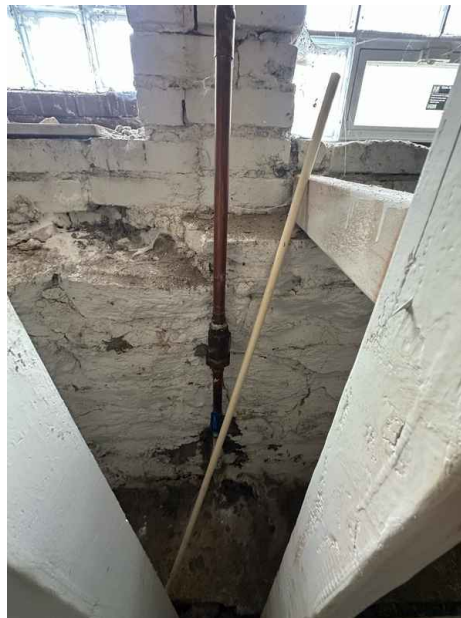
#### Water Supply & Shut Off: Location of Main Shut-Off Valve

Basement

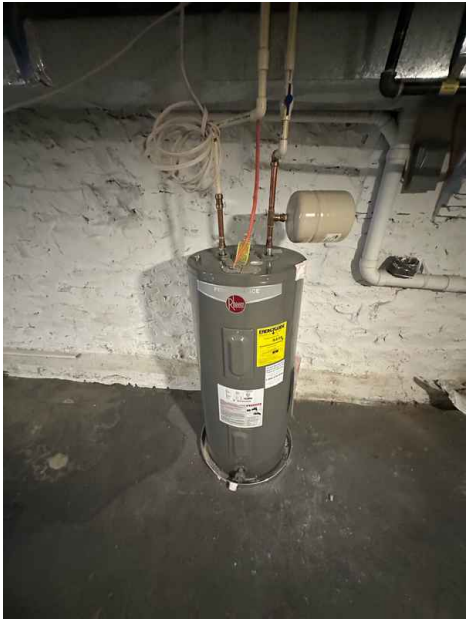
Hot Water Source: Photo of water heater  
The photo shows the data plate of the water heater.

Hot Water Source: Water heater location  
basement

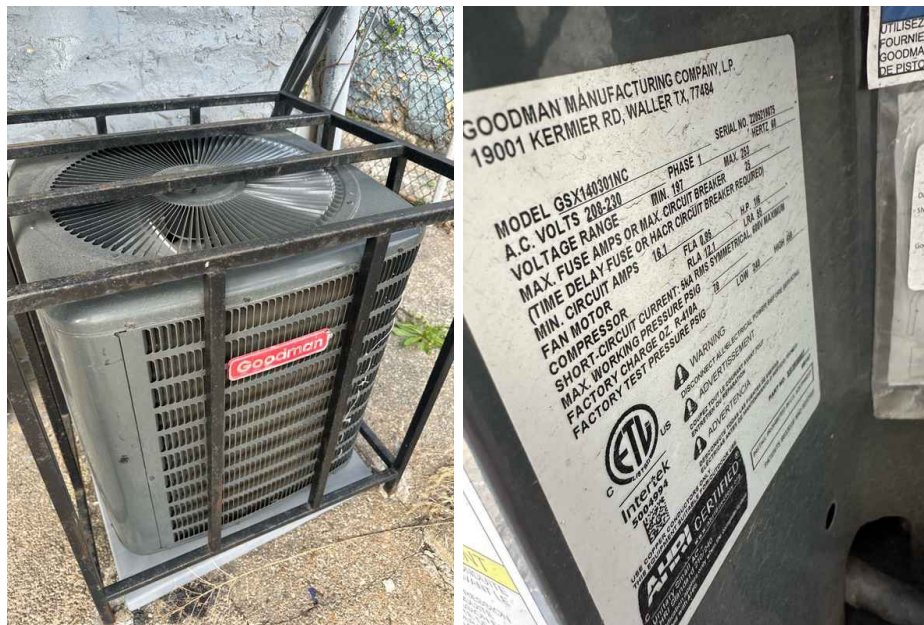
## Cooling: AC compressor data plate AND date of manufacture

2022

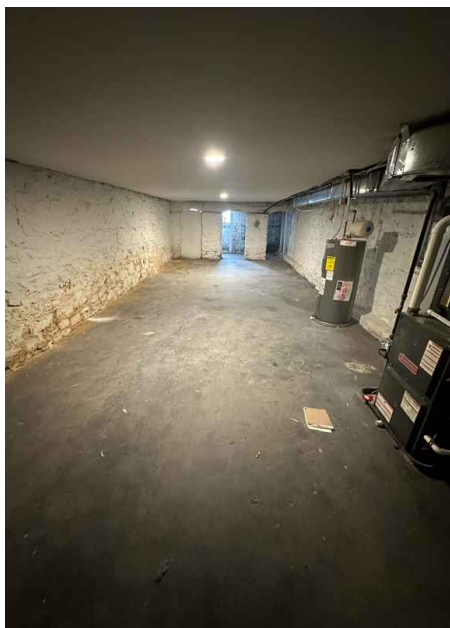
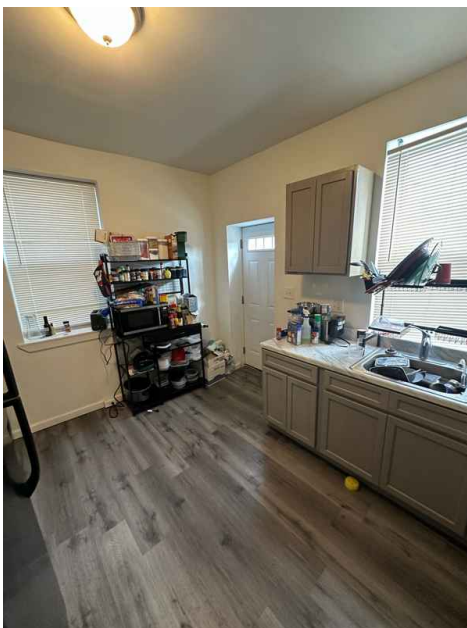
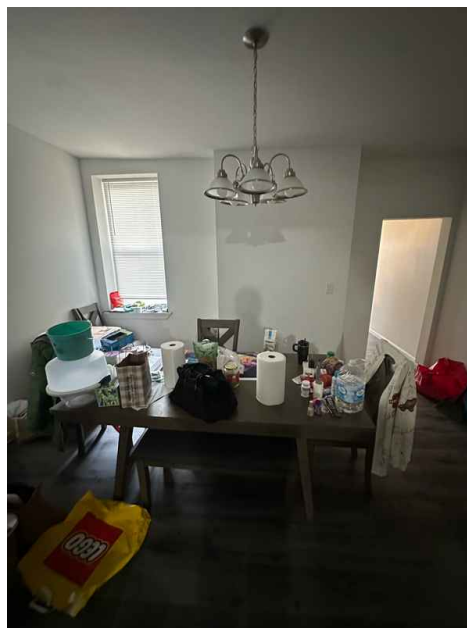
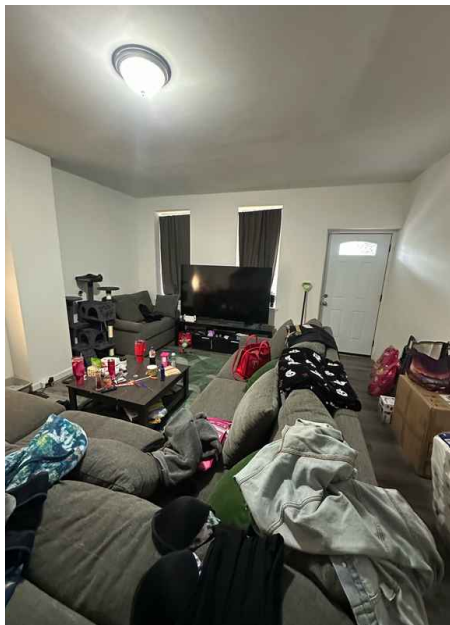
## Floors, Walls, Ceilings: Floors, Walls & Ceilings Inspected

Floors, walls, and ceilings were inspected in accordance with the Standards of Practice. Readily accessible interior surfaces were evaluated for visible defects, damage, and general condition. A thermal imaging camera and moisture meter were used to help identify potential hidden moisture or temperature anomalies where accessible, though these tools are supplemental and not a guarantee of uncovering all issues. No destructive testing or movement of furnishings was performed.
