## Inspection Report (Telehandler)

Year	1982
Make	CAT
Model	V80D
Serial Number	40X01620
Hour Meter Reading	N/A
Previous Application (e.g., earth moving, mining, demolition, etc)	General Construction (Warehouse Use Only)

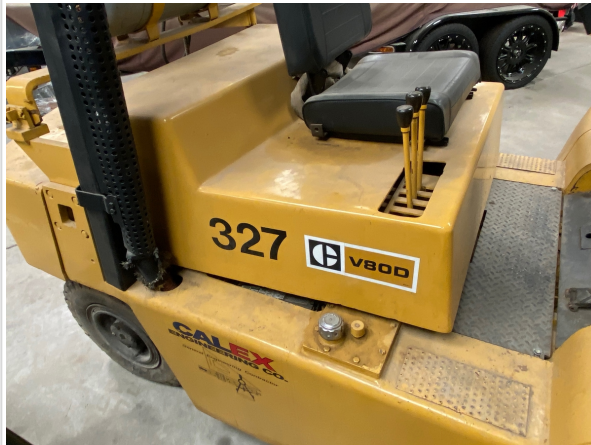
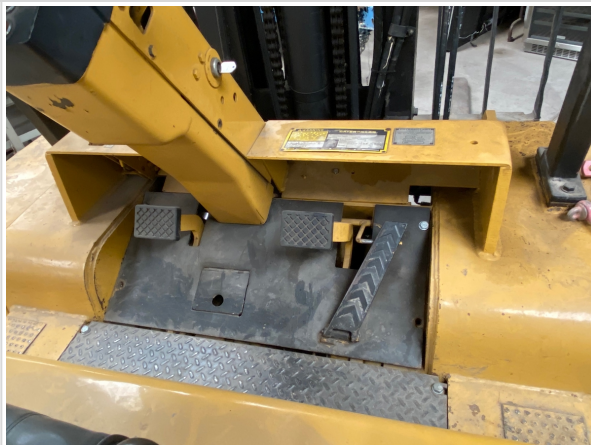
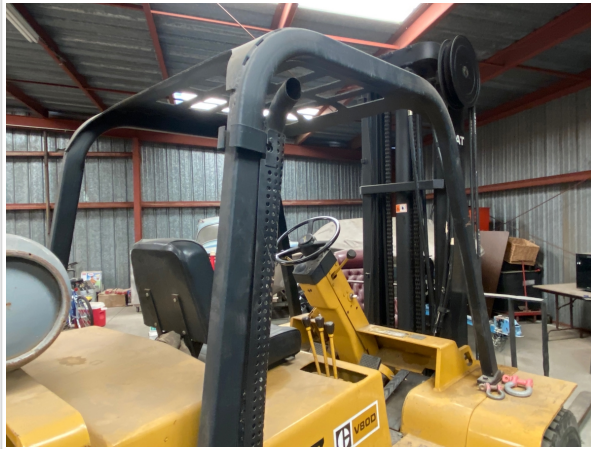
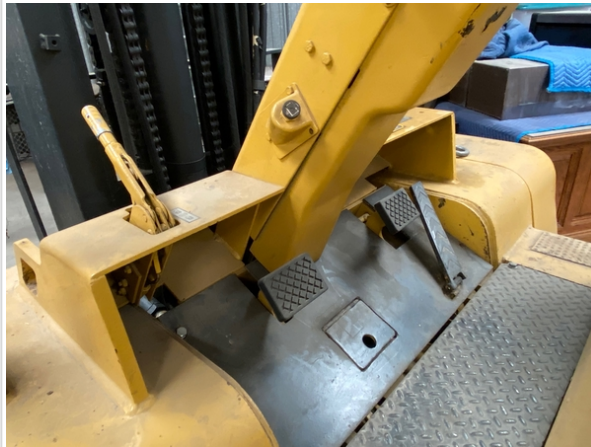
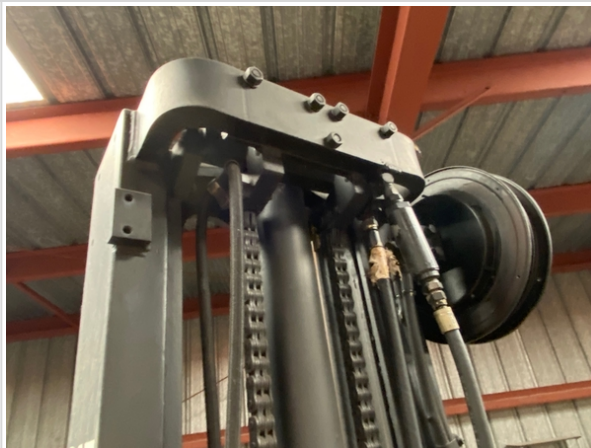
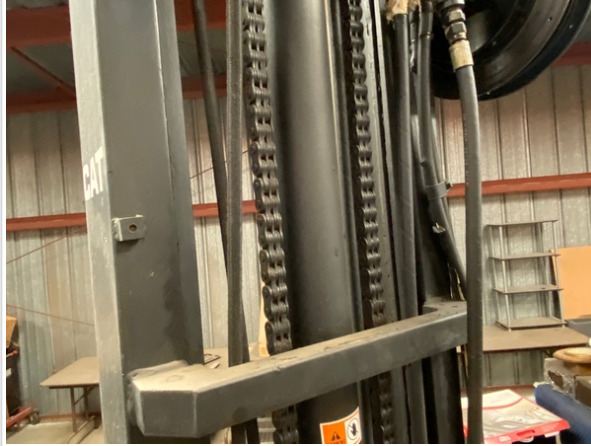
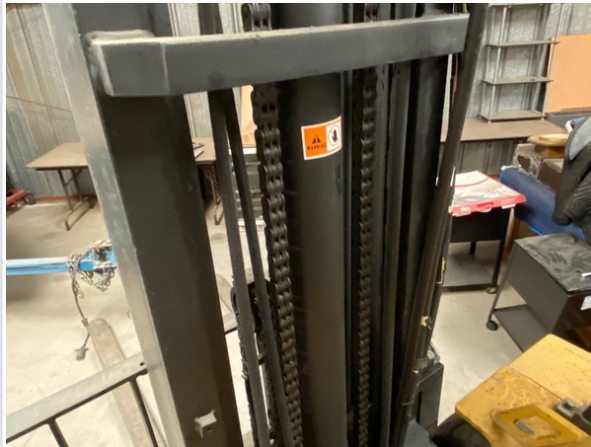
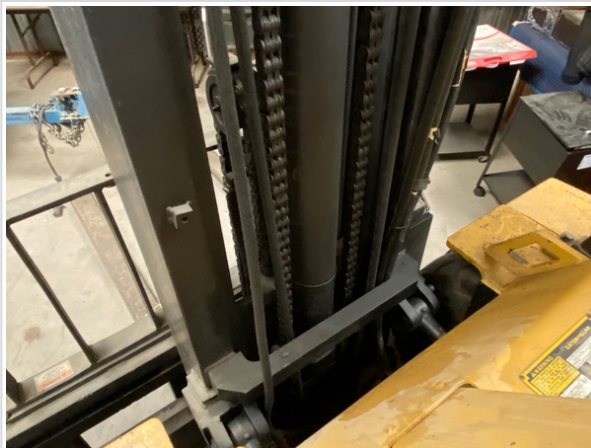
Close-up Exterior Photos

<b>Body Panels</b>	3 - Normal Wear & Tear
<b>Body Panel Condition</b>	No visible damage, good paint condition and panel fitment
<b>Doors / Canopy Latches</b>	3 - Normal Wear & Tear
<b>Doors / Canopy Latches Condition</b>	No visible damage
<b>Steps / Ladders</b>	3 - Normal Wear & Tear
<b>Steps / Ladders Condition</b>	Steps/ladders are fully intact and appear structurally sound
<b>Handrails</b>	0

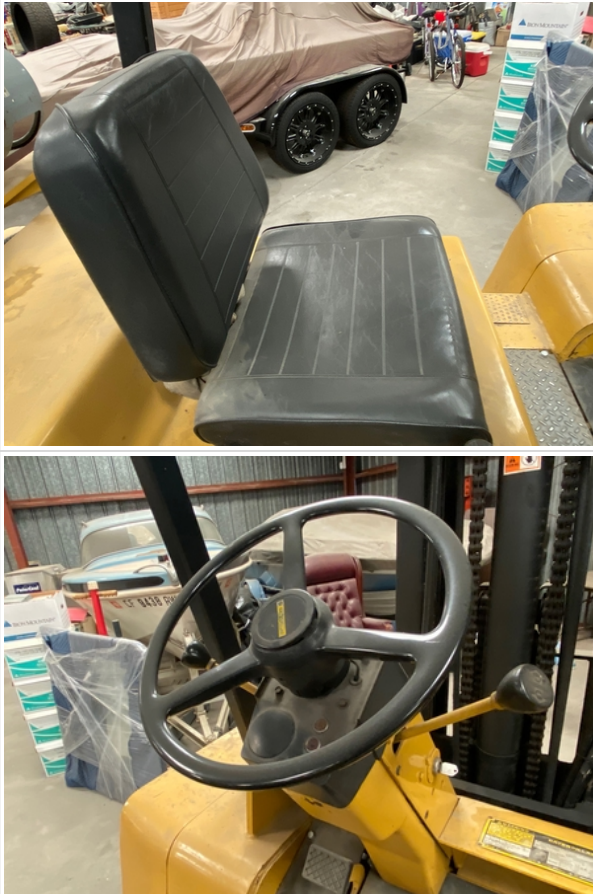
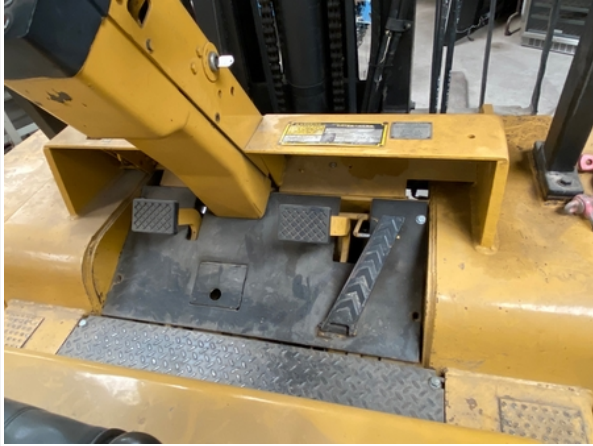
Operator Cabin Overall	3 - Normal Wear & Tear
Operator Cabin Overall Condition	Good cabin appearance, solid floors, panels, and ceiling
Operator Seat	3 - Normal Wear & Tear
Operator Seat Condition	Seat(s) in good condition, no stains or tears in upholstery
Cabin Lights	0
Safety Lock Out / Stop	0
Controls & Switches	0
Hour Meter Activity	0
Other Gauge Activity	0
Heater & A/C	0
Travel Alarm	0
Horn	0
Backup Camera	0

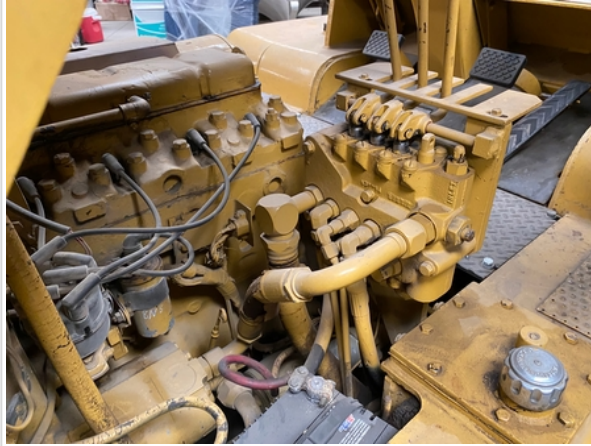
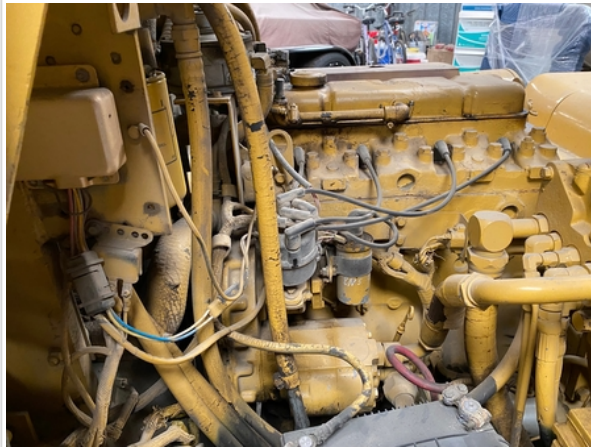
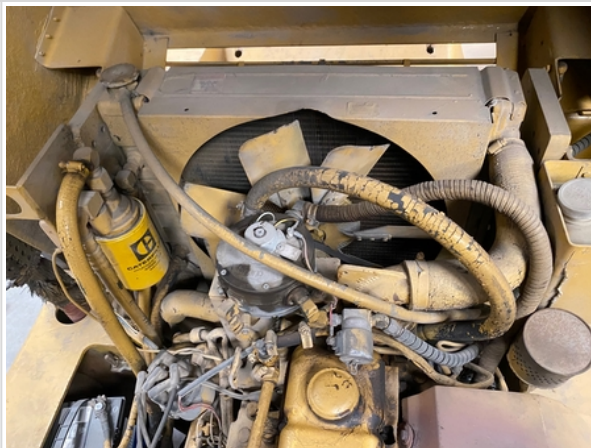
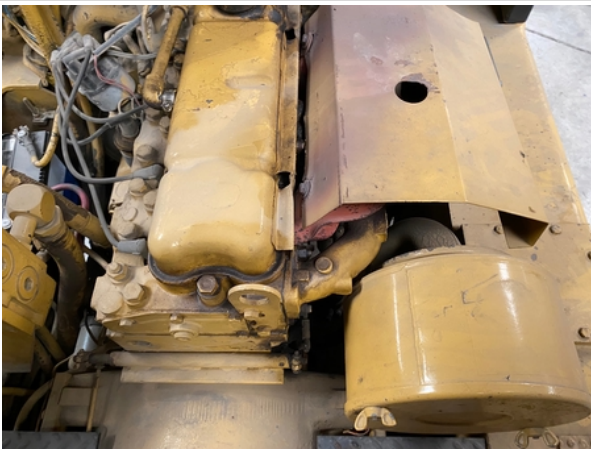
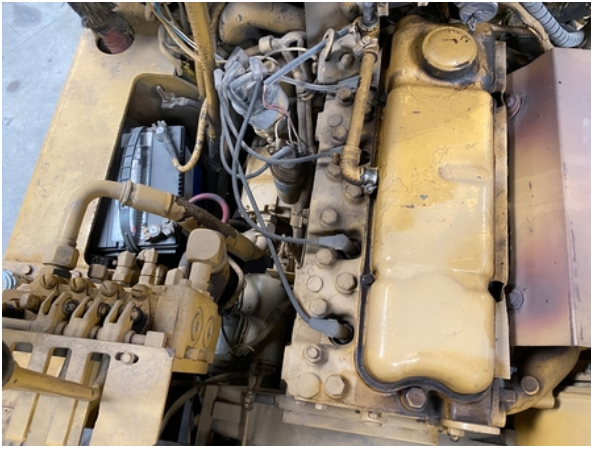
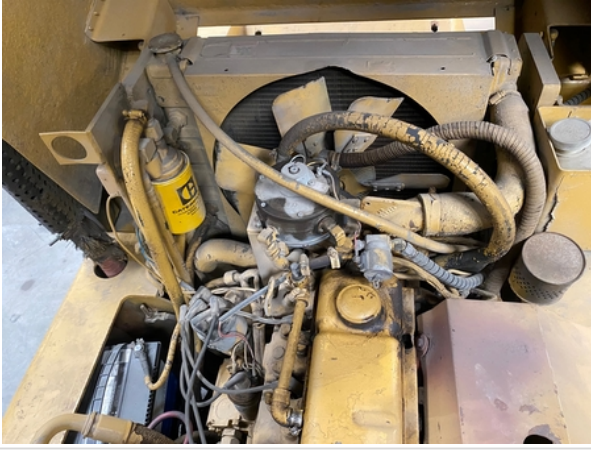
Engine Photos

<b>Blow-by (Visual Observation Check)</b>	N/A	
<b>Battery</b>	2 - Above Average Wear	
<b>Battery Condition</b>	Other (see comments)	
<b>Comments</b>	Battery was low on voltage at time of inspection	
<b>Radiator</b>	3 - Normal Wear & Tear	
<b>Radiator Condition</b>	Radiator fins & components appear to be in good working order, no signs of damage or leaks

<b>Belts</b>	3 - Normal Wear & Tear
<b>Belt Condition</b>	Belts appear in good condition & alignment with proper tension
<b>Hoses</b>	3 - Normal Wear & Tear
<b>Hose Condition</b>	Firm, pliant hoses with no signs of wear or leaks
<b>Water Pump</b>	3 - Normal Wear & Tear
<b>Water Pump Condition</b>	No unusual pump noises heard
<b>Cooling System Leaks</b>	No
<b>Coolant Color / Appearance</b>	3 - Normal Wear & Tear
<b>Coolant Color/Appearance Notes</b>	Normal Translucent appearance, no visual signs of contamination
<b>Oil Leaks</b>	No
<b>Oil Color / Appearance</b>	3 - Normal Wear & Tear
<b>Oil Color / Appearance Notes</b>	Clean oil appearance, no signs of cross contamination, Appropriate oil level
<b>Fuel Leaks</b>	No
<b>Requires DEF (Diesel Exhaust Fluid)</b>	No
<b>Overall Engine Appearance</b>	Clean & dry
<b>Overall Engine Comments</b>	Unable to fire engine up during inspection. Customers lead mechanic mentioned that the forklift unit runs well. Battery simply loses charge after sitting for long periods.

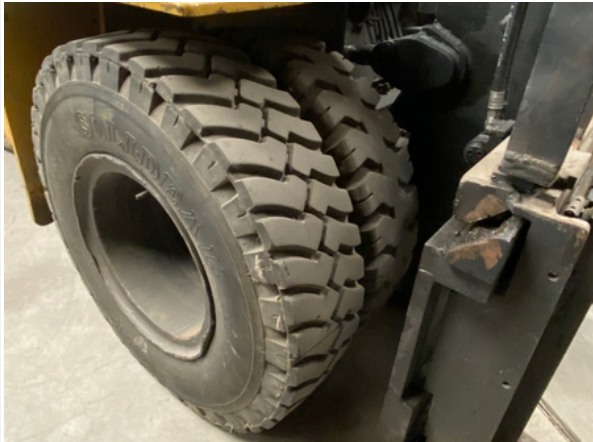
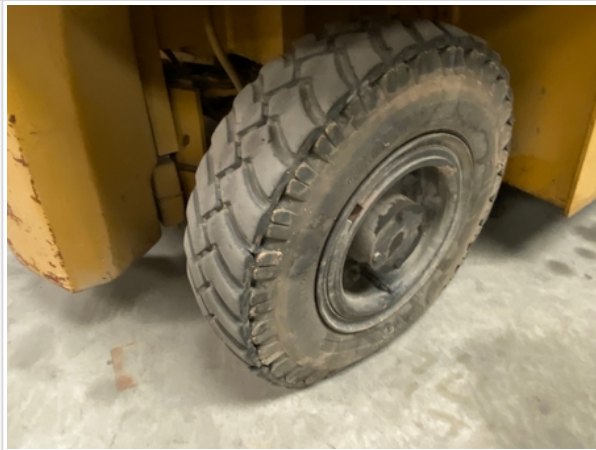
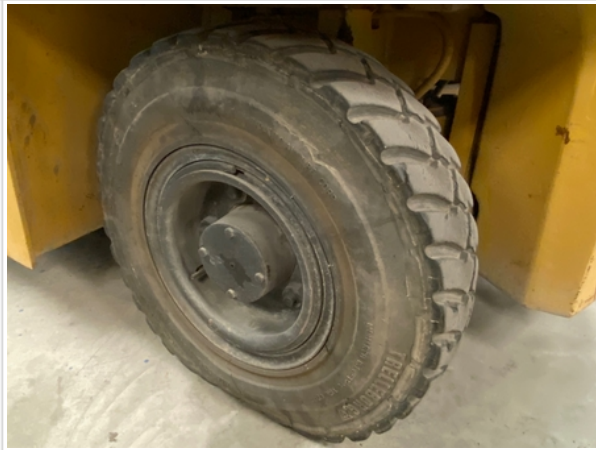
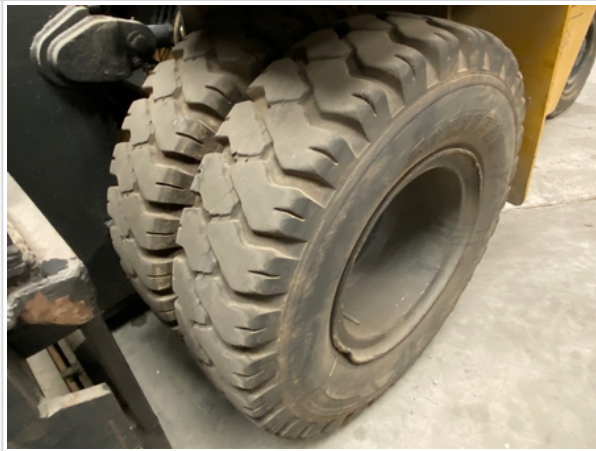
<b>Frame</b>	3 - Normal Wear & Tear
<b>Stance</b>	3 - Normal Wear & Tear
<b>Wheels &amp; Tires</b>	3 - Normal Wear & Tear
<b>Wheels &amp; Tires Photos</b>

<b>Tire Brand</b>	Solideal	
<b>Front Left Tire - Ratio Remaining</b>	30%	
<b>Rear Left Tire - Ratio Remaining</b>	30%	
<b>Front Right Tire - Ratio Remaining</b>	50%	
<b>Rear Right Tire - Ratio Remaining</b>	30%	
<b>Chain / Tensioners</b>	3 - Normal Wear & Tear	
<b>Rollers &amp; Guides</b>	3 - Normal Wear & Tear

Overall Chassis	3 - Normal Wear & Tear
Overall Chassis Comments	Overall, from a visual standpoint, the machine's chassis looked to be in well maintained condition.

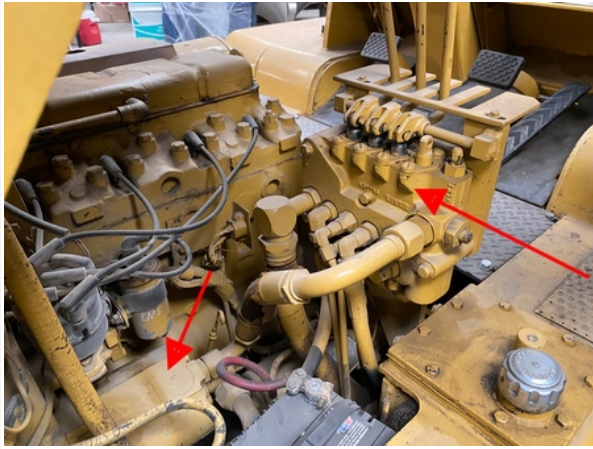
Hydraulic System	Take close-up photos of the hydraulic components including the pump, lines, fittings, controls, and levers. Note any damage, wear, or leaks.
Hydraulic System Photos

<p>Arrows pointing at Hydraulic Pump (on the left) &amp; Main Control Valve (on the right)</p>

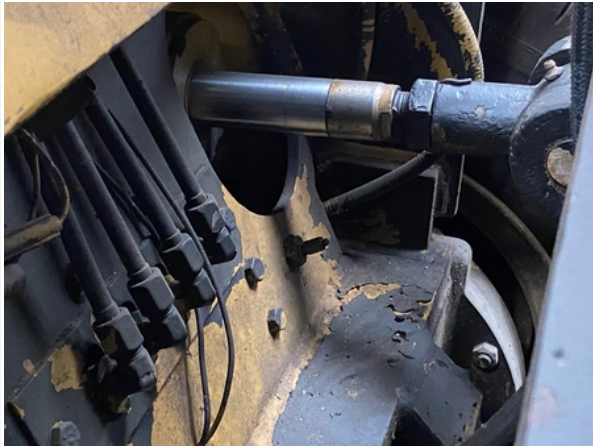
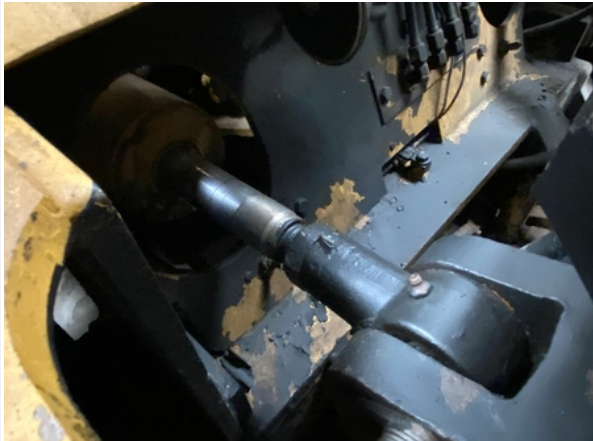
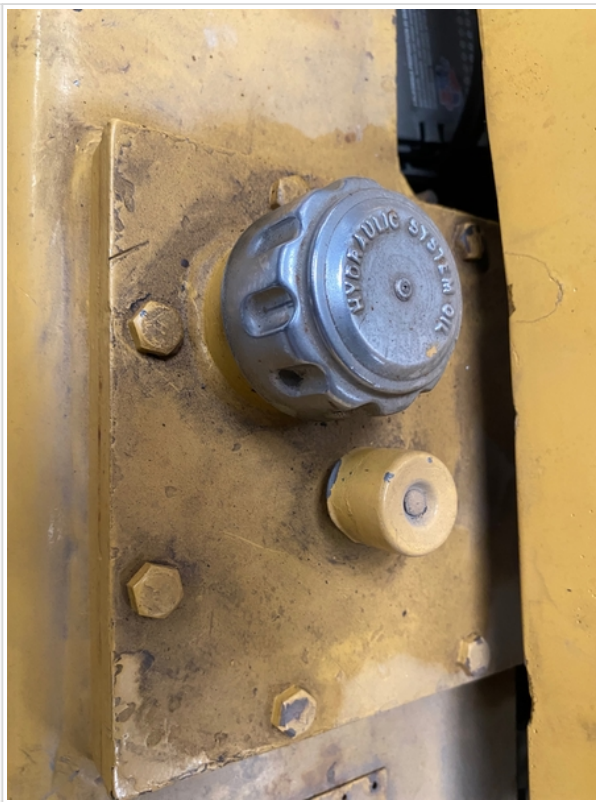
<b>Wet or Damp Hydraulic Lines / Fittings</b>	No
<b>Appearance of Hydraulic Lines / Fittings</b>	3 - Normal Wear & Tear
<b>Hydraulic Lines / Fittings Condition</b>	Other (see comments)
<b>Comments</b>	Main hydraulic lines/hoses visible from topside looked to be in good condition .

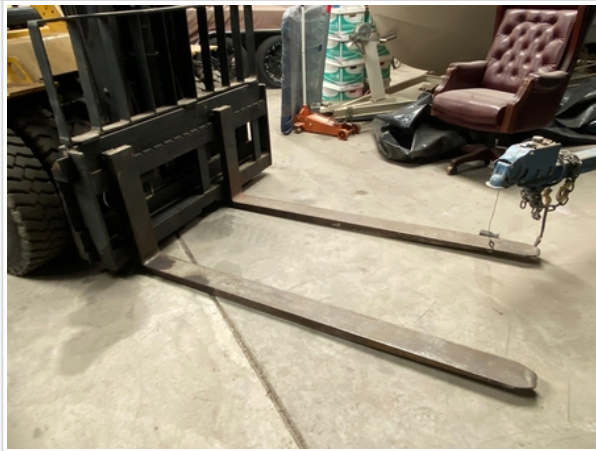
<p>Forks / Work Tool Photos</p>

<b>Forks / Work Tool Condition</b>	3 - Normal Wear & Tear
------------------------------------	------------------------

<p>Back Rest Condition</p>	<p>3 - Normal Wear &amp; Tear</p>
