Inspection Report (Generator)

Year	2005
Make	AIRMAN
Model	185 CFM
Serial Number	Unit #103
Hour Meter Reading	7,420
Previous Application (e.g., earth moving, mining, demolition, etc)	General Construction

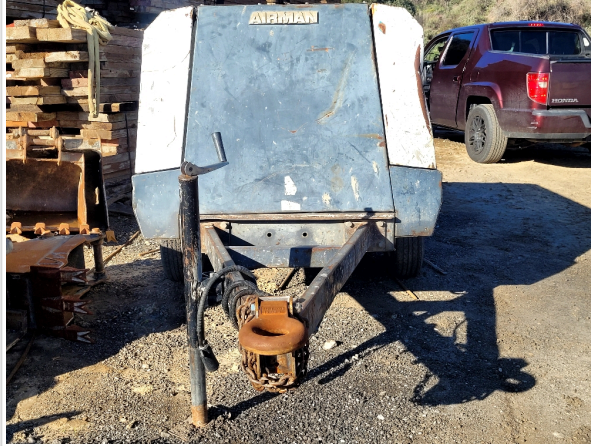
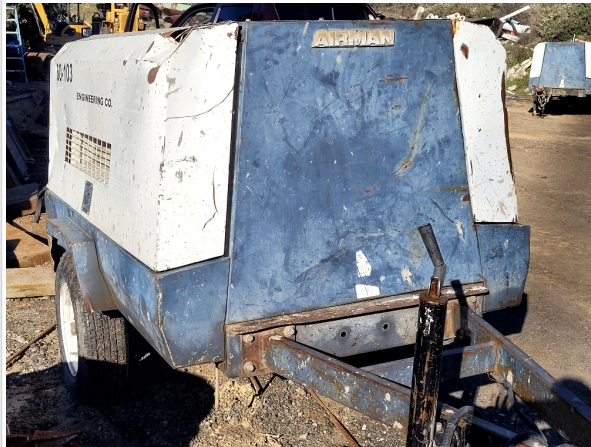
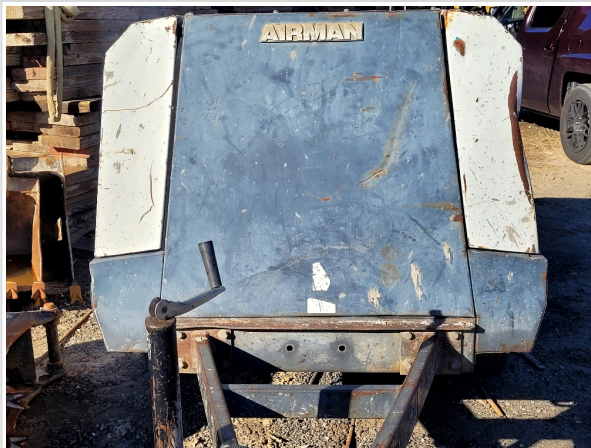
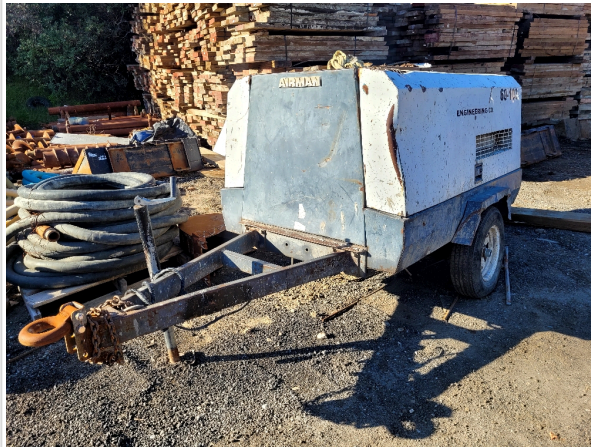
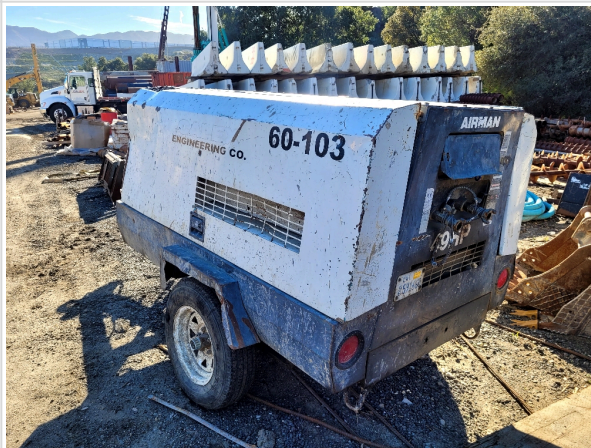
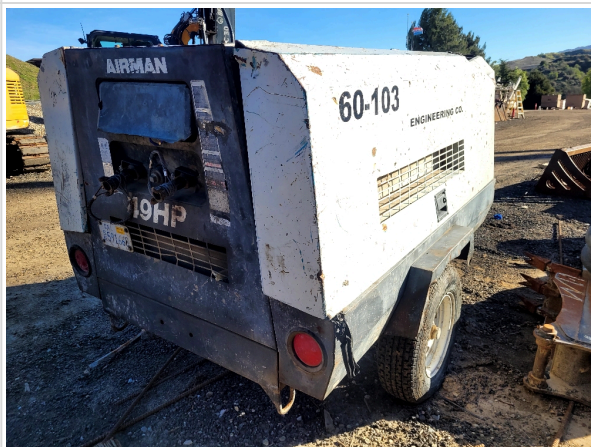
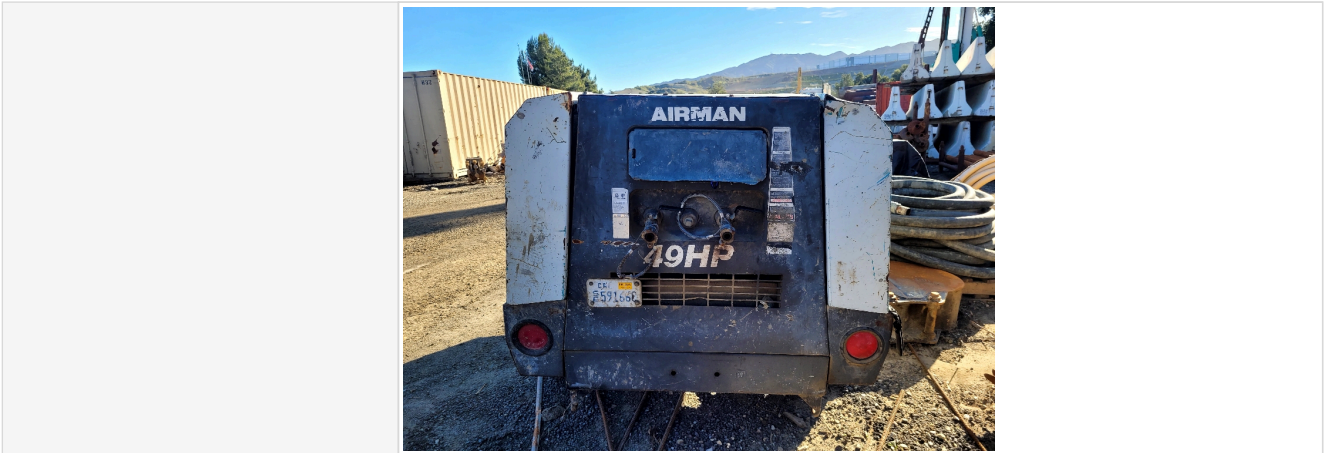
Exterior Walkaround Photos

Exterior Rating	2 - Above Average Wear
Interior Rating	3 - Normal Wear & Tear
Safety Rating	3 - Normal Wear & Tear
Quality Rating	3 - Normal Wear & Tear
Functionality Rating	3 - Normal, Operating as Expected
Overall Rating	3 - Normal Wear & Tear
What's Great About the Machine	Engine fires right up and air compressor works normally. Machine is ready to tow and connections seem to be in good condition.
What Needs Work	Cosmetic dents and scuff marks observed all the way around unit.
Date/Time	01-31-2023

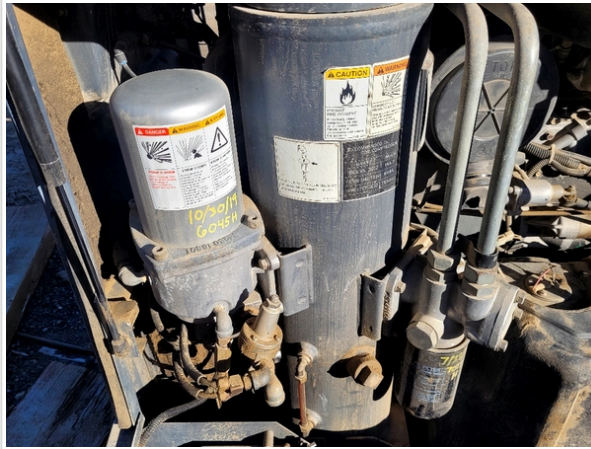
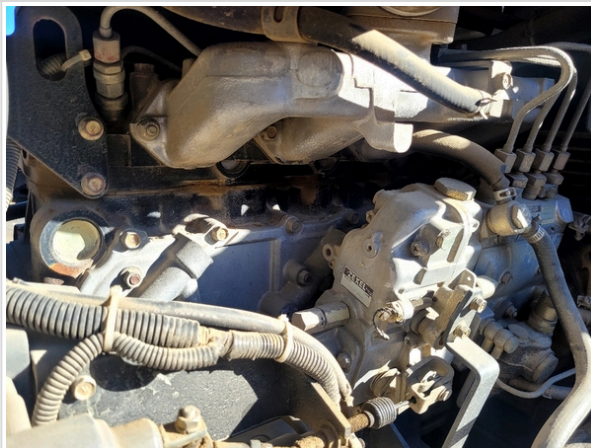
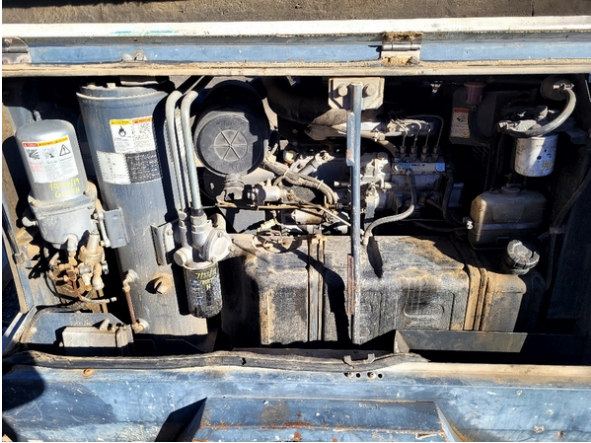
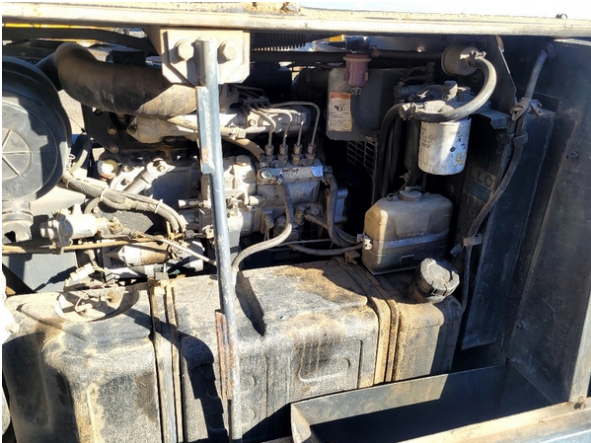
Engine	
Engine Type (Make, Model, Cylinders, Hp)	Nissan - 4 Cyl. - TD27 - 2.6L - 49HP
Emissions Tier	Tier 1
Engine Serial Number	n/a
Engine Fuel Type	Diesel
Engine Photos

Blow-by (Visual Observation Check)	No
Unusual Noises (Upon Start-up, Idle, Shutdown)	No
Unusual Noise Notes	No unusual noises heard
Engine Smoke (Upon Start-up, Idle, Shutdown)	No
Engine Smoke Notes	No engine smoke issues observed
Engine Exhaust Color	Clear
Battery	3 - Normal Wear & Tear
Battery Condition	Other (see comments)
Comments	Air compressor started up with no cranking problems
Radiator	3 - Normal Wear & Tear
Belts	3 - Normal Wear & Tear
Belt Condition	Belts appear in good condition & alignment with proper tension
Hoses	3 - Normal Wear & Tear
Hose Condition	Firm, pliant hoses with no signs of wear or leaks
Water Pump	3 - Normal Wear & Tear

Water Pump Condition	No unusual pump noises heard
Cooling System Leaks	No
Coolant Color / Appearance	3 - Normal Wear & Tear
Coolant Color/Appearance Notes	Normal Translucent appearance, no visual signs of contamination
Oil Leaks	No
Oil Color / Appearance	3 - Normal Wear & Tear
Oil Color / Appearance Notes	Clean oil appearance, no signs of cross contamination, Appropriate oil level
Fuel Leaks	No
Requires DEF (Diesel Exhaust Fluid)	No
Overall Engine Appearance	Clean & dry
