CONSOLE LID REPAIR KIT INSTRUCTIONS

01-06/07 CLASSIC GM PICKUP CENTER CONSOLE LID REPAIR KIT

SKU 1449-0003DGY, 1449-0003GY, 1449-0003TN

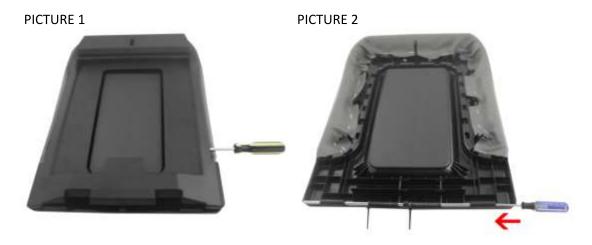
- 1. (OPTIONAL) Remove center console from vehicle.
- 2. Using a flathead screwdriver, or equivalent, pry loose the inner plastic panel from your console lid (PICTURE 1).
- 3. Push or pull the hinge rod out to remove the lid from the center console (PICTURE 2).
