# **PRELIMINARY INVESTIGATION**

## **BROAD STREET WEST, SUMMIT, NJ**

### **DATE: September 15, 2017**

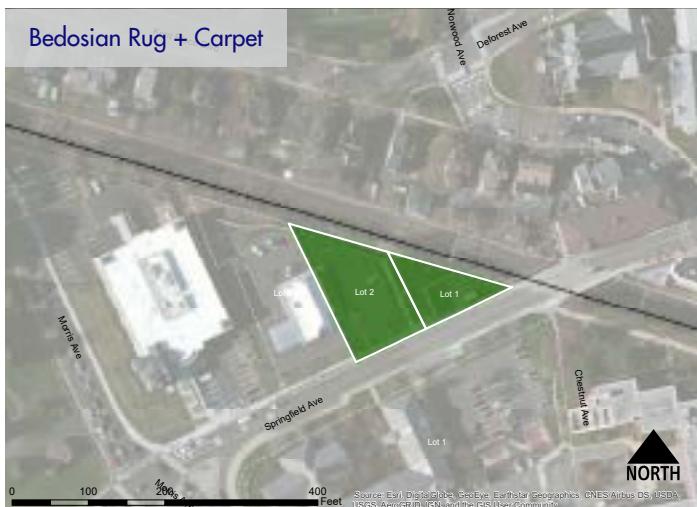
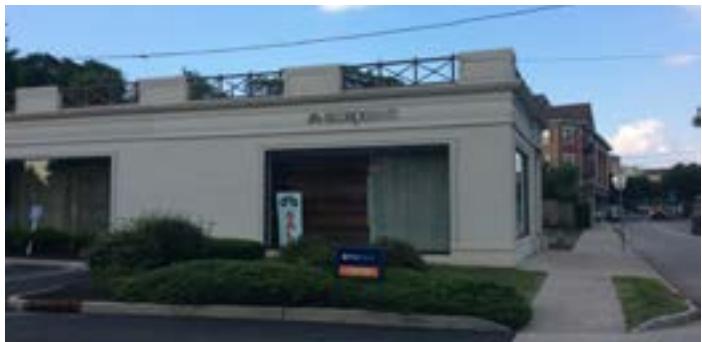
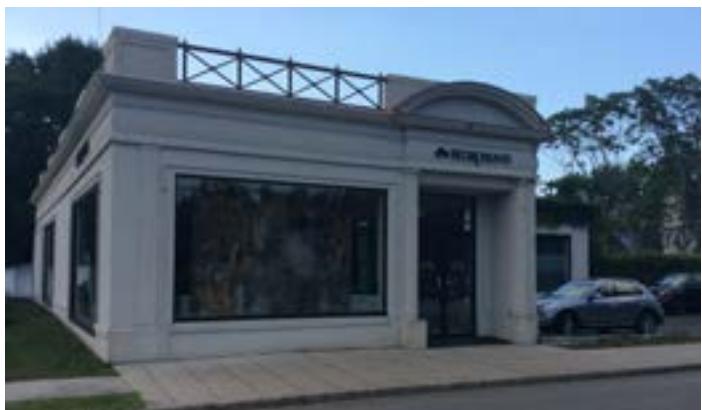
## Block 1913, Lots 1 & 2 - (Bedrosian Rug & Carpet)

Block 1913, Lots 1 & 2 contain a single-story commercial retail structure and seven-spot parking lot. The back of the lot is directly adjacent to the commuter rail right-of-way. The retail location that fronts on Springfield Avenue is owner-occupied and houses a carpet and rug store. The building and façade are in good condition. New retail windows were installed in 2008 and the stucco facade was updated as recently as 2015.

Based upon an inspection of the property and an examination of construction and inspection records, Block 1913, Lots 1 & 2 do not meet any of the criteria under the LRHL. While access was not gained into the building, the exterior of the structure and improvements to the site appear to be in good condition.

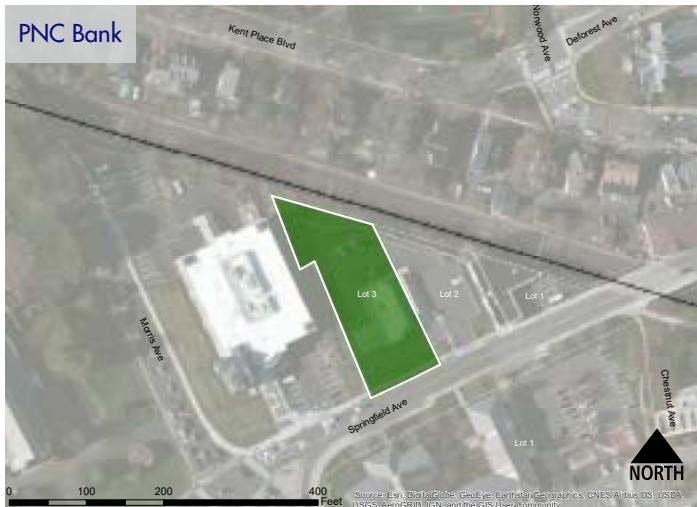
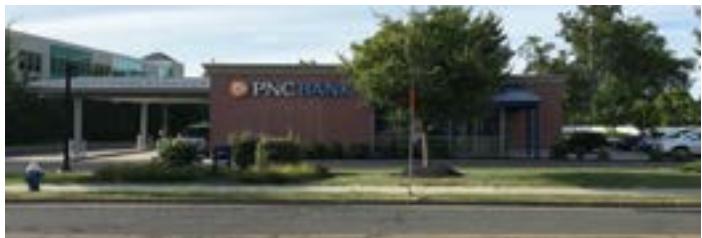
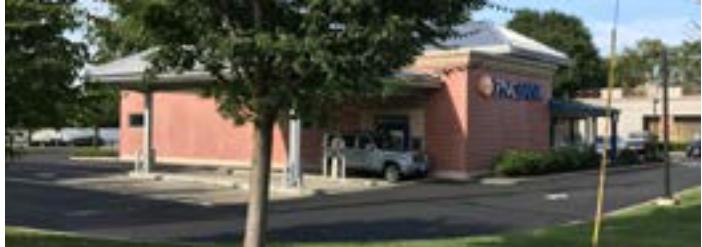
## Block 1913, Lot 3 - (PNC Bank)

Block 1913, Lot 3 contains a commercial bank location on a 0.55 acre site. A twenty-spot parking lot on the site serves bank employees and customers. The building also includes a drive-thru banking use. The commercial bank on the site was built in 2009 and is in good condition. The site is well-maintained and the

site design provides for landscaping and clear circulation markings. The façade is free of any visible signs of deterioration.

Based upon an inspection of the property and an examination of construction and inspection records, Block 1913, Lot 3 does not meet any of the criteria under the LRHL. While access was not gained into the building, the exterior of the structure and improvements to the site appear to be in good condition.

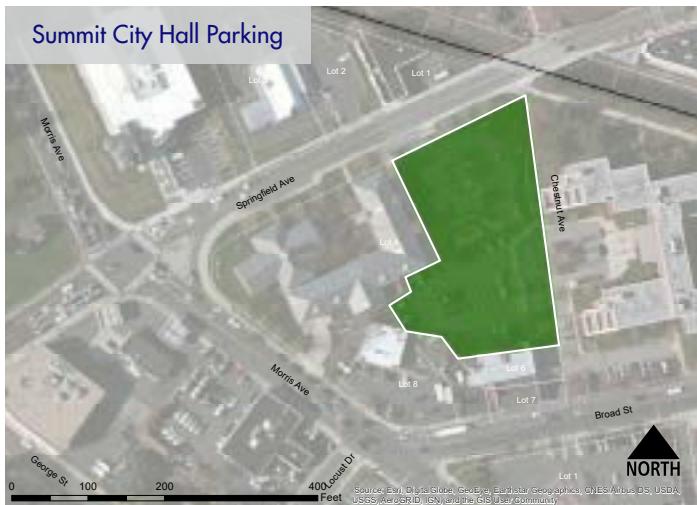
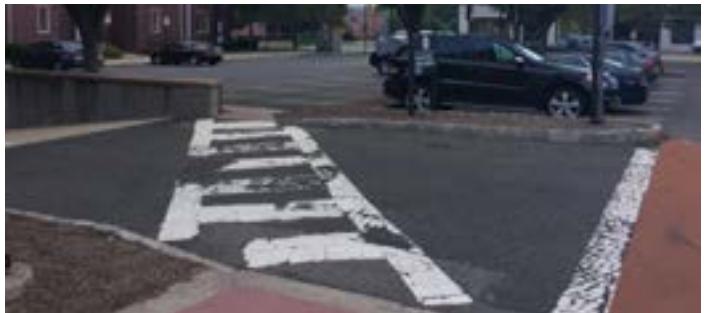
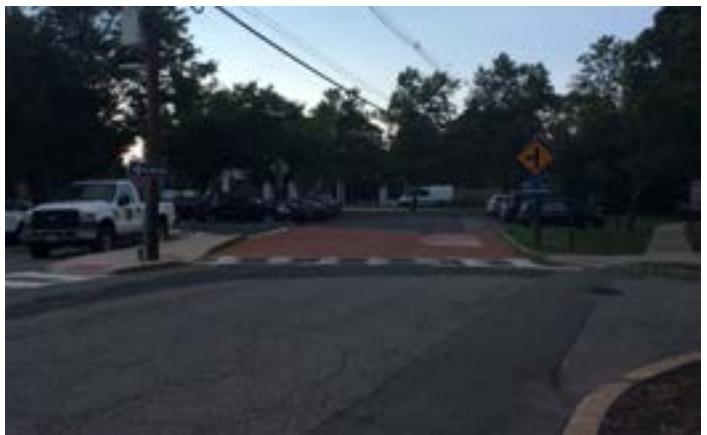
## Block 2701, Lot 1 - Partial (Summit City Hall Parking)

Based upon an inspection of the property and an examination of construction and inspection records, Block 2701, Lot 1 meets the following criteria under the LRHL:

While the City Hall Building was not found to meet any criteria under the LRHL, based on the foregoing, sufficient evidence exists to conclude that the current use and conditions of the parking lot in Block 2702, Lot 3 support designation under "Criterion D." The lot is an outdated and unplanned land use that evolved over time in a way that resulted in an inefficient, unsafe, and obsolete surface parking facility.

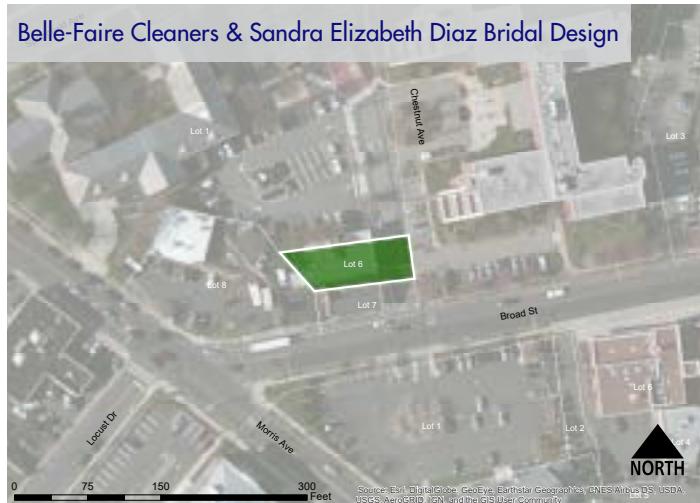
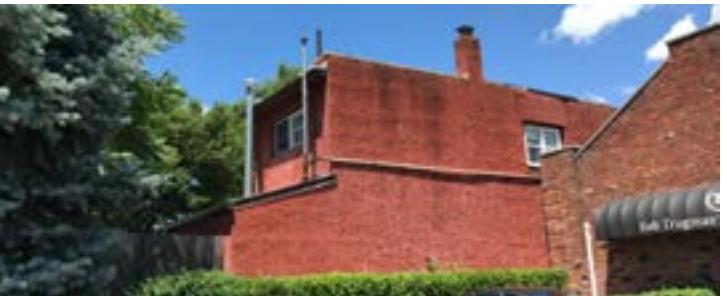
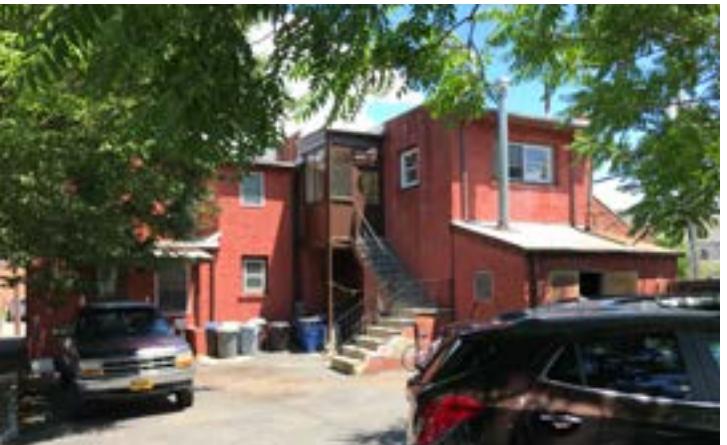
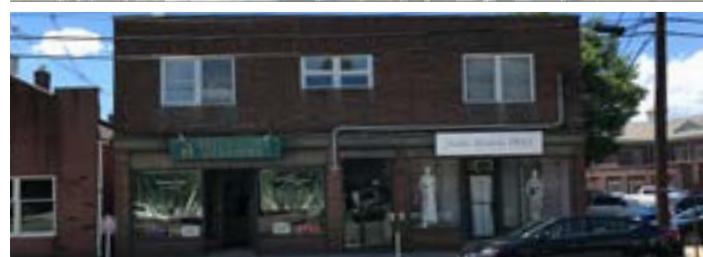
## Block 2701, Lot 6 - (Belle-Faire Cleaners & Sandra Elizabeth Diaz Bridal Design)

Block 2701, Lot 6 contains a two-story mixed-use structure on a 0.12 acre parcel. The ground floor of the building houses two retail storefronts that front Chestnut Avenue. A dry cleaner and a bridal design shop occupy the ground floor. The second story has residential units that are accessed through the back of the property. The service parking and loading areas are in the back of the property and can only be accessed via the adjacent City Hall parking lot.

While access to the interior of the building was not gained, an external inspection of the property supports the finding that the existing structure shows signs of obsolescence and the site design exhibits a faulty arrangement. Based on a review of historic Sanborn maps and current aerial photographs, it appears the current mixed-use structure is largely an addition to an existing frame dwelling that was observed in maps as early as 1903. This unique aspect of the existing building's history would explain the multitude of physical adaptations – the structure is in itself an adaption, not initially constructed for the purpose it ultimately came to serve.

One significant observation is the lack of parking for the second-story residential units, which would support a conclusion of obsolescence. Parking is generally demanded by the marketplace and is required by the City's zoning code for all new residential dwellings. Upon inspection of the building, several signs of deterioration were observed both on the façade of the building and building improvements. The stucco façade of the building shows signs of water infiltration and is spalled, which could have been caused over time by improper drainage of window air conditioning units. On the retail storefront of the building, the painted finish on metal panels of the storefront facades shows significant signs of wear and are in need of maintenance. Roof gutters and drainpipes were found to be detached from the building façade and in need of repair.

Inspection of the side and rear facades of the building revealed multiple furnace exhaust pipes projecting through the one-story roof. One of the pipes leading into the one-story roof shows significant corrosion. Furthermore, the parking area located at the rear of the building is not striped and the commercial refuse was not stored in an appropriate enclosure. The rear staircase, presumably second means of egress for the second-floor residential units, shows signs of multiple repair attempts and is likely in need of replacement. Taken together, the configuration of the existing improvements and faulty parking arrangement as well as its

The back of the building on Block 2701, Lot 6 has a parking area and rear entrance for deliveries, trash and service functions. Access to the rear of the lot is only provided through the adjacent municipally-owned City Hall parking lot. The property owner enjoys an easement right to access the back of the property via the municipal parking lot. Over time, the use of this building and the back area evolved to be interdependent on the basis of access arrangements that allowed for the continued use of this and adjacent property. Diverse ownership across these interdependent properties impedes the viable redevelopment of both Lot 3 and discourages the further improvement of the adjacent City owned surface parking lot. Based on the foregoing, the conditions of title surrounding this parcel and the adjacent City lot results in a stagnant or unproductive condition upon land potentially valuable for contributing to the public welfare, as contemplated in "Criterion E."

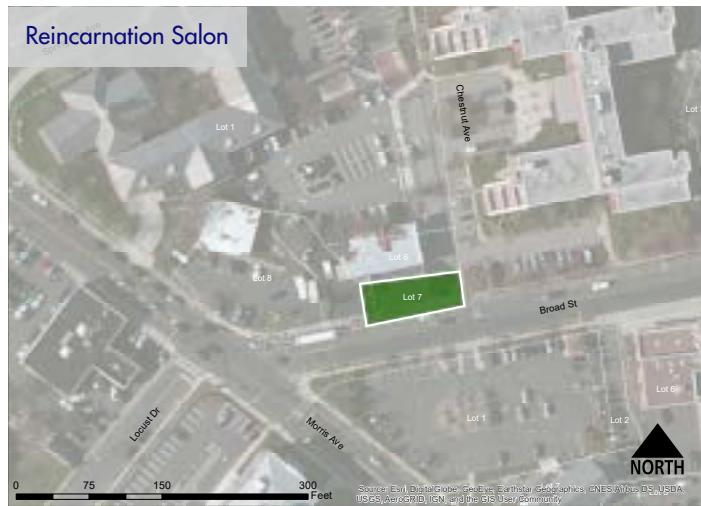
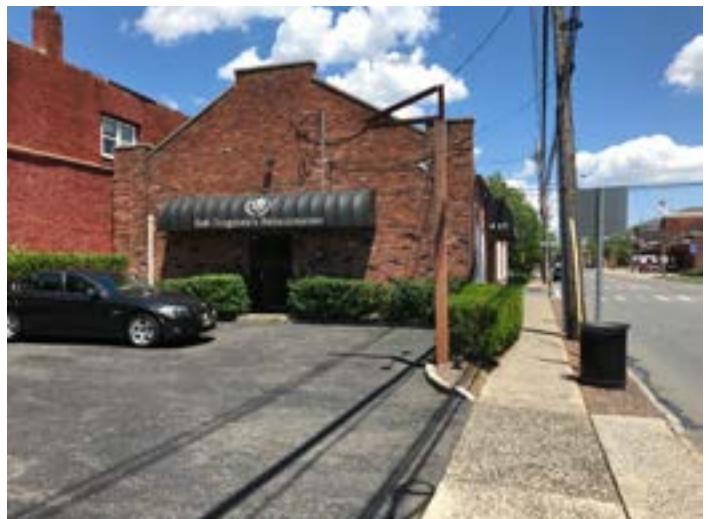
## Block 2701, Lot 7 - (Reincarnation Salon)

Block 2701, Lot 7 contains a one-story structure with a retail storefront on a 0.09 acre parcel. Rob Trugman's Reincarnation Salon occupies the retail location. The building is owner-occupied and located on the corner of Chestnut Avenue and Broad Street. There is a small four-space parking lot on the west side of the building that is used by the salon.

Access was gained into the building and both the exterior and interior of the structure appear to be in good condition. Based upon an inspection of the property and an examination of construction and inspection records Block 2701, Lot 7 does not meet any of the criteria under the LRHL, per se.

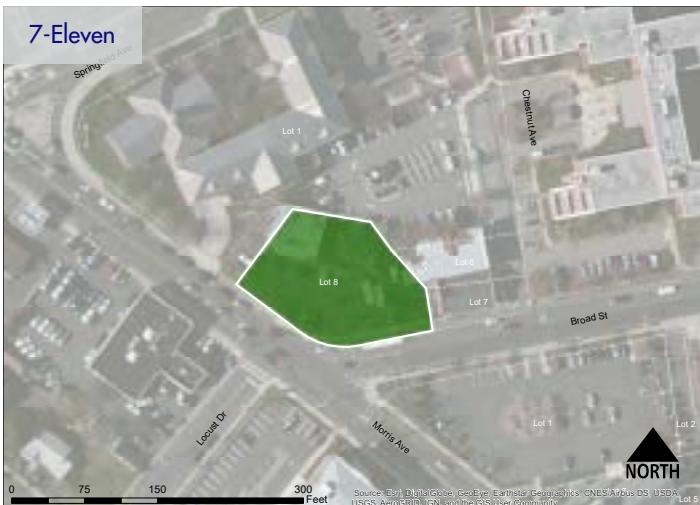
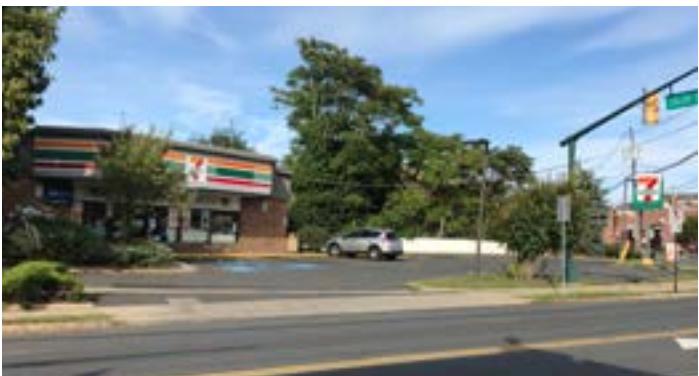
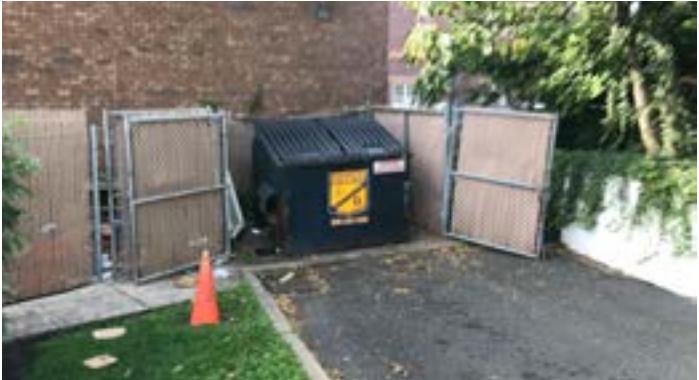
## Block 2701, Lot 8 - (7-Eleven)

Block 2701, Lot 8 is a 0.43 acre corner lot that is located at the intersection of Broad Street and Morris Avenue. The lot is currently occupied by a 7-Eleven convenience market that is open twenty-four hours a day. The single-story commercial building is situated at the back of the lot, making way for an eighteen-space parking lot at the front of the site that is used by customers and store employees. The parking lot provides for two points of access: directly onto Broad Street and Morris Avenue. The lot is adjacent to two commercial structures to the east and surrounded by City Hall and one of City Hall's parking lots to the northeast, north and northwest. The convenience store itself is less than seven feet from the City Hall building, which is directly behind the structure.

The arrangement and design of the site is faulty and found to be detrimental to the safety, health, morals and welfare of the community. The irregularly shaped lot contains a front-yard parking lot consisting of eighteen spaces without a marked loading area for deliveries. There is a long drive to access a side yard dumpster enclosure. The parking lot has two access points, one along Broad Street that egresses into a dedicated right-turn queue lane that is separated from oncoming traffic by a double-yellow line (i.e. no legal left turns). The other access point is along Morris Avenue, which contains a driveway that is not aligned with the signalized 4-way intersection, resulting in driver confusion where left egress turns would also require crossing of a double-yellow line. The high-volume parking lot has limited lines of sight, a particularly dangerous condition where vehicles are backing out of spaces on both sides of a two-way drive aisle. There were eight (8) vehicular accidents in this parking lot in 2016 alone and forty (40) such accidents between the years 2012 and 2017. This corner parking lot, necessitated by the faulty arrangement of improvements on the site, con-

Taken together, the faulty arrangement of the site design and the deleterious nature of the use itself, provides sufficient evidence to conclude Lot 3 meets the specifications of "Criterion D."

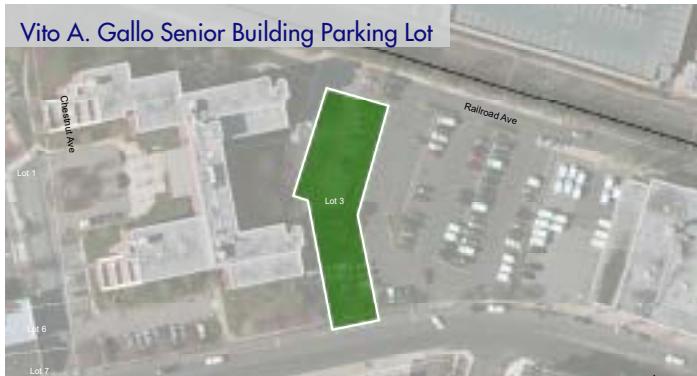
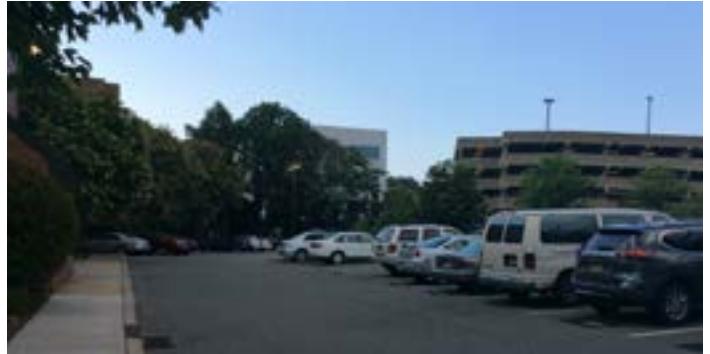
## Block 2702, Lot 3 - Partial (Vito A. Gallo Senior Building Parking Lot)

Lot 3 is a 1.84 acre parcel owned by the City of Summit Housing Authority. The structure on the parcel is the Vito A. Gallo Senior Building which contains 125 units of senior housing. This Study does not include the senior housing building, only the parking lot located on the western portion of Lot 3 which is .33 acres and has 39 parking spaces.

be part of a thriving downtown district is, in itself, significant to this analysis. Sufficient evidence exists to conclude that the current use and conditions of the parking lot in Block 2702, Lot 3 support designation under "Criterion D." The lot is an outdated and unplanned land use that evolved imperfectly over time, resulting in an inefficient, unsafe, and obsolete surface parking facility.

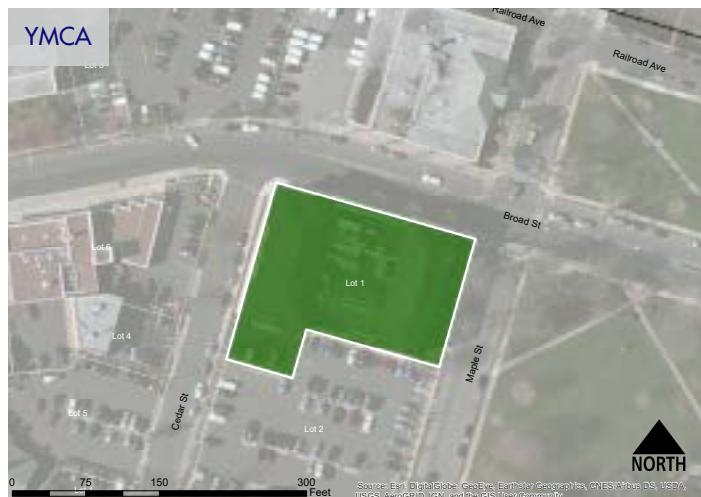
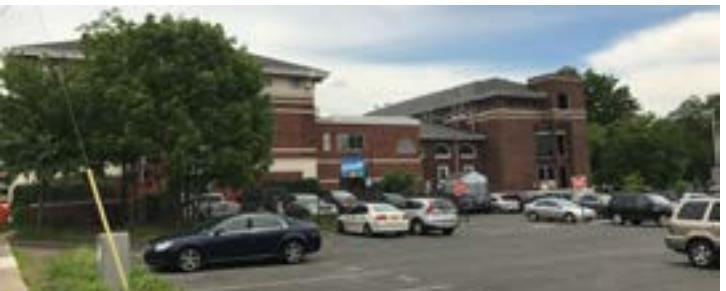
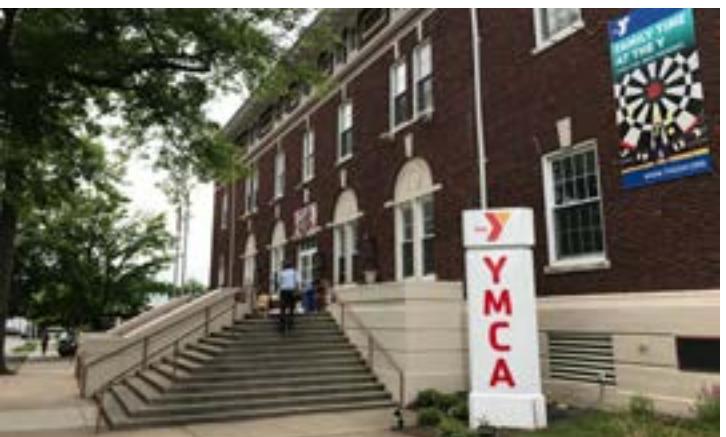
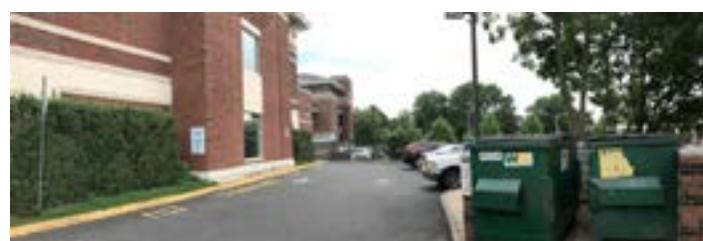
### Block 2705, Lot 1 - (YMCA)

Block 2705, Lot 1 is home to the Summit Area YMCA. The main structure of the facility was built in 1912 and underwent a major renovation, that included the addition of a new wing to the building, in 1998. The facility covers that majority of the 0.74 acre parcel and has only four parking spots on-site. The adjacent municipally owned parking lot offers additional parking to patrons of the YMCA.

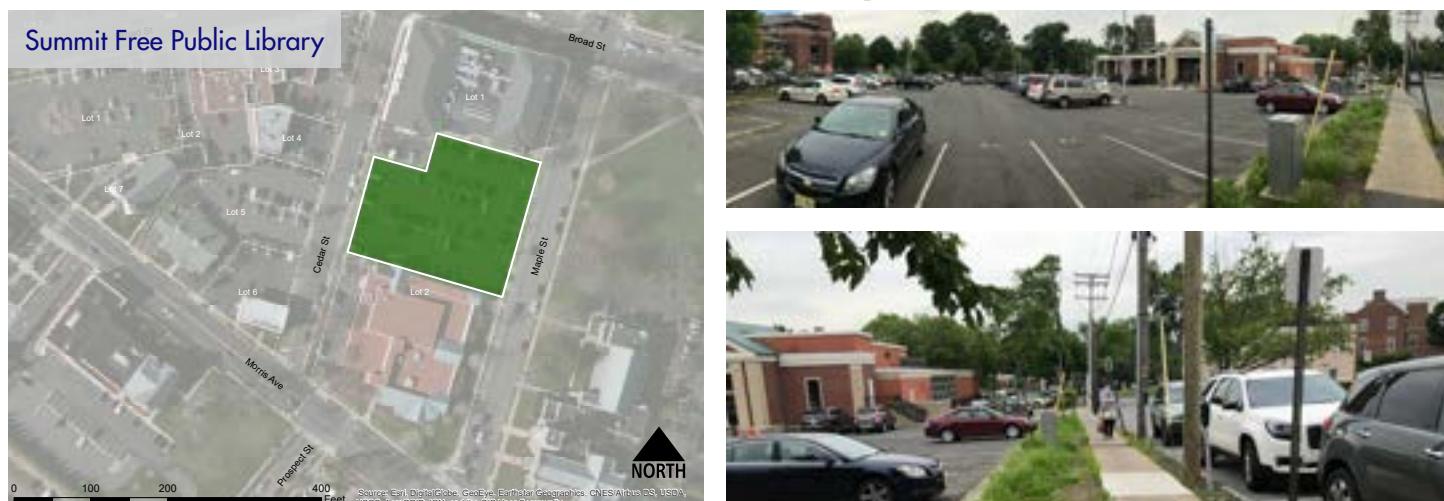
## Block 2705, Lot 2 - Partial (Summit Free Library)

Block 2705, Lot 2 is home to the Summit Free Public Library. The one-story brick building covers approximately half of the 1.8 acre parcel. The other half of the parcel is covered by a publicly accessible surface parking lot. The lot serves both the library's patrons as well as the adjacent YMCA recreation facility.

The building is in generally good condition and was not found to meet criteria under the LRHL. The parking lot, however, does meet the criteria and based upon an inspection of the property, a portion of Block 2705, Lot 2 meets the following criteria under the LRHL:

The use of this lot as a surface parking lot adjacent to a thriving downtown district is, in itself, significant to this analysis, based on the theory advanced under Concerned Citizens, (described above). Sufficient evidence exists to conclude that the current use and conditions upon the parking lot in Block 2705, Lot 2 support designation under 'Criterion D.'

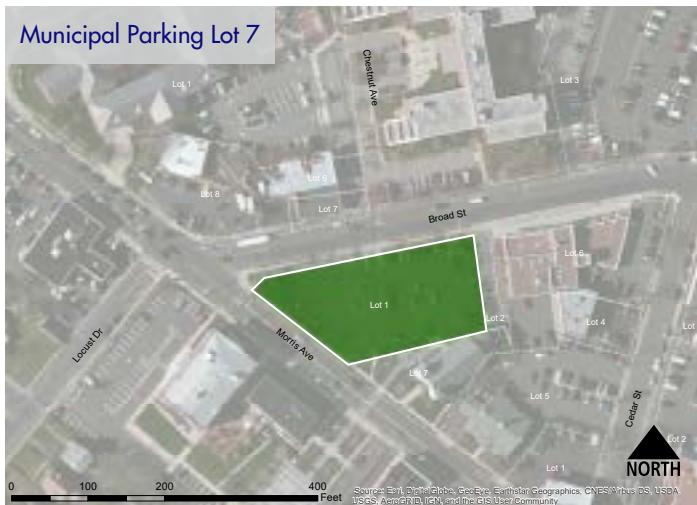
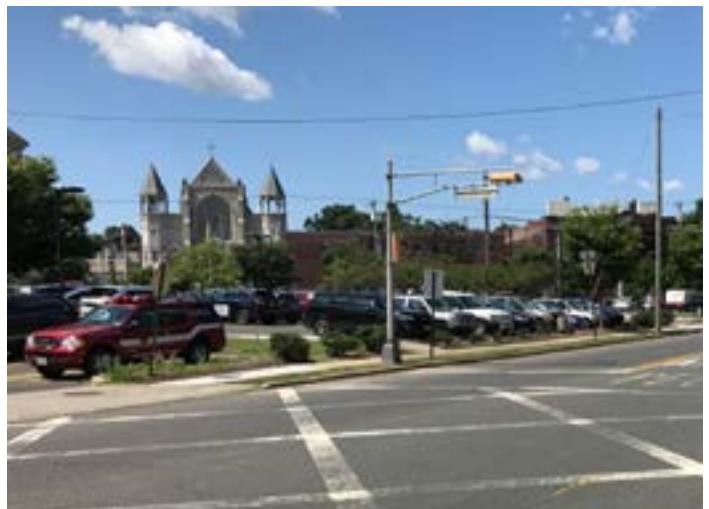
## Block 2706, Lot 1 - (Municipal Parking Lot 7)

Block 2706, Lot 1 contains Municipal Lot 7, also known as the Chestnut Avenue Lot, which has 62 parking spaces designated for residents and employees. It is located at the corner of Broad Street and Morris Avenue. The lot has a single egress point off Broad Street. The lot is paved but provides limited landscaping that includes shrubbery and trees. The municipal lot is marked with pedestrian crossings and has circulation markings throughout the lot.

Improvements on the lot consist almost entirely of surface parking, with limited pedestrian and landscaped area. Impervious coverage, primarily blacktop, occupies nearly the entire area of the parking lot. The condition of the lot is fair, the lot is properly stripped and appears to afford an efficient and safe circulation pattern.

Despite the fair condition, design and circulation, the use of this lot as a surface parking lot adjacent to a thriving downtown district is, in itself, significant to this analysis based on the theory described above relating to Concerned Citizens. As such, sufficient evidence exists to conclude that the current use and conditions of the parking lot in Lot 1 supports designation under 'Criterion D.'

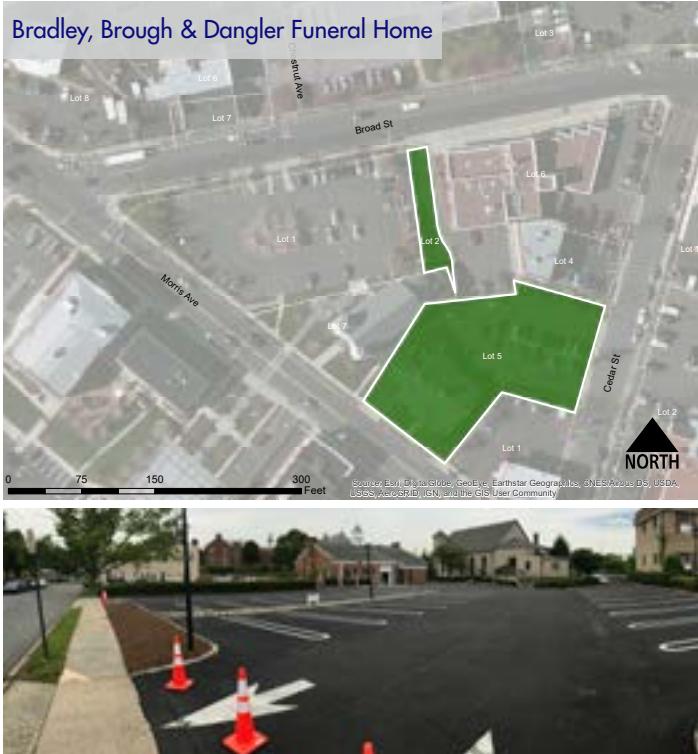
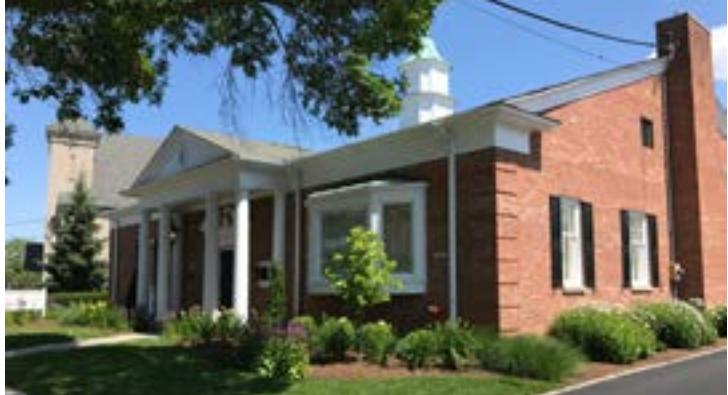
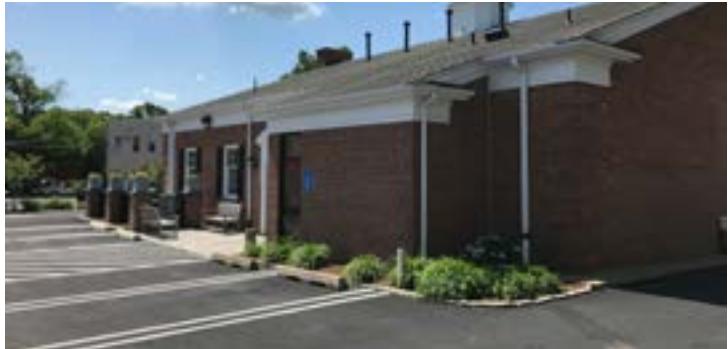
## Block 2706, Lots 2 & 5 - (Bradley, Brough & Dangler Funeral Home)

Block 2706, Lots 2 & 5 contain a single-story, brick, commercial building and accessory parking lots. Lot 5, which fronts on Morris Avenue, houses the principle commercial structure on the site: a funeral home. Lot 5 also has direct frontage onto Cedar Street, where a thirty-one spot parking lot is located. The parking lot is used by funeral home employees and visitors. Lot 2, which contains another twelve-spot parking lot, primarily serves as an additional point of egress onto Broad Street. Lot 2 is also used — via an easement, as the vehicular access point to the Summit Fire Department Headquarters building. The irregular three-pronged shape of these two lots give the property direct access to three streets: Broad Street, Cedar Street, and Morris Avenue.

Sufficient evidence exists to conclude that the current use and conditions upon Lots 2 & 5 support designation under "Criterion E."

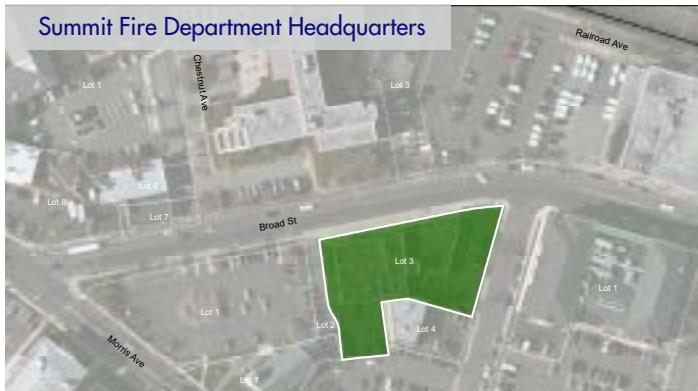
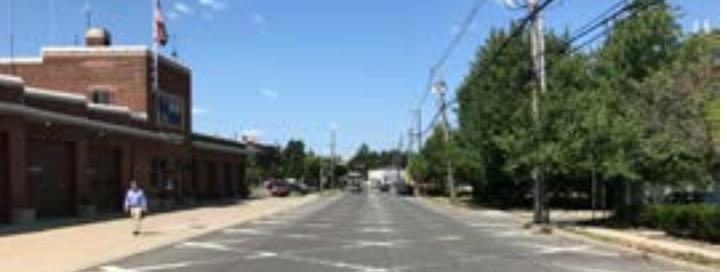
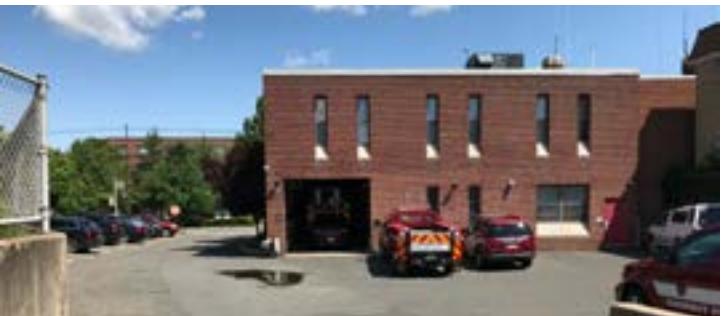
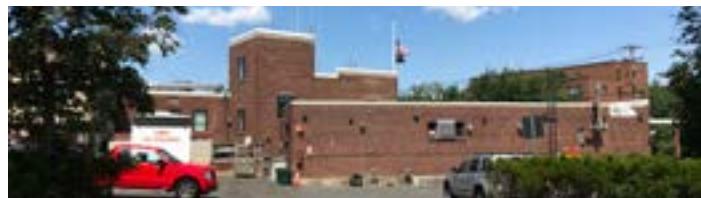
## Block 2706, Lot 3 - (Summit Fire Department Headquarters)

Block 2706, Lot 3 houses the Summit Fire Department Headquarters. The 16,298 s.f. two-story structure is located at 396 Broad Street. The center, two-story portion of the existing building was built in 1901. In 1948 four back-in bays were added in a saw-tooth arrangement to the structure. The two-story addition on the west side of the building was constructed in 1968, when three more back-in bays were added. In 1996, an exterior courtyard area was enclosed and interior office spaces were renovated.

In 2014, the City of Summit Fire Department commissioned a facility assessment of Fire Department Headquarters' building. The assessment report, completed by LeMay Erickson Willcox Architects and Brinjac Engineering, found that the building does not meet current station design standards. The Headquarters building was given a score of 12% based on criteria that included life safety code, accessibility, station alerting, emergency response paths, gender equality, and bunk facilities, among other criteria. Similarly, the site design was evaluated and found to not meet design standards. The site design was given a score of 22% based on criteria that included vehicle circulation, paving conditions, training features, outdoor amenities, trash/dumpster location, among other criteria.

The adjacent Lot 2 of the same Block provides the only point of entry to the back of the Firehouse building. The back of the building has one bay for emergency vehicles and several parking spots used by the Fire Department. Access to the back of the building is crucial to the function of this site and emergency response dispatch station. The City of Summit enjoys an easement on Lot 2, without which no access to the back of the building would exist. This condition of title impedes land assemblage and discourages the undertaking of improvements and results in a stagnant condition of the land.

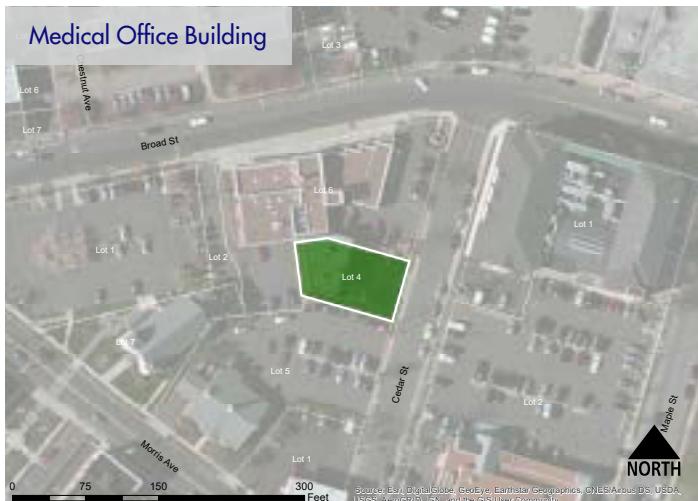
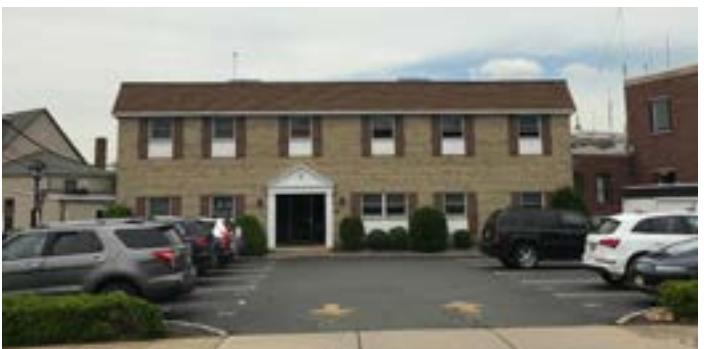
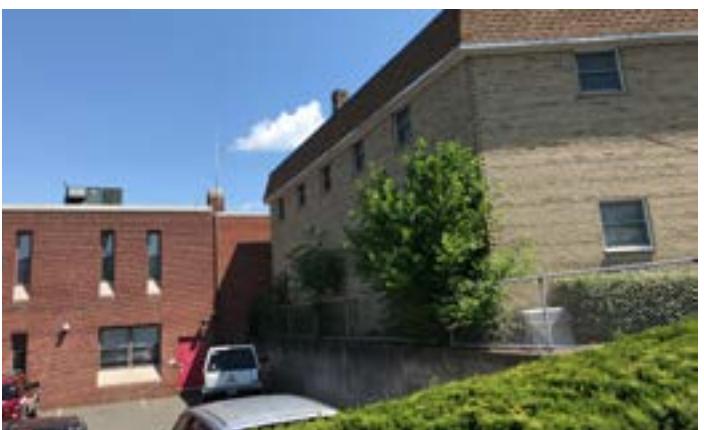
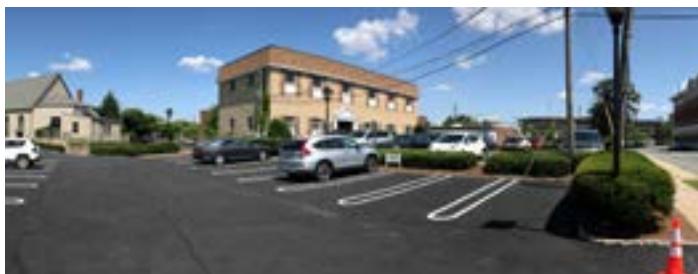
## Block 2706, Lot 4 - (Medical Office Building)

Block 2706, Lot 4 contains a two-story office building located on Cedar Street that abuts both the Summit Fire Department Headquarters building and the Bradley, Brough & Dangler Funeral Home parking lot. The 6,000 s.f. office building is a fully leased Class-B office building that houses multiple medical-office tenants. The office building is set back from Cedar Street and has a 12-car parking lot in front of the building.

The 6,000 s.f. office building is currently in fair condition and is fully leased. The arrangement and design of the site, however, is faulty due to the placement and amount of parking available to the facility which is entirely leased by dental and medical offices. Per the City of Summit's Development Regulation Ordinance, medical and dental offices shall have one parking space per 150 gross square feet of building area. This provision is in place in order to ensure that patients visiting medical or dental offices, who may have limited mobility due to disability, injury, or age, are able to safely access the offices. This site offers only twelve parking spaces for visitors to the office building. Per the aforementioned code, a 6,000 s.f. building that houses dental and medical uses should have forty spaces. The number of spaces provided (12) is twenty-eight spaces short of what would typically be deemed appropriate for such a use.

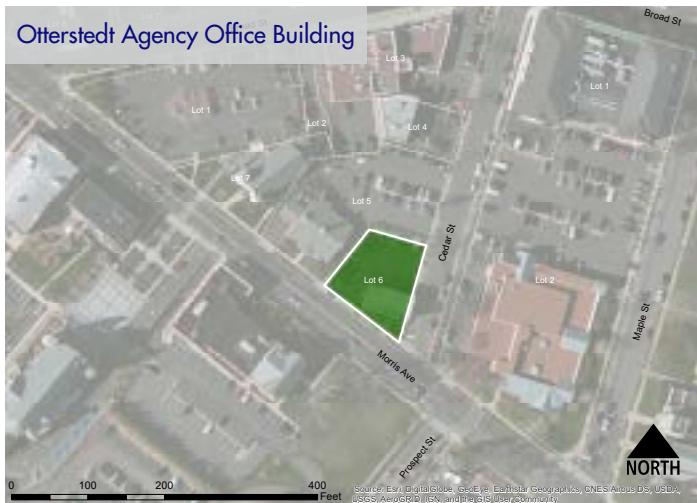
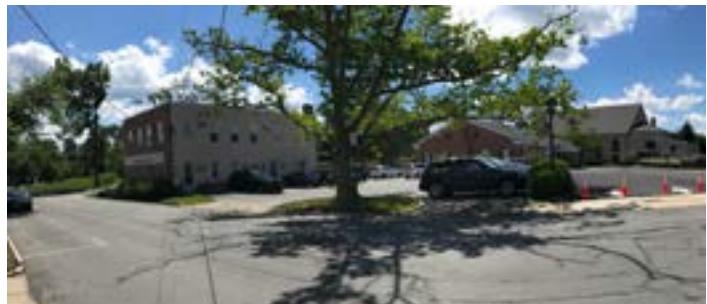
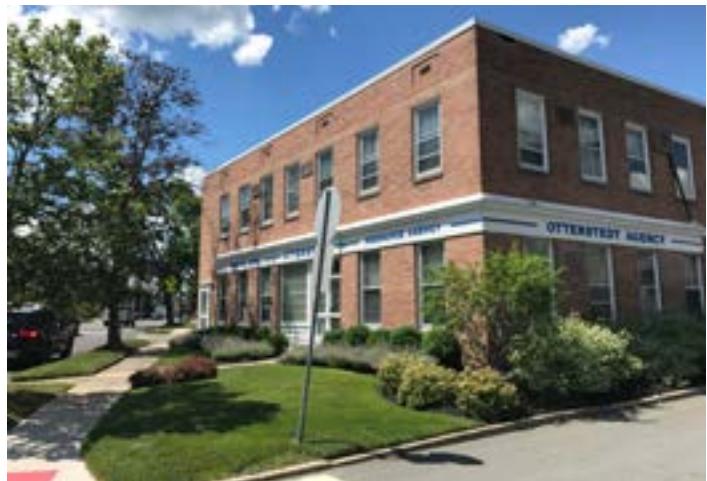
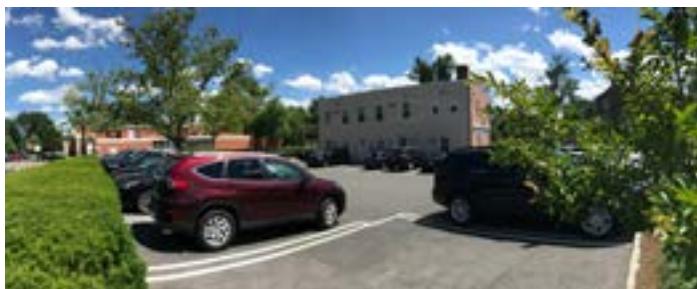
## Block 2706, Lot 6 - (Otterstedt Agency Office Building)

This owner-occupied office building is found to be in good condition and does not meet the criteria established in the LRHL (N.J.S.A. 40A:12A-5 et seq.).

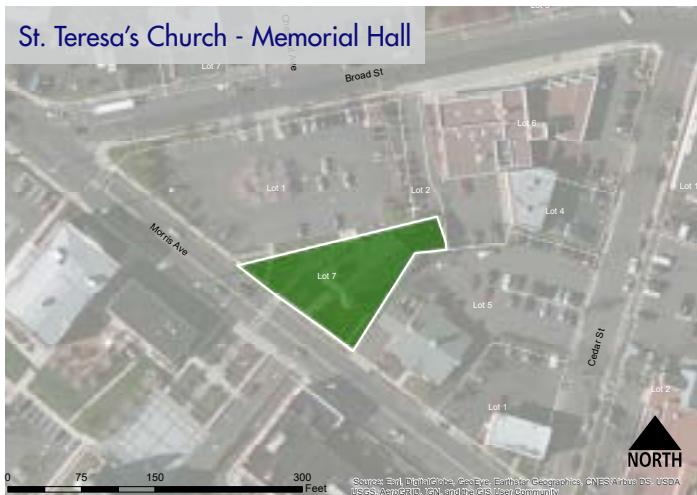
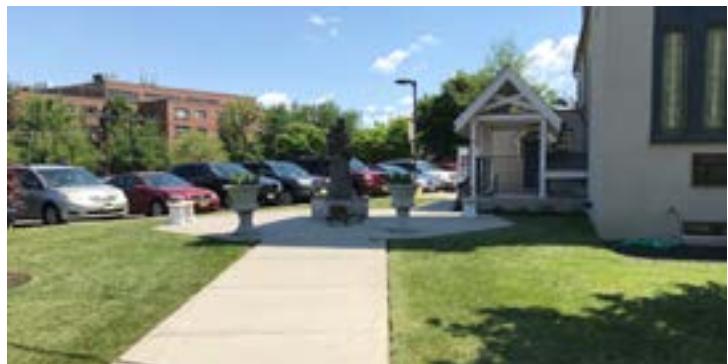
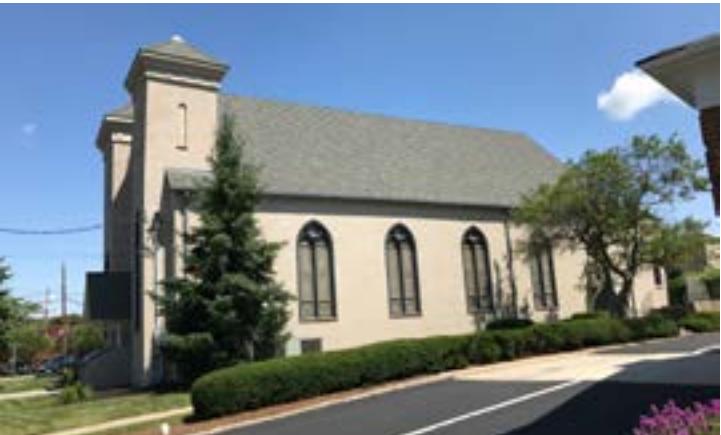
## Block 2706, Lot 7 - (St. Teresa's Church – Memorial Hall)

Memorial Hall is owned by the St. Teresa's Roman Catholic Church which also owns a much larger church across the street from this location on Morris Avenue. This smaller structure was moved here from its original location across the street around 1905, when the new place of worship was constructed. The church is in generally good condition and the site is well-maintained, with few signs of deterioration to its facade and windows. The facility does not have any dedicated parking adjacent to the premises.

Based upon an inspection of the property and an examination of construction and inspection Block 2706, Lot 7 does not meet any of the criteria under the LRHL. While access was not gained into the building, the exterior of the structure and improvements to the site appear to be in good condition. The church itself does not have any direct parking on-site as it shares parking with the much larger St. Teresa's Church across the street. The only adjacent ADA accessible parking spots are available at Municipal Lot 7 northwest of the building.
