Restoring Failing Pipe Systems Is a Win-Win Decision

By Amanda Strouse

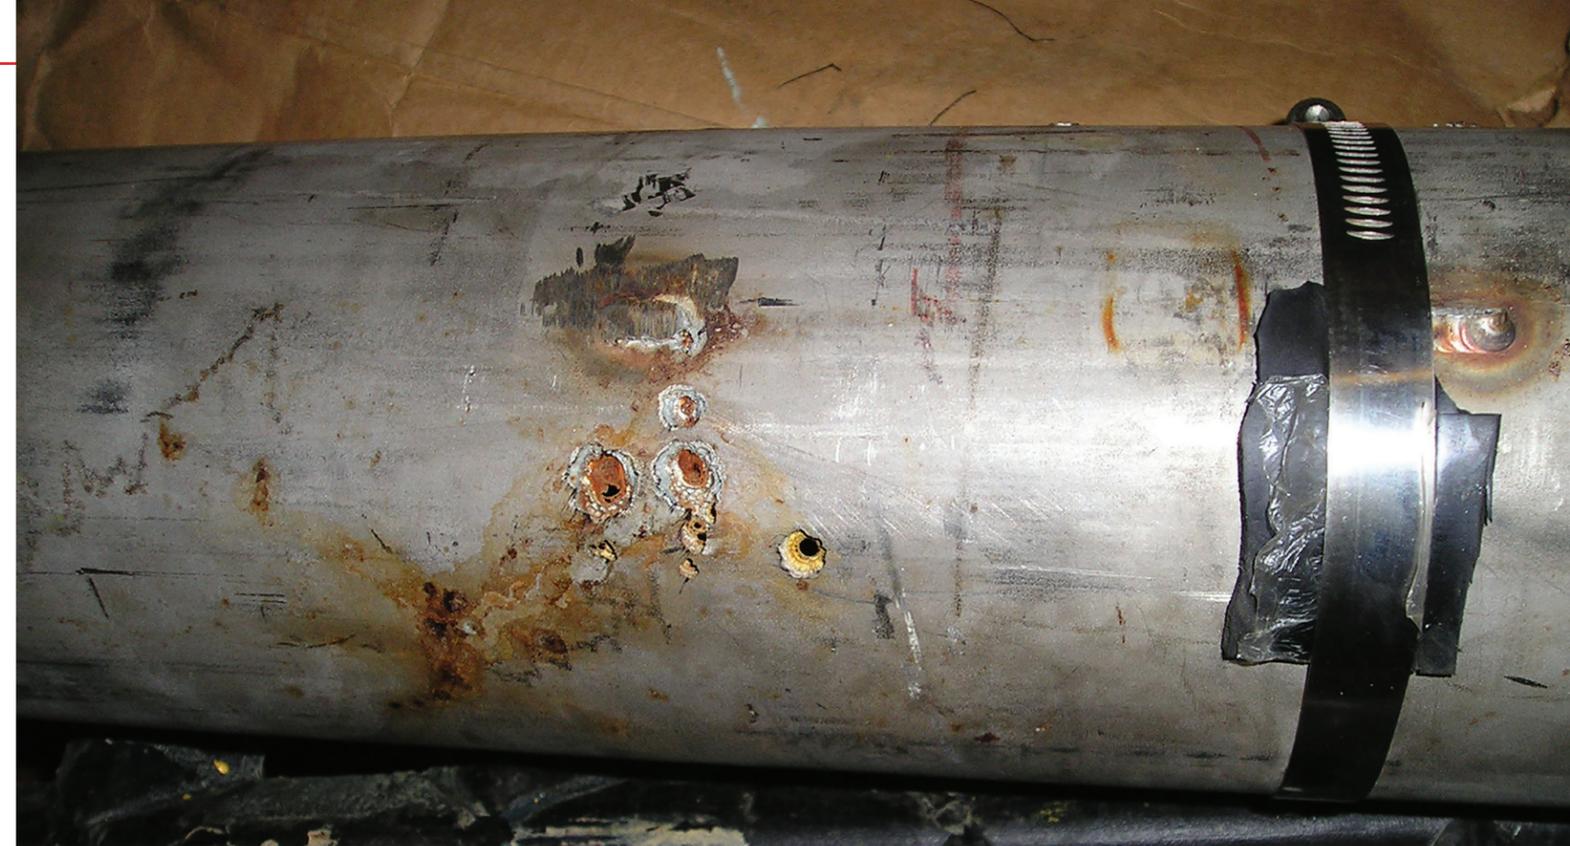
Pictured: Failing pipes with holes that caused leaks.

profile the pipes. Next, the epoxy is blown through the pipe system using compressed air and sometimes a vacuum assist, then the epoxy coating inside the pipe system is left to cure. Finally, after the curing time has passed, the epoxy has formed a thin, yet protective barrier coating inside the pipes. This barrier coating will prevent pinhole leaks, slab leaks, corrosion, buildup, rusty water and other types of failures.

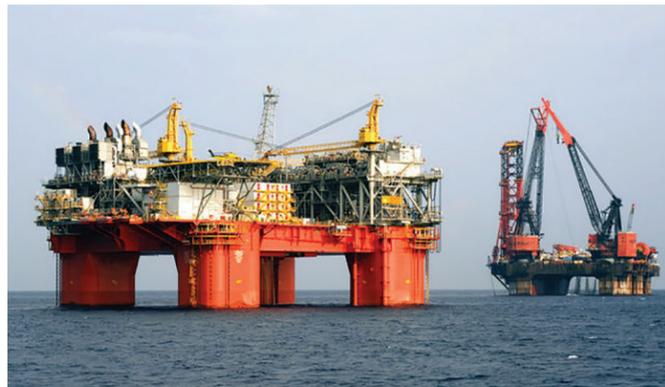
The Atlantis production and drilling platforms, where pipe corrosion necessitated an ePIPE solution.

domestic pipe system for the living quarters, ranging from ½" to 3" in diameter, was experiencing constant leaks due to premature corrosion, dissimilar metal corrosion or workmanship error.

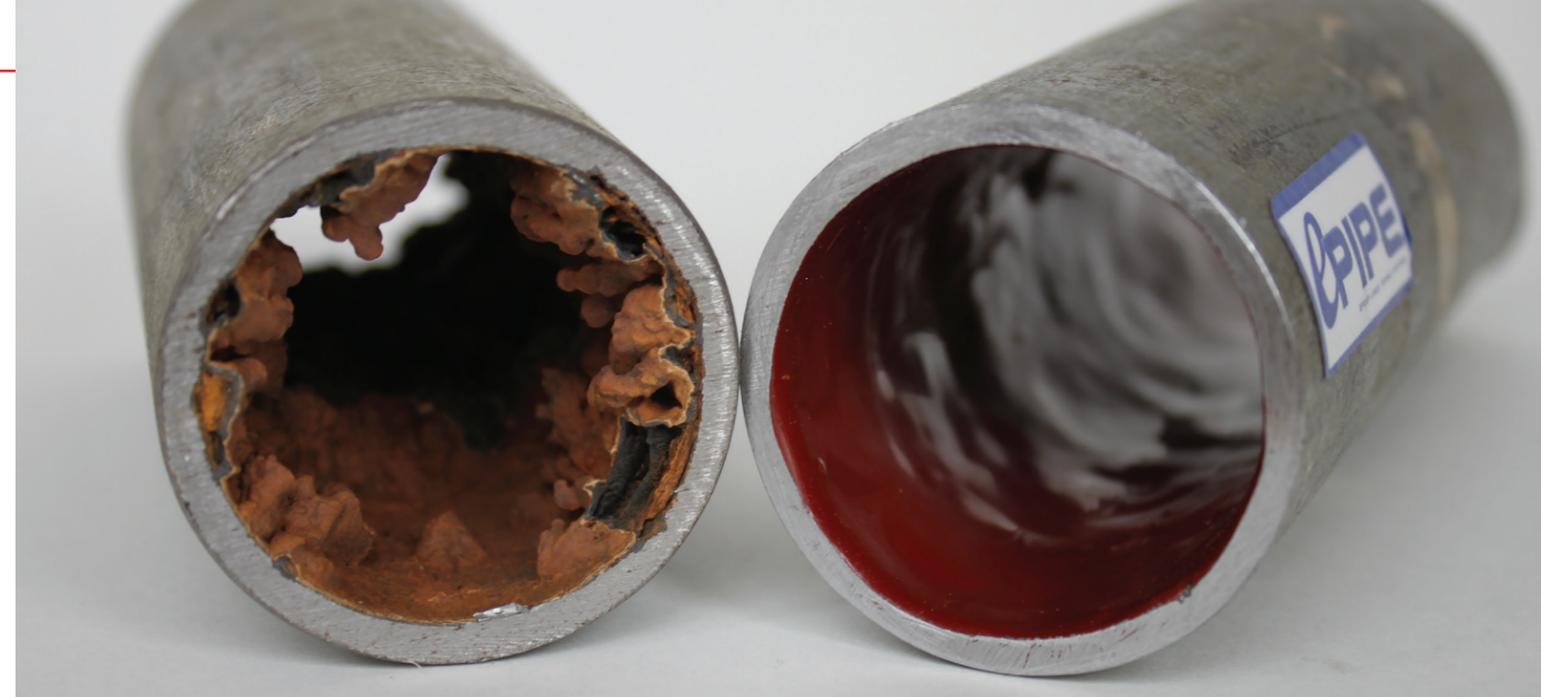
A heavily corroded galvanized drinking water pipe (left) and the same pipe cleaned and lined with the ePIPE epoxy coating (right) galvanized pipes.

After hooking up the equipment to access points, the epoxy coating was blown through the pipe system using clean, compressed air. The epoxy cured to form a protective barrier coating throughout the pipes, which will prevent future pinhole leaks, corrosion and other failures. The entire epoxy coating project was of no hindrance to the other crews working on their ongoing maintenance projects for the platform.
