HISTORIC BRICKWORK

Background

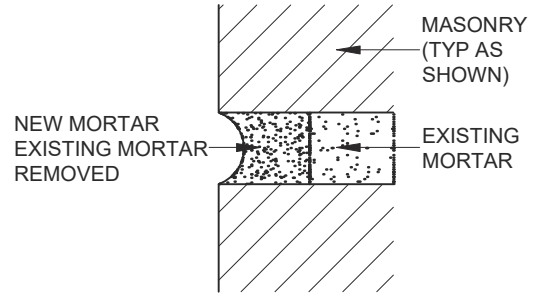
VEE (G)

TUCK POINTING (I)

different manners, and, by replicating the mortar joints, the remediation should present a wetted surface similar to the existing. A copy of common mortar joints has been included in APPENDIX 'A'.
