# Truss Analysis

Truss spans about 37 feet with a 4/12 pitch on top and a 2/12 pitch. Spacing 2'-0". (I was wrong about 30 feet) all 2x4 members

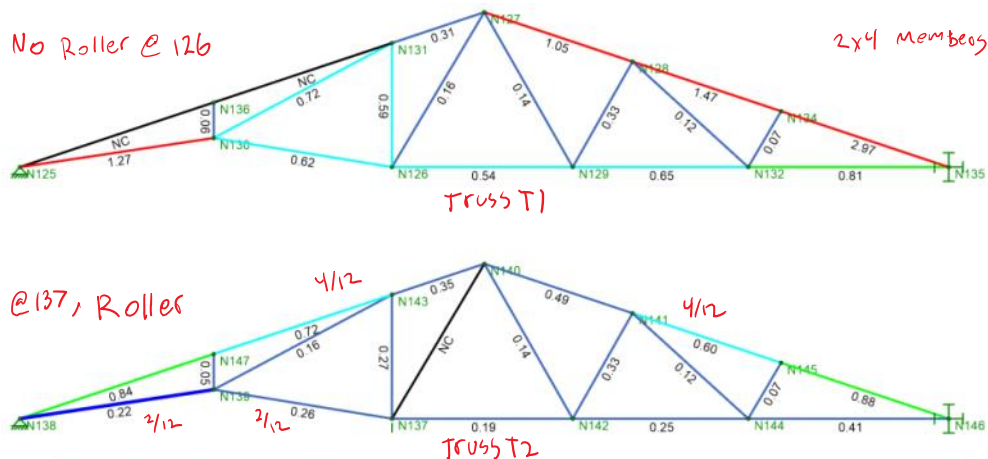
Risa model. Pinned all members. Used unbraced length

Top chord	Bottom chord
<b>Design Properties</b> le2, ft: 1 le1, ft: Segment le-bend top, ft: 1 le-bend bot, ft: Segment K y-y: ... K z-z: ...	<b>Design Properties</b> le2, ft: 2 le1, ft: Segment le-bend top, ft: Segment le-bend bot, ft: 2 K y-y: ... K z-z: ...

Envelope Node Displacements					
	Node Label		X [in]	LC	Y [in]
1	N126	max	0.282	2	-0.362
2		min	0.105	1	-0.975
3	N127	max	0.149	2	-0.329
4		min	0.055	1	-0.886
5	N140	max	0.018	2	-0.011
6		min	0.007	1	-0.029

Same trusses, just a roller added at N137. Truss is failing, looks like the wall is load bearing, and or not an intentional load bearing wall. Went into the crawl space and the wall looks to be about 32" away from the center beam. what do you guys think?
