## TEST REPORT 1103/23-520-2-EN

on testing hail resistance on  
External Thermal Insulation Composite System

DALMAÇYALI ORGANIC  
THERMAL INSULATION SYSTEM

according to  
according to FM Approval 4473

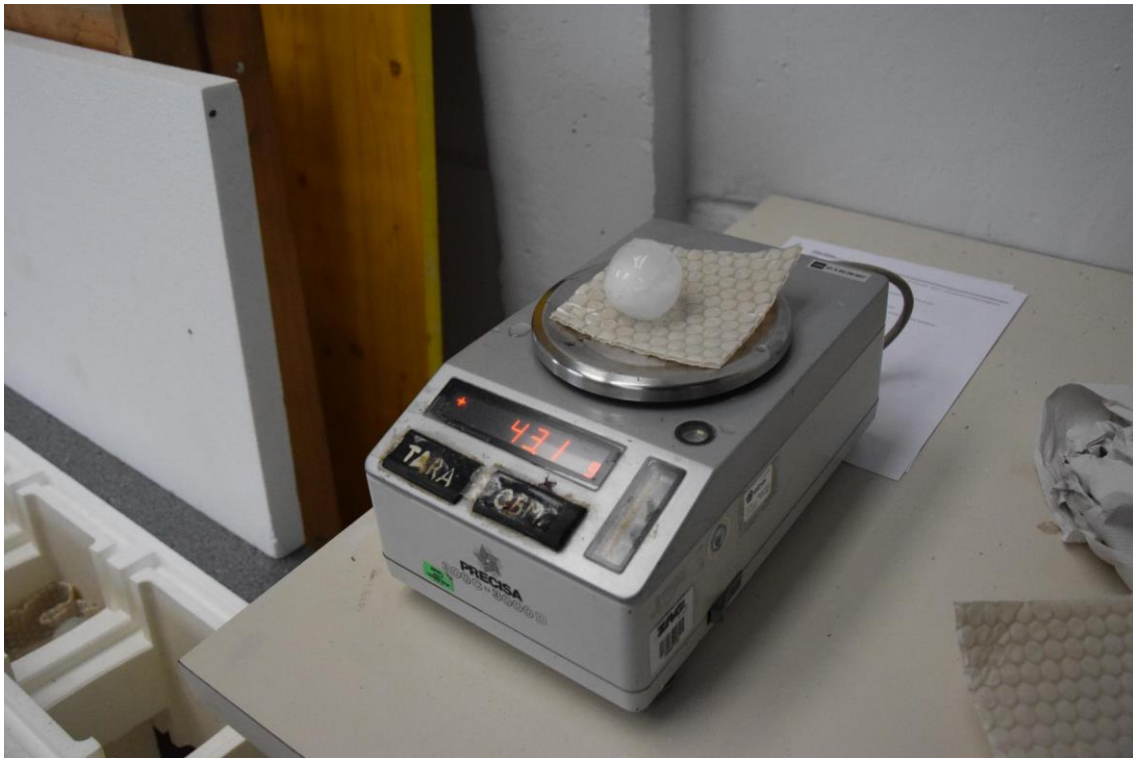
*Picture 2: Weighing of the ice balls*

Ice balls were prepared by freezing distilled water in freezing molds at  $-22^\circ\text{C}$ . During the test, the corresponding number of nominally equal ice balls was fired onto the sample. The target location of the ice balls, missiles, were different places on the sample. Before the launch, each ice ball was weighed to determine its mass, and measured to determine the diameter.

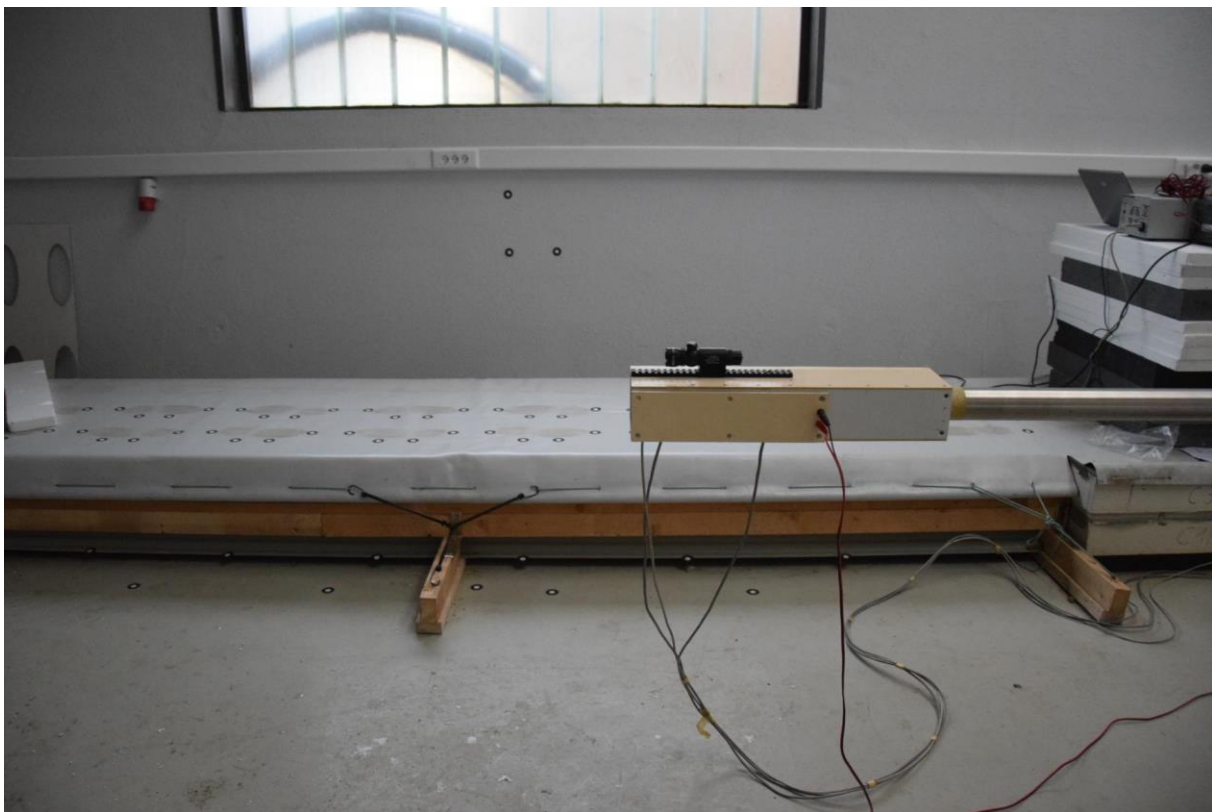
*Picture 4: The velocity measurement cell on the end of the bombarding pipe.*

Testing on the sample under consideration was carried out with an aerial cannon. The test equipment consisted of an aerial cannon with adjustable speed of a projectile, a metering system for measuring the velocity of the projectile at the exit from the cannon tube and ancillary equipment.

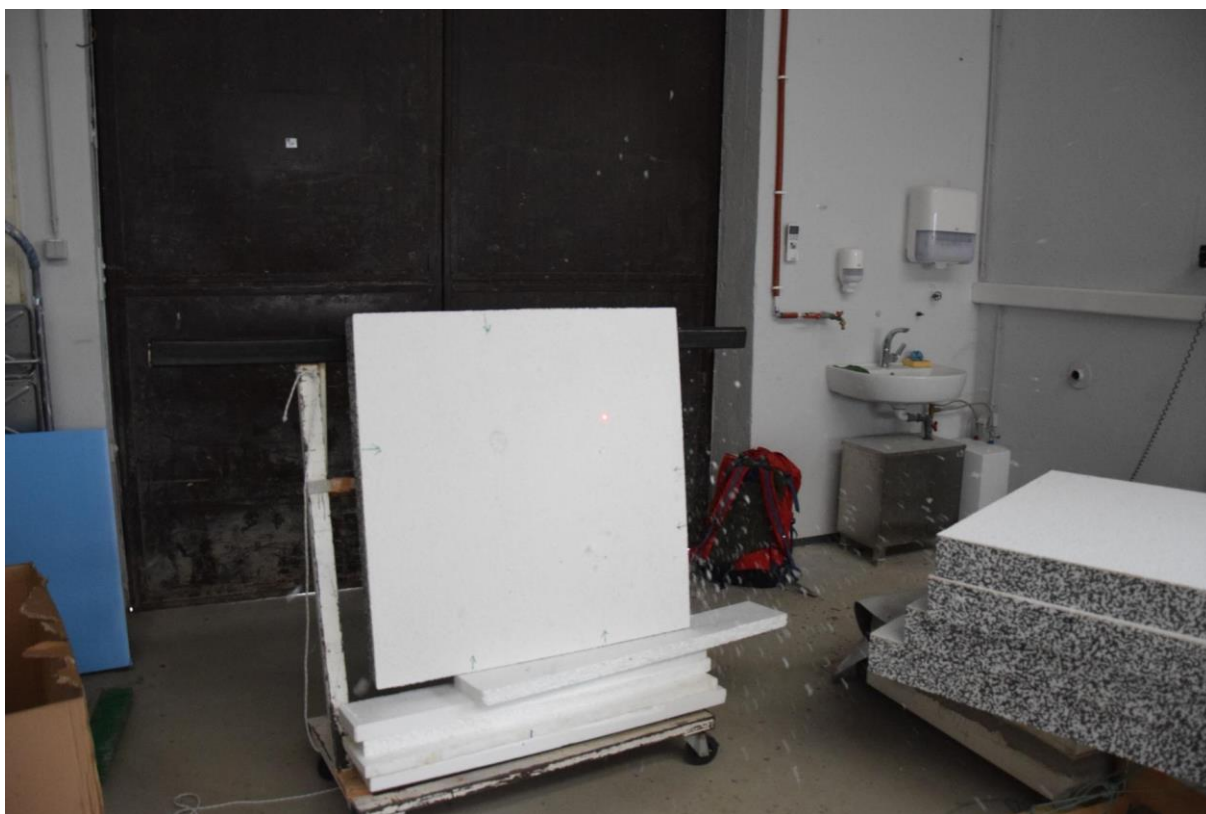
*Picture 5: Moment of the impact of the ice ball*

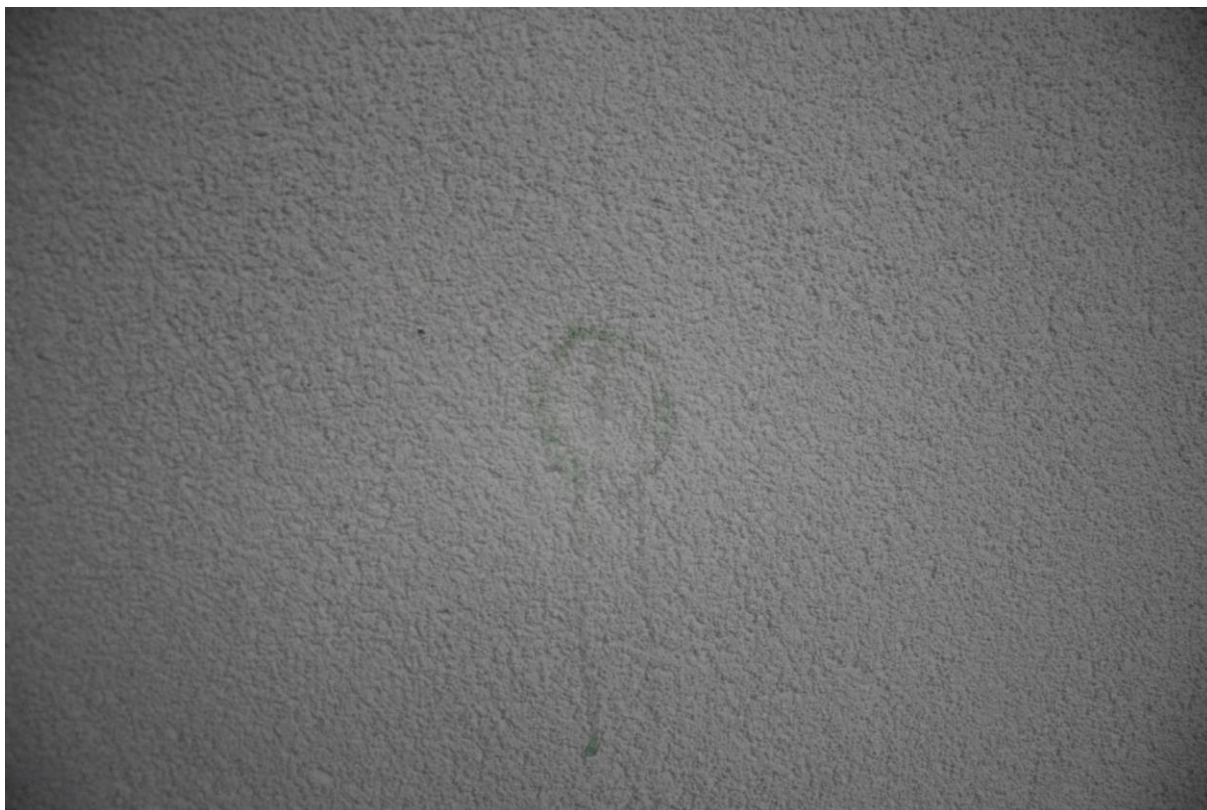
*Picture 7: Inspection of the damage caused by the impact - only a slight depression is visible on the surface of the ETICS, without any cracks*

During the test, i.e. controlled bombardment with the ice balls with a nominal size of 44.5 mm and a nominal impact energy of 19.0 J (category 3), very small depressions have occurred on the outer surface of the ETICS, therefore the Category 3 is achieved. There was no difference in damage between individual specimens of the sample.

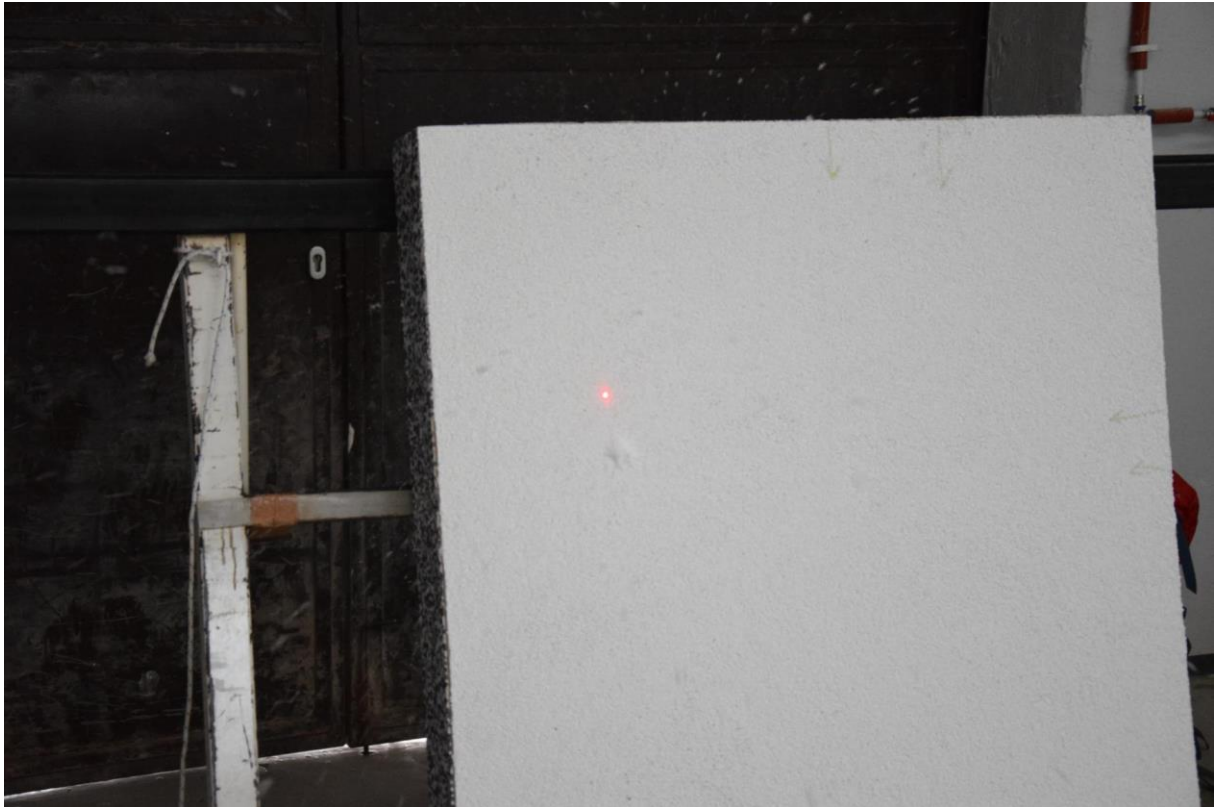
*Picture 9: After the impact some ice is visible on the surface of the ETICS*

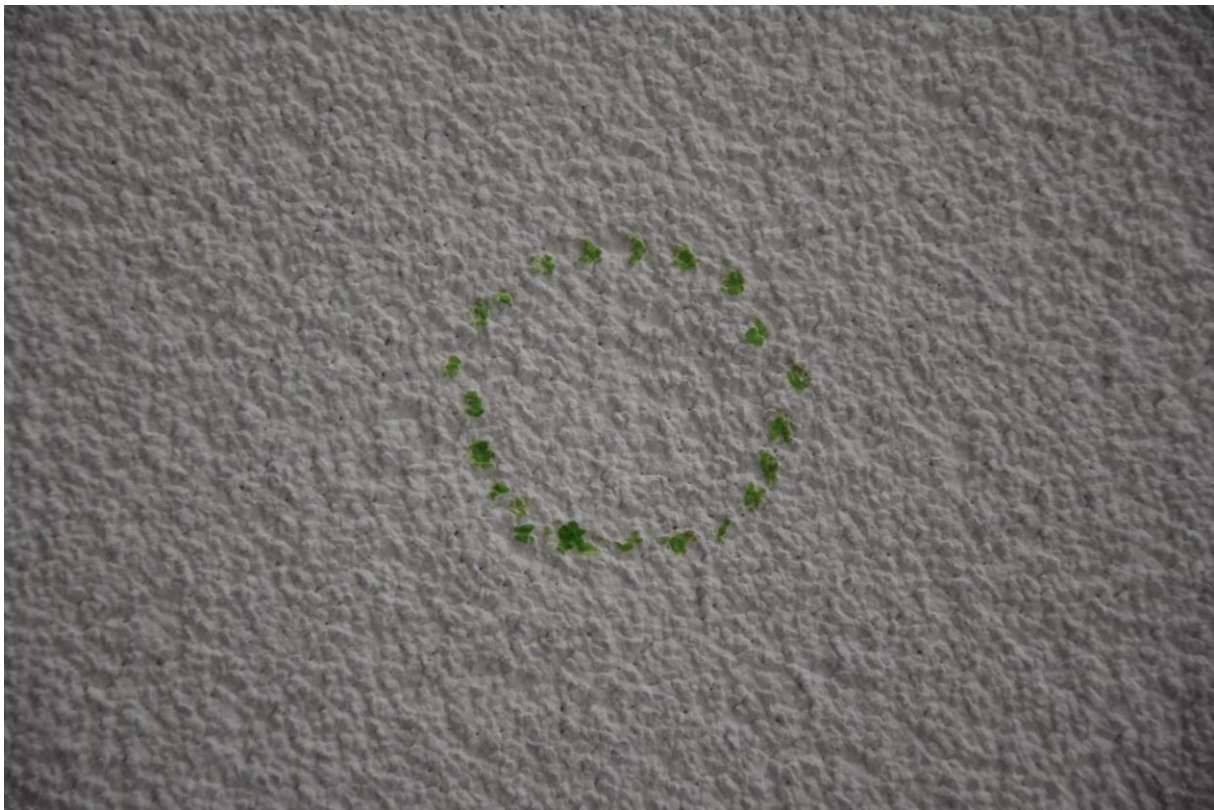
*Picture 10: Inspection of the damage after the impact - almost no visible damage on the surface of the ETICS*
