Daniel Blücher, Ole Øystein Knudsen SINTEF

The Problem

Korrosjonsbeskyttelse av sprinklersystemer

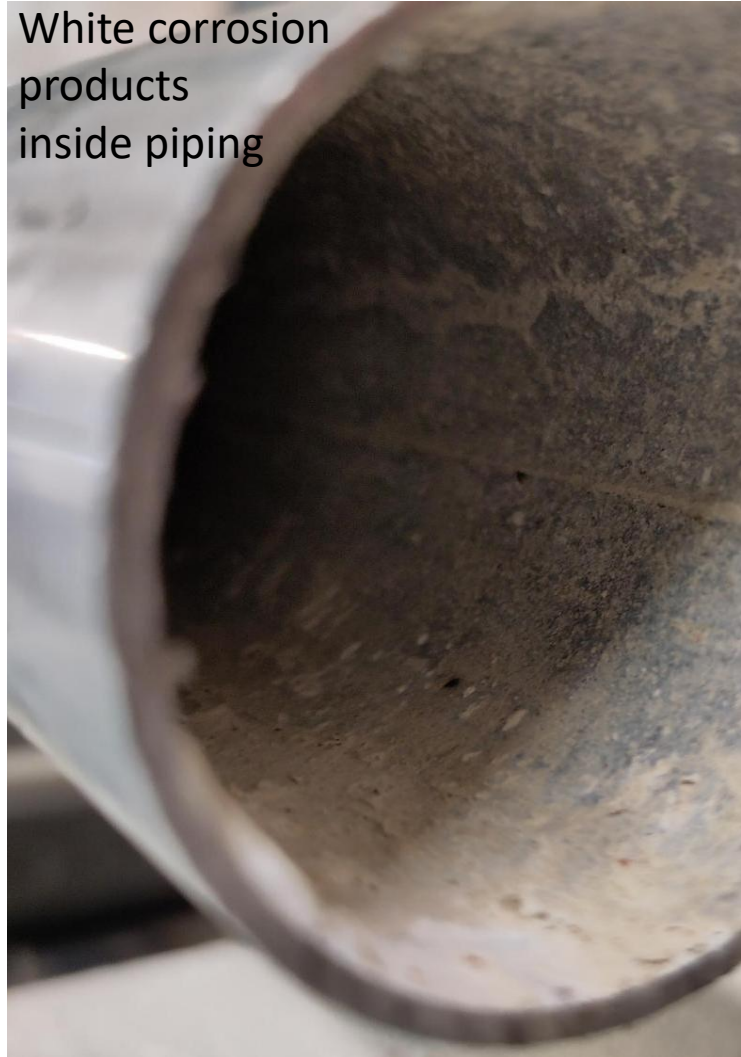
White corrosion products inside piping

1.8 mm steel pipes protected from corrosion by a zinc coating. Installation 2014. Filled with tap water at 5 bar with pressure increase reported in 2015

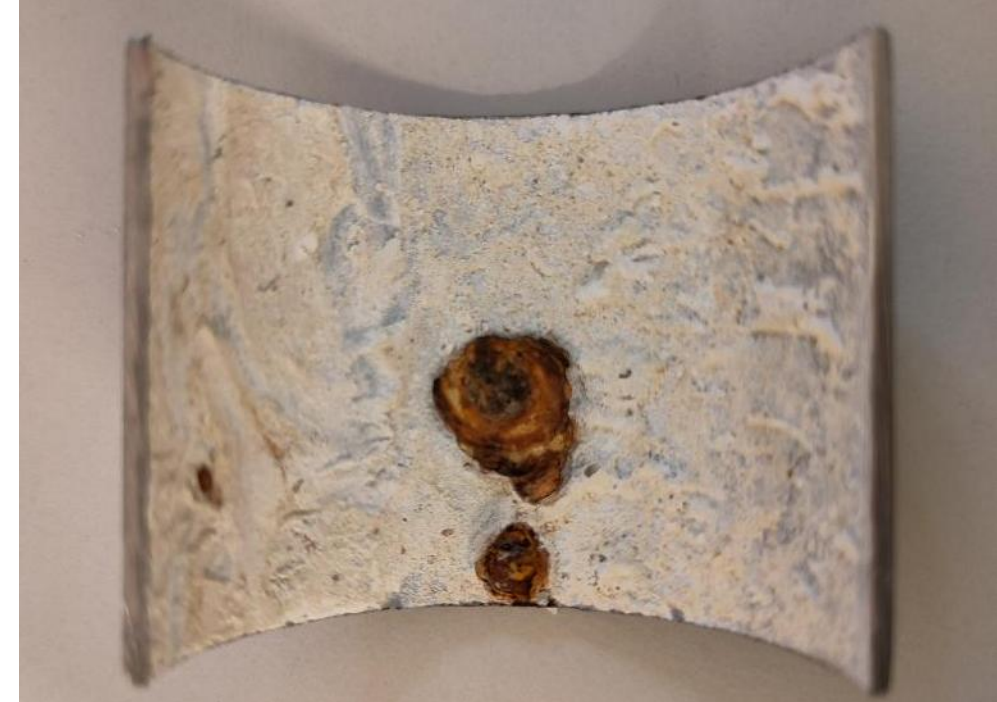
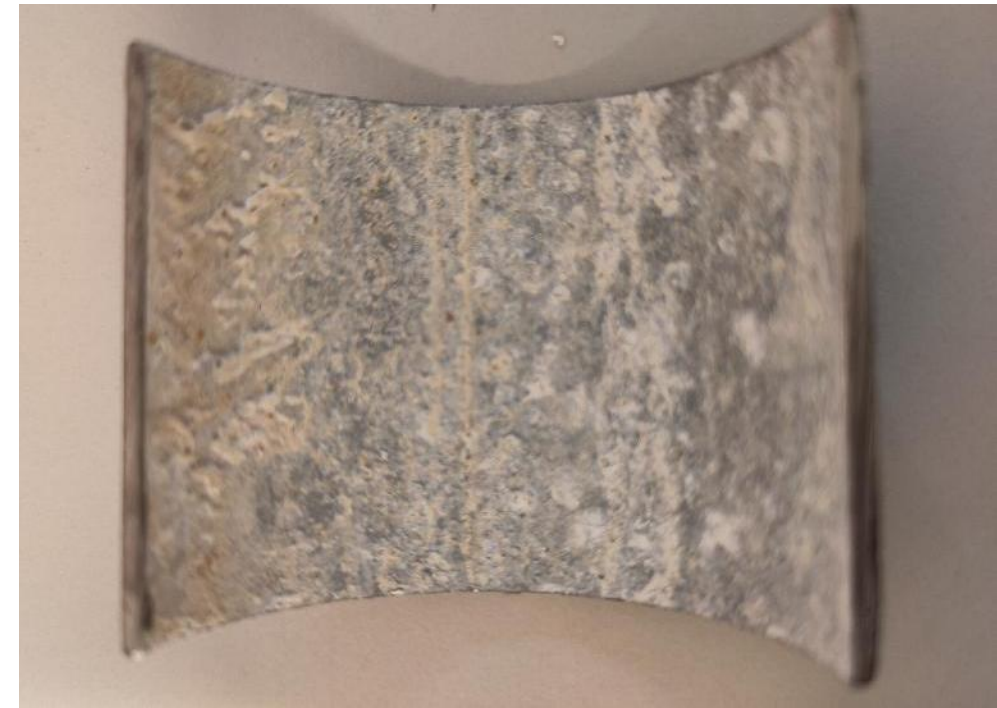
- The pipe system is half filled with water
 - Hydrogen evolution pushes the water out of the pipe
 - The pipe system is not properly ventilated during filling
- The zinc corrodes away in the water phase under hydrogen evolution
- When the zinc is gone, there is no cathodic protection → red rust formation.
- The microbes in the water can form tubercles and create an aggressive environment for the steel substrate
- The zinc in the atmosphere can still produce hydrogen from the humidity

- A possible way to solve the problem with the hydrogen pressure increase is to install evacuation valves at the highest points for the hydrogen gas to escape
- Vent the system frequently
- Use of carbon steel, stainless steel or glass fibre re-inforced piping
- Dry piping over nitrogen gas can also be a solution

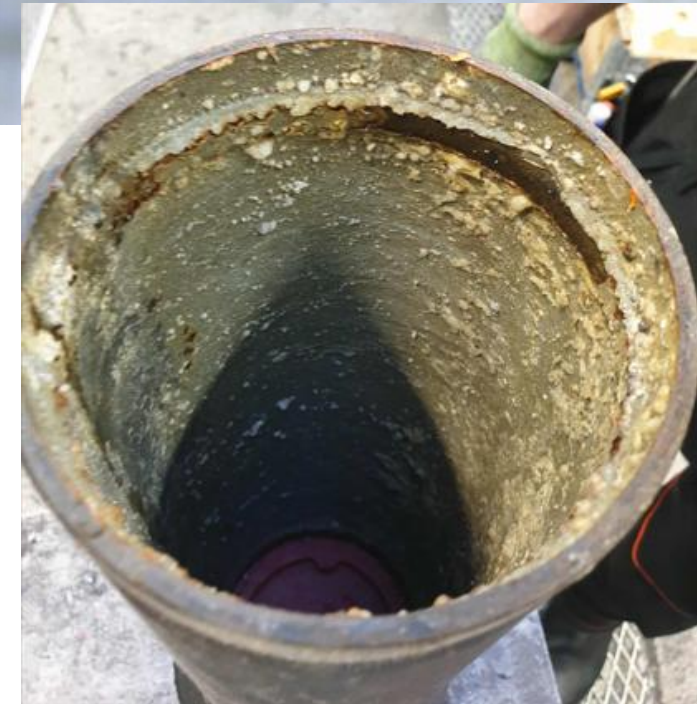
- The microbes in the water may produce an acidic environment that etches the steel
- But is microbiologically influenced corrosion possible?
 - The zinc is somewhat toxic – should this not kill the microbes?
 - The water contains no nutrients or organic molecules to build cells?

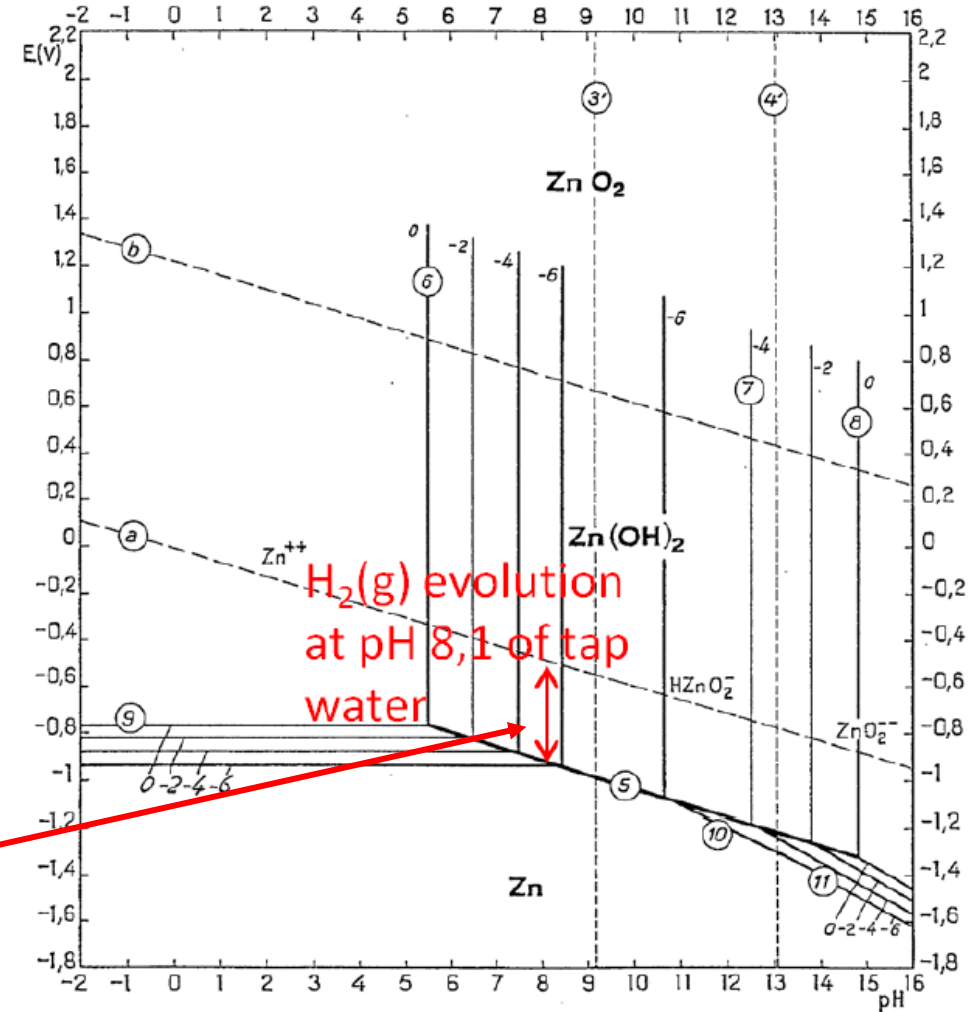
- Zinc is a very active material. This is illustrated in the stability diagram of Zn in aqueous solution. The red arrow is the hydrogen overpotential at with Zn corrodes causing the evolution of hydrogen gas.
- The corrosion of the zinc layer inside the pipes is governed by the selective dissolution of zinc to protect the steel.
- The chemical reaction for this is:
 - (1) $\text{Zn} \rightarrow \text{Zn}^{2+} + 2\text{e}^-$
 - The counter reaction being:
 - (2) $\text{O}_2 + 2\text{H}_2\text{O} + 4\text{e}^- \rightarrow 4\text{OH}^-$ Dissolved oxygen in the water is consumed, or:
 - (3) $2\text{H}_2\text{O} + 2\text{e}^- \rightarrow \text{H}_2(\text{g}) + 2\text{OH}^-$
 - The hydrogen evolution will cause the pressure to increase, as observed.

Pourbaix diagram for Zn in aqueous solution [Pourbaix 1954]

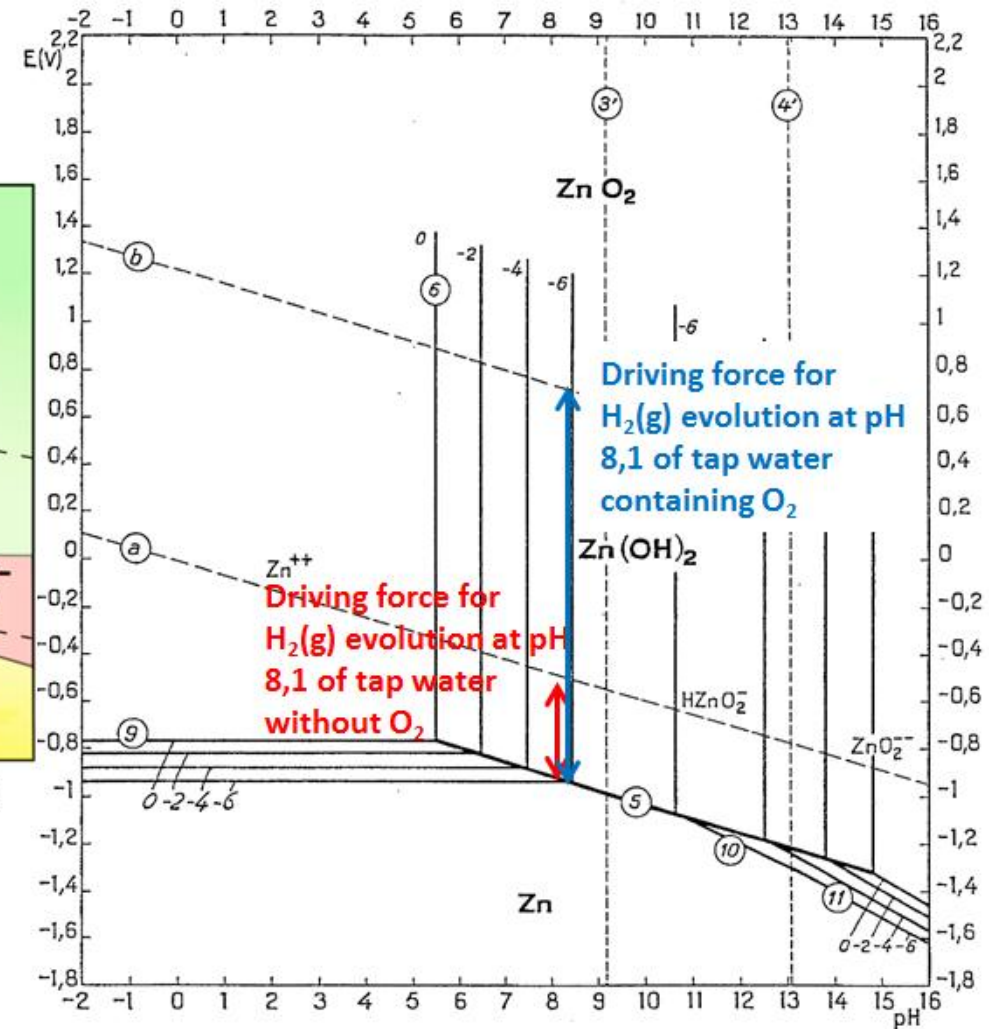
Stability diagrams (Pourbaix) of the iron and Zn chemistry

The thermodynamical driving force for the zinc dissolution and the formation of hydrogen gas is also strong without O_2 (dead water) dissolved in it.
